bullion S

Customer Release Note - TS006.04

■ Number DEL000906

■ Version F.4

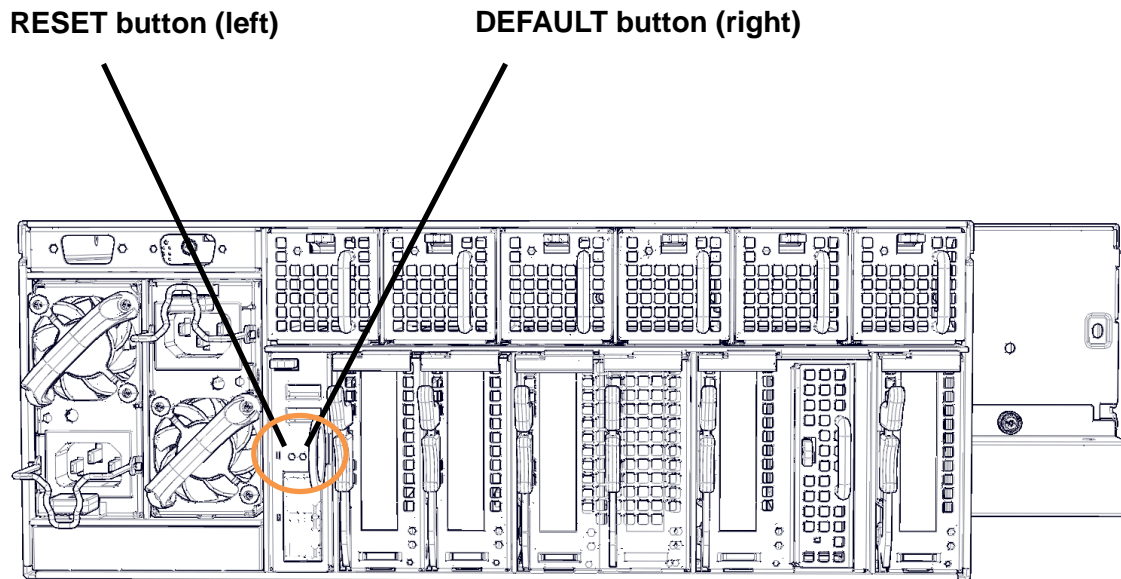
8.4. Reset and Default buttons

The Reset and Default buttons are close together. Be careful to press the appropriate button indicated on the figure to reset the BMC / EMM.

Pressing the Default button restores the EMM manufacturing configuration.

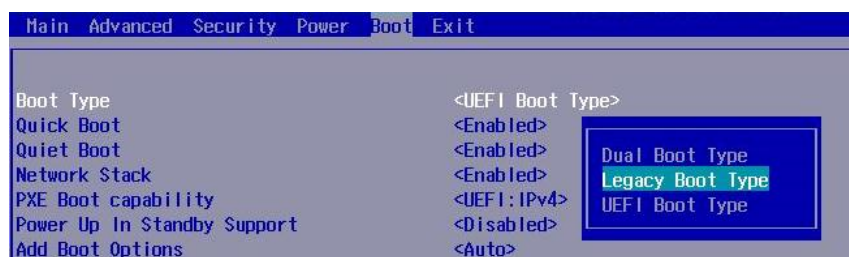
Issue

2. In the “**Boot**” section, select for Boot type “**Legacy Boot Type**”. Save by pressing F10 and reboot the system in Legacy mode.

3. Reconfigure or rebuild the RAID disks under LSI utility
4. When the install is done, let the system reboot and go again to BIOS “**Setup Utility**”, then “**Boot**” section, select for Boot type “**UEFI Boot Type**”. Save by pressing F10 and reboot the system in UEFI mode.
