Customer Release Note - TS008.02

■ Number DEL000906

■ Version H

This document is the customer release note for **Technical Status 008.02**.

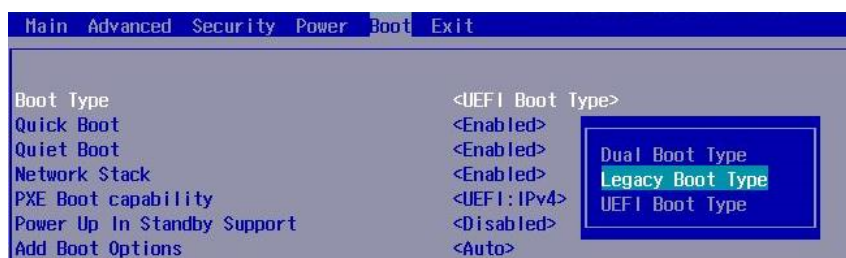
9.3. LSI MegaRAID 9261 card first configuration

Issue

Legacy mode (not UEFI) must be used the first time the LSI MegaRAID 9261 card is configured.

1. Boot the server to BIOS “**Setup Utility**”, by pressing the ESC key or using the bsmBootDevice CLI command:
 - From a Linux console:

Launch Cygwin:
bash login -i
 Enter:
cd /bin
bsmBootDevice.sh -H <host> -u <user> -p <password> -d bios
2. From the **Boot** menu, select **Legacy Boot Type** as a boot type. Save by pressing F10 and reboot the system in Legacy mode.

3. Reconfigure or rebuild the RAID disks using the LSI utility
4. When the installation is finished and the system reboots, enter the BIOS **Setup Utility**, and from the **Boot** menu select **UEFI Boot Type**. Save by pressing F10 and reboot the system in UEFI mode.
