# Customer Release Note - TS008.04

■ Number DEL000906

■ Version J

This document is the customer release note for **Technical Status 008.04**.

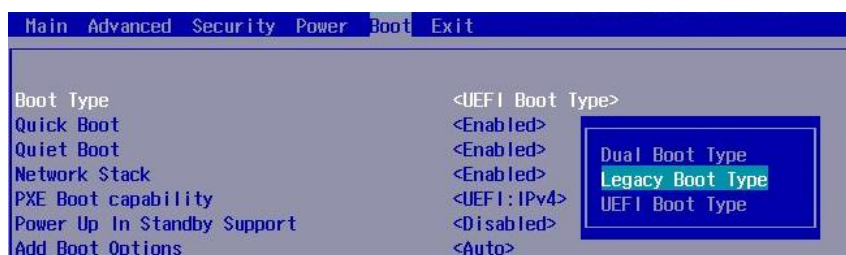
### 9.3. LSI MegaRAID 9261 card first configuration

Legacy mode (not UEFI) must be used the first time the LSI MegaRAID 9261 card is configured.

Launch Cygwin:  
**bash login -i**  
 Enter:  
**cd /bin**  
**bsmBootDevice.sh -H <host> -u <user> -p <password> -d bios**
2. From the **Boot** menu, select **Legacy Boot Type** as a boot type. Save by pressing F10 and reboot the system in Legacy mode.

3. Reconfigure or rebuild the RAID disks using the LSI utility
4. When the installation is finished and the system reboots, enter the BIOS **Setup Utility**, and from the **Boot** menu select **UEFI Boot Type**. Save by pressing F10 and reboot the system in UEFI mode.
