Release Note TS 21.02

Hardware

July 2019

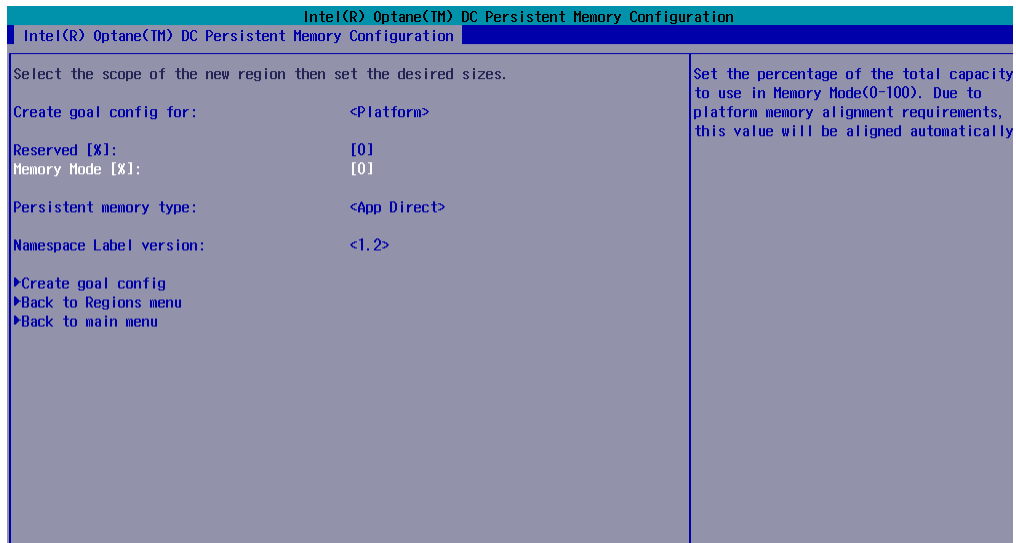
4.13. Intel® Optane™ DCPMM for SAP HANA

Check that Intel® Optane™ DC Persistent Memory (DCPMM) configuration is as follows:

Reserved [%]:	[0]
Memory Mode [%]:	[0]
Persistent memory type:	<App Direct>

If that is not the case, modify the configuration.
