# Release Note TS 22.02

### **Hardware**

**December 2019**

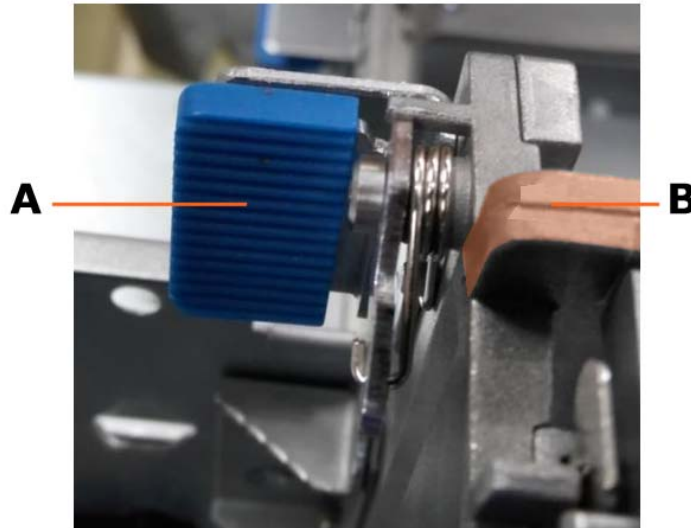
1. Check that the latch (A) is parallel to the top of the side wall (B) as shown below.

2. Press the latch (A) down to secure the HDD cage in place.

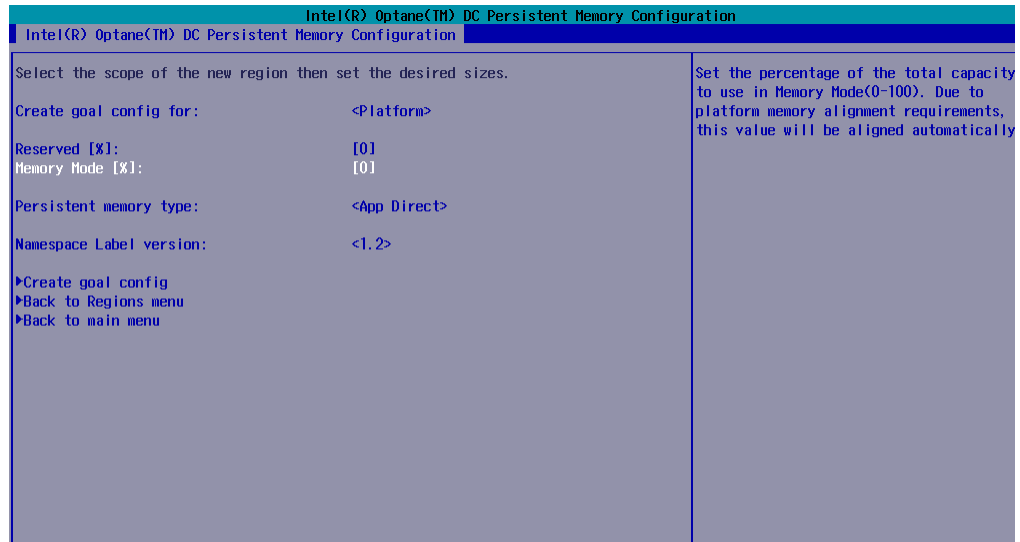
Check that Intel® Optane™ DC Persistent Memory (DCPMM) configuration is as follows:

Reserved [%]:	[0]
Memory Mode [%]:	[0]
Persistent memory type:	<App Direct>

If that is not the case, modify the configuration.
