Release Note

TS 05.02

Hardware

April 2018

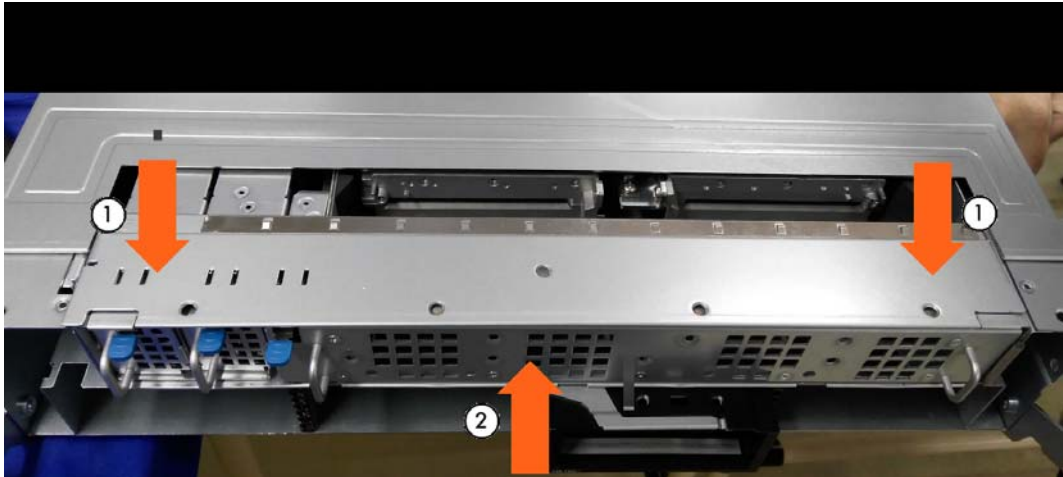
2.20. Storage Unit insertion in a multi-module

For BullSequana S400 server or BullSequana S800 server there are cases where the storage drawer does not insert smoothly into the compute box.

1. Carefully press on the top cover of the storage drawer

2. Insert the storage drawer into the compute box.

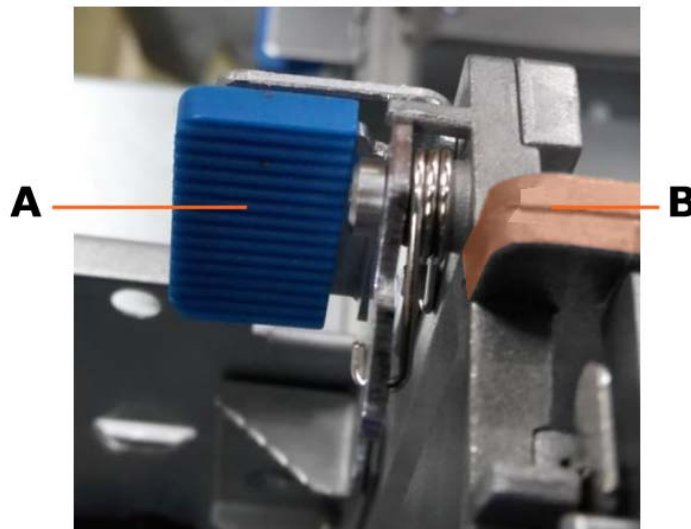
2.21. Locking a 2.5" Disk Storage Unit

In some cases the latch does not insert properly into the locking bracket

1. Check that the latch (A) is parallel to the top of the side wall (B) as shown below.

2. Press the latch (A) down to secure the HDD cage in place.
