Release Note TS 20.03

Hardware

May 2019

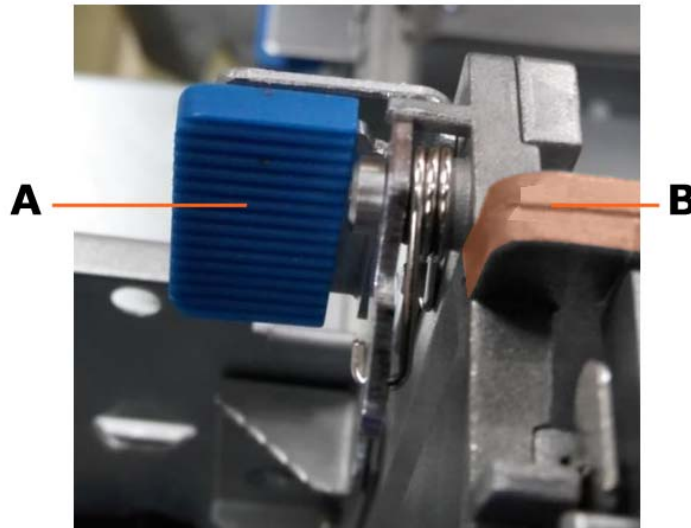
2.1.16. Locking a 2.5" Disk Storage Unit

Issue

In some cases the latch does not insert properly into the locking bracket

Workaround

1. Check that the latch (A) is parallel to the top of the side wall (B) as shown below.

2. Press the latch (A) down to secure the HDD cage in place.
