# Release Note TS 22.04

### **Hardware**

**August 2020**

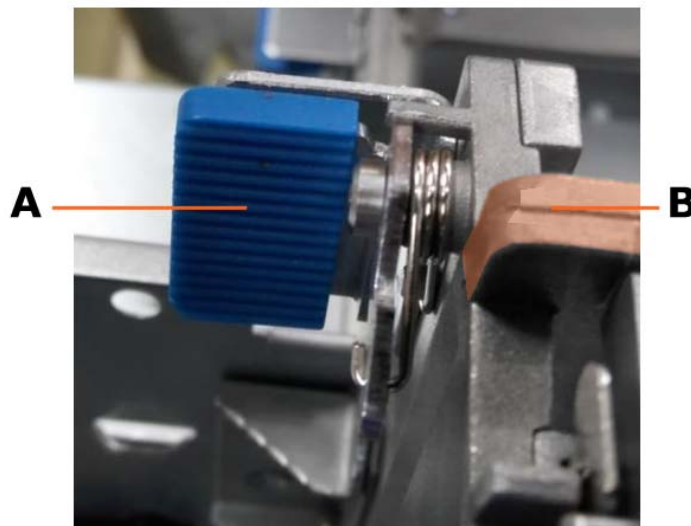
### 2.1.21. Locking a 2.5" Disk Storage Unit

In some cases the latch does not insert properly into the locking bracket

1. Check that the latch (A) is parallel to the top of the side wall (B) as shown below.

2. Press the latch (A) down to secure the HDD cage in place.

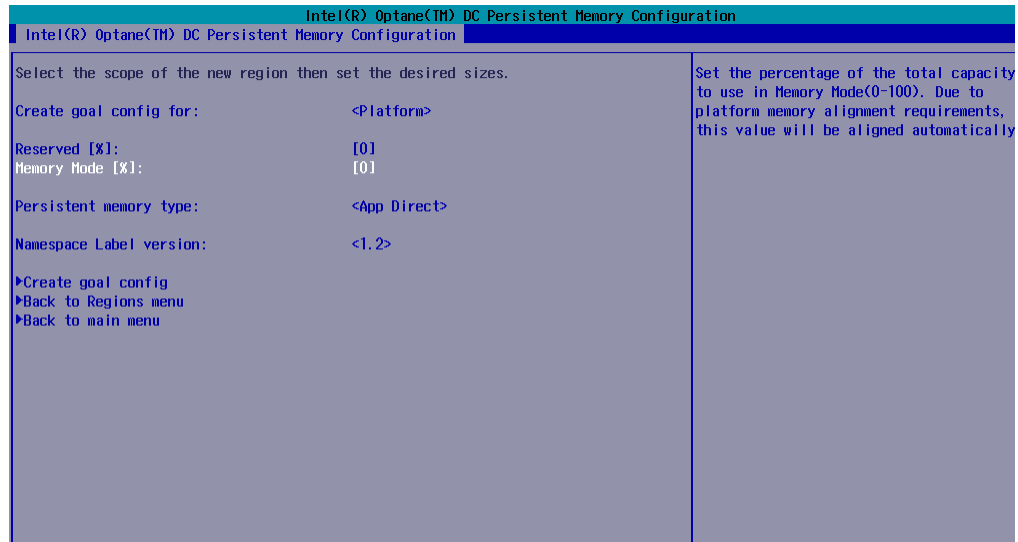
## 4.18. Intel® Optane™ DCPMM for SAP HANA

Check that Intel® Optane™ DC Persistent Memory (DCPMM) configuration is as follows:

Reserved [%]:	[0]
Memory Mode [%]:	[0]
Persistent memory type:	<App Direct>

If that is not the case, modify the configuration.
