# Release Note

## TS 07.02

### **Hardware**

**November 2018**

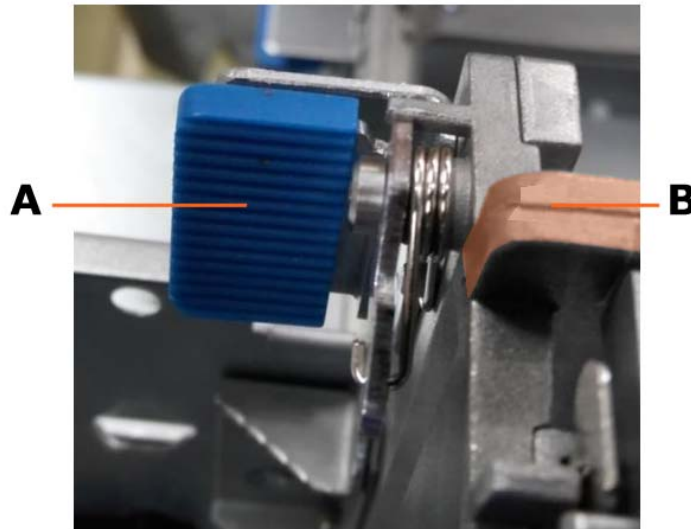
## 2.20. Locking a 2.5" Disk Storage Unit

In some cases the latch does not insert properly into the locking bracket

1. Check that the latch (A) is parallel to the top of the side wall (B) as shown below.

2. Press the latch (A) down to secure the HDD cage in place.
