# Release Note

## TS 05.04

**June 2018**

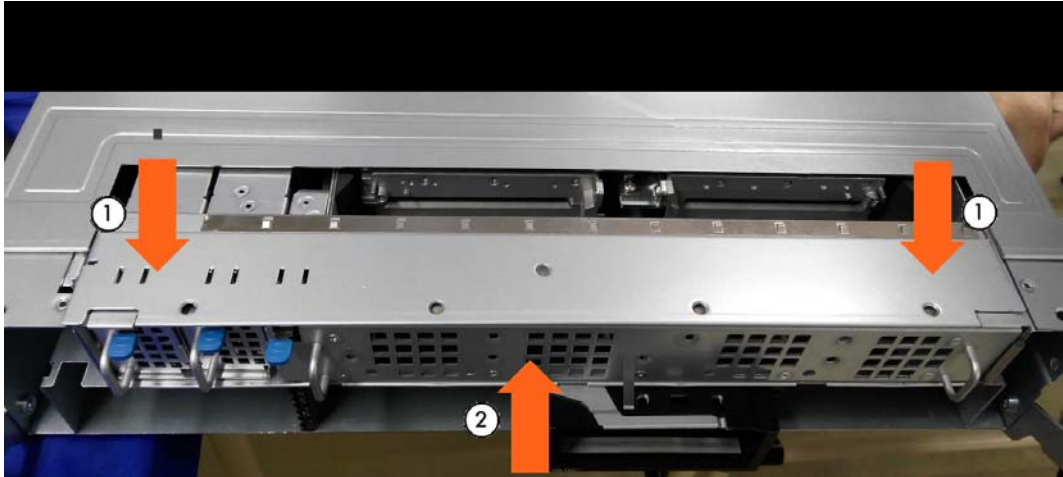
For BullSequana S400 server or BullSequana S800 server there are cases where the storage drawer does not insert smoothly into the compute box.

1. Carefully press on the top cover of the storage drawer
2. Insert the storage drawer into the compute box.

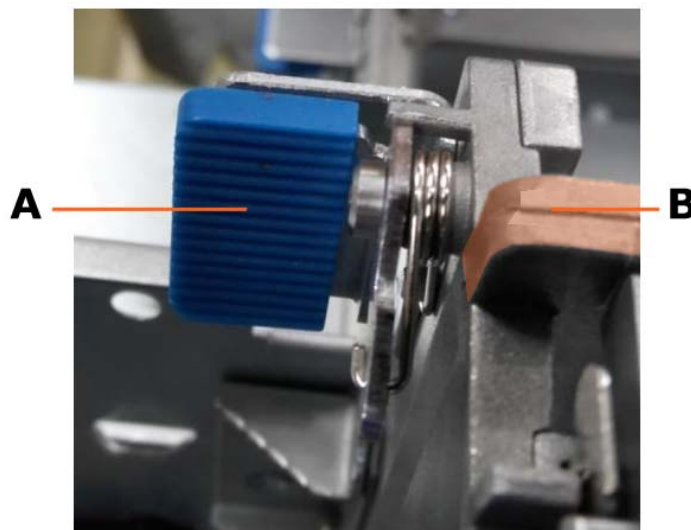
In some cases the latch does not insert properly into the locking bracket

1. Check that the latch (A) is parallel to the top of the side wall (B) as shown below.

2. Press the latch (A) down to secure the HDD cage in place.
