# Release Note

## TS 06.02

**August 2018**

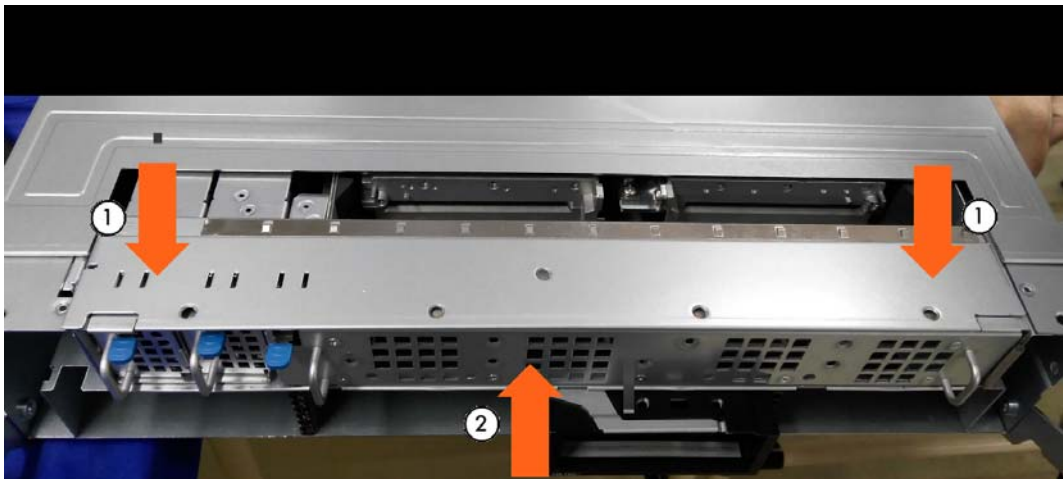
### Issue

For BullSequana S400 server or BullSequana S800 server there are cases where the storage drawer does not insert smoothly into the compute box.

1. Carefully press on the top cover of the storage drawer
2. Insert the storage drawer into the compute box.
