Release Note TS 22.03

Hardware

February 2020

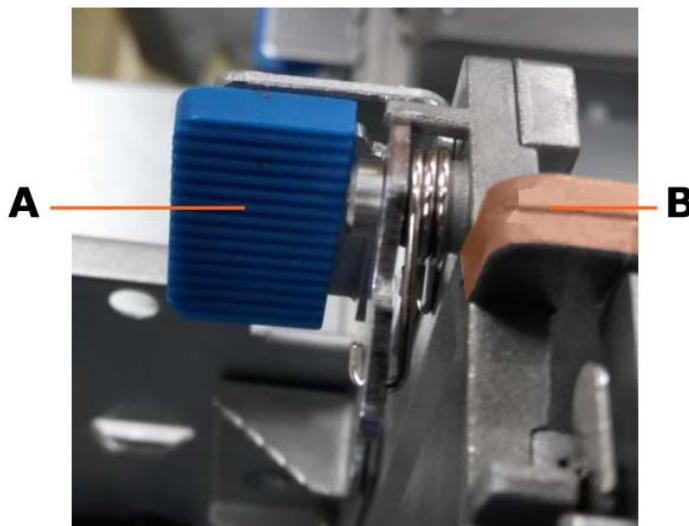
2.1.21. Locking a 2.5" Disk Storage Unit

In some cases the latch does not insert properly into the locking bracket

1. Check that the latch (A) is parallel to the top of the side wall (B) as shown below.

2. Press the latch (A) down to secure the HDD cage in place.
