Release Note TS 21.03

Hardware

September 2019

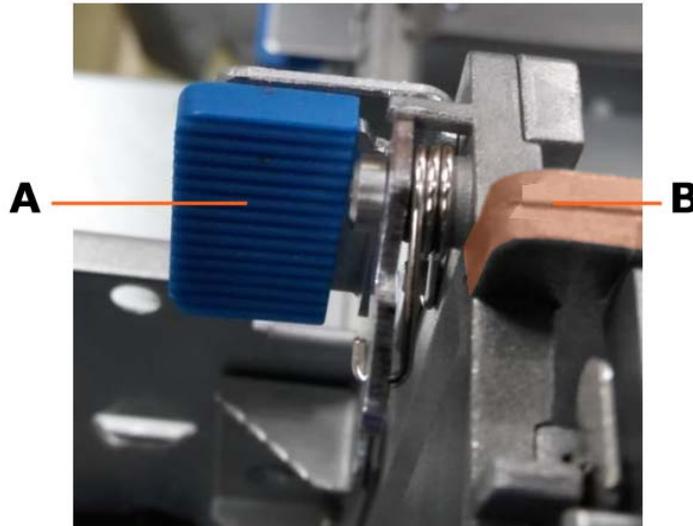
2.1.14. Locking a 2.5" Disk Storage Unit

In some cases the latch does not insert properly into the locking bracket

1. Check that the latch (A) is parallel to the top of the side wall (B) as shown below.

2. Press the latch (A) down to secure the HDD cage in place.

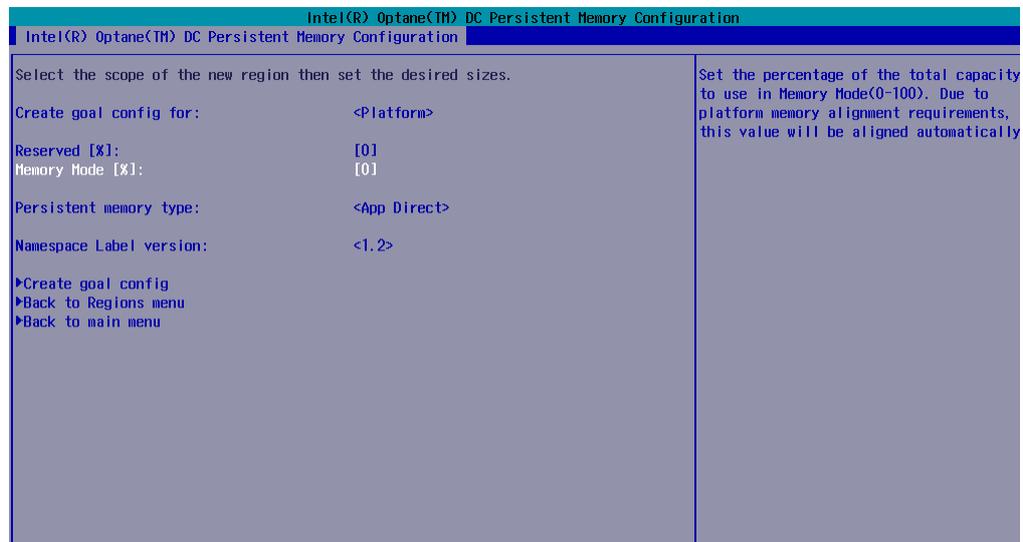
4.13. Intel® Optane™ DCPMM for SAP HANA

Check that Intel® Optane™ DC Persistent Memory (DCPMM) configuration is as follows:

If that is not the case, modify the configuration.
