# Release Note

## TS 07.02

### **Hardware**

**November 2018**

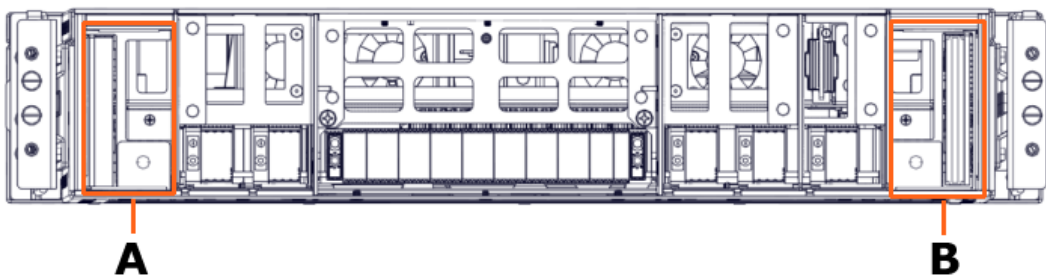
**Rear view**

In the BullSequana S Description Guide, 86 A1 13FR, the numbering of the PSUs is missing. It will be added to the guide for the next delivery.

Mark	Description
A	PSU 1
B	PSU 0

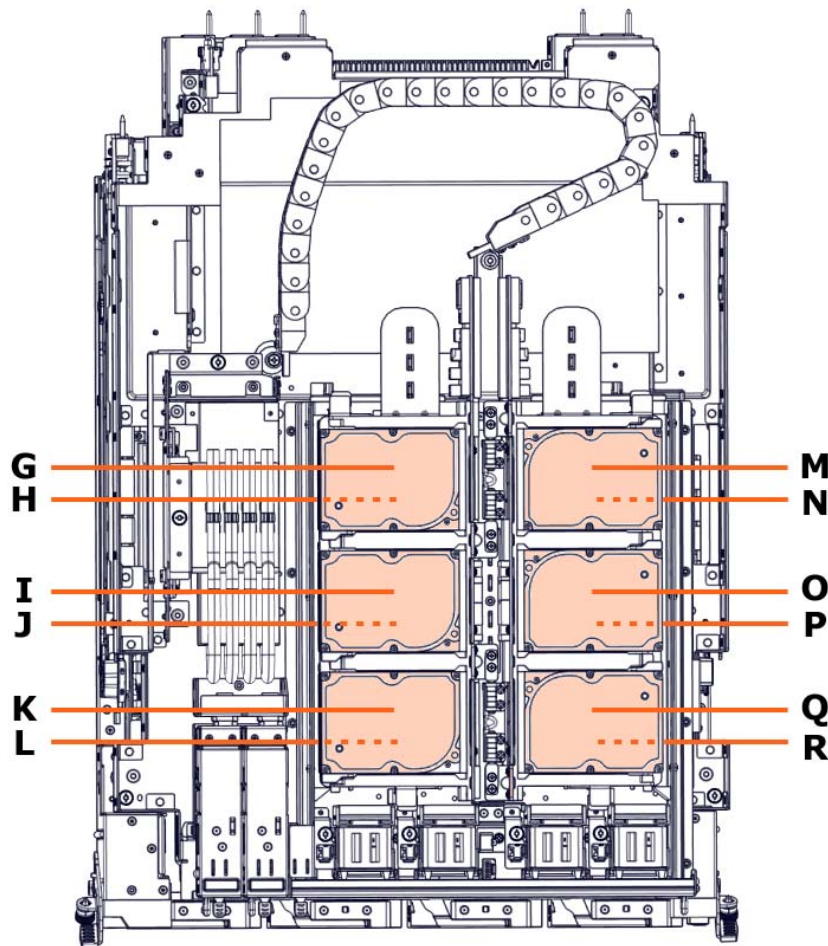
**Top view**

In the BullSequana S Description Guide, 86 A1 13FR, the mapping of the 2.5" disks with the LSI 9305-16i Raid controller is missing. It will be added to the guide for the next delivery.

Mark	SBB 2P5	Description		Mapping	LSI Disk Port
G	0	Disk 0	Top	SAS Port 0:1:4	4
H			Bottom	SAS Port 0:1:7	7
I		Disk 1	Top	SAS Port 0:1:0	0
J			Bottom	SAS Port 0:1:3	3
K		Disk 2	Top	SAS Port 0:1:1	1
L			Bottom	SAS Port 0:1:2	2
M	1	Disk 0	Top	SAS Port 0:1:15	15
N			Bottom	SAS Port 0:1:12	12
O		Disk 1	Top	SAS Port 0:1:11	11
P			Bottom	SAS Port 0:1:8	8
Q		Disk 2	Top	SAS Port 0:1:10	10
R			Bottom	SAS Port 0:1:9	9

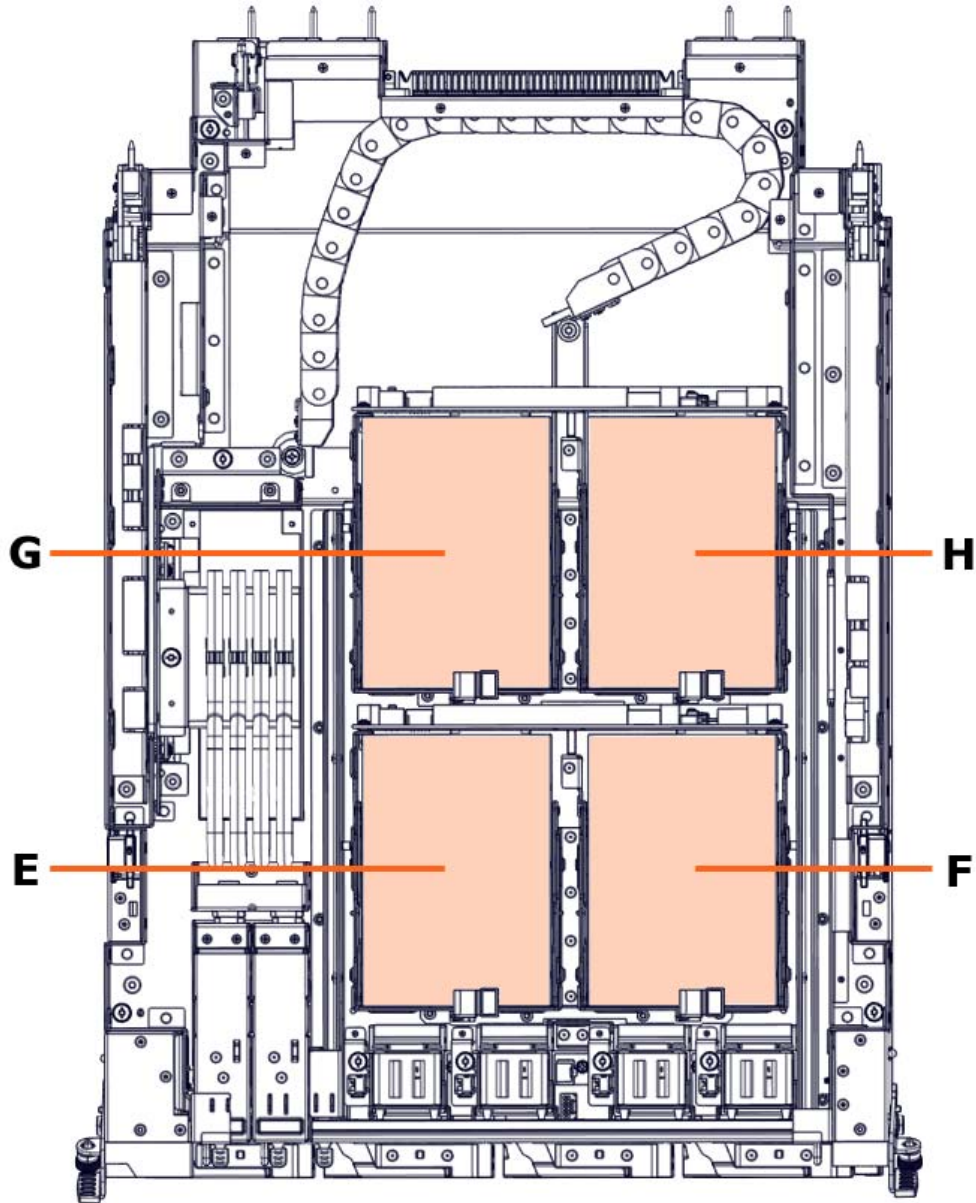
**Top view**

In the BullSequana S Description Guide, 86 A1 13FR, the mapping of the 3.5" disks is missing. It will be added to the guide for the next delivery.

Mark	SBB 35	Description	Mapping
E	Front	Disk 0	Port-7
F		Disk 1	Port-4
G	Rear	Disk 0	Port-3
H		Disk 1	Port-0
