Bull ESCALA PL 3200R

Service Guide

Hardware

March 2004

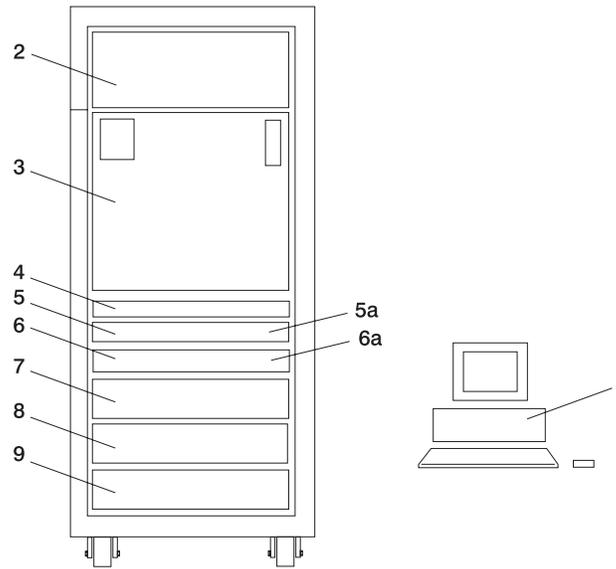
The basic system consists of the redundant bulk power subsystem, one processor subsystem, a media subsystem, and one I/O subsystem in the same rack, and one HMC, as shown in the following illustration:

1 Hardware Management Console

2 406/1R Bulk Power Subsystem

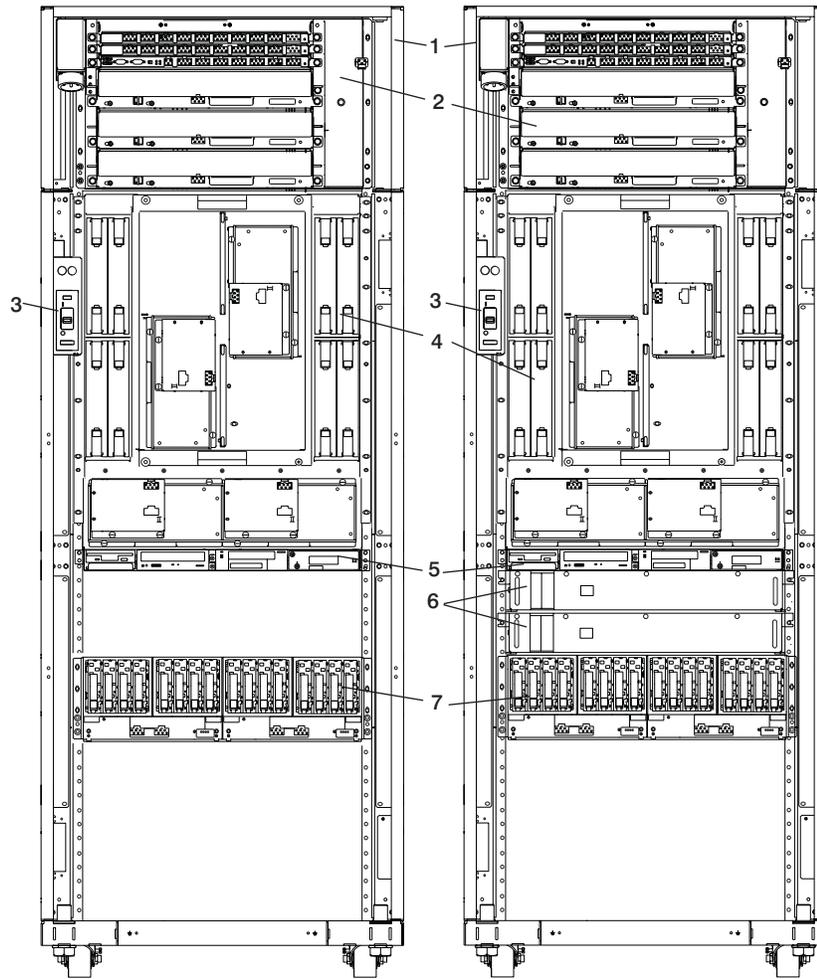
In each of the following figures, the minimum system configuration is shown on the left. The minimum system configuration with the integrated battery feature (IBF) is shown on the right in each of the figures.

- 1 Rack
- 2 Bulk Power Assembly
- 3 UEPO Switch
- 4 Memory Books

- 5 Media Subsystem
- 6 Optional Integrated Battery Feature
- 7 First I/O subsystem

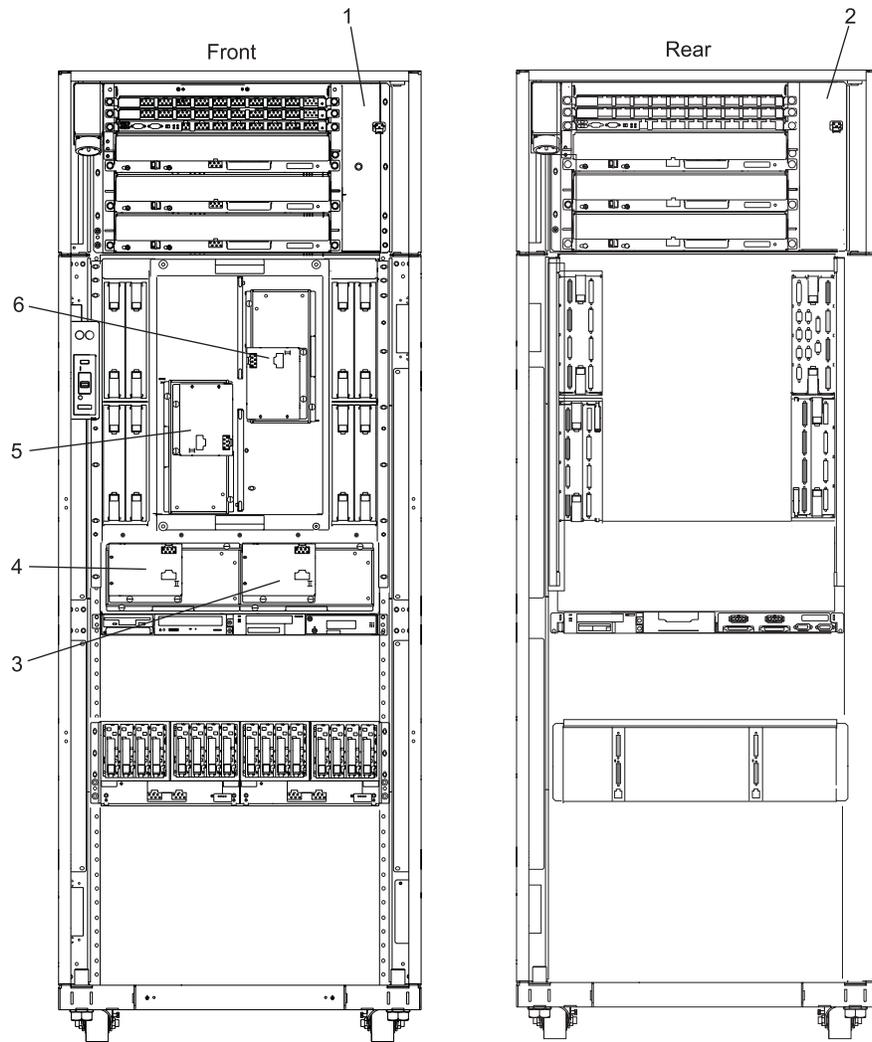
- 1 BPA Fan (U1.35-P1-F1)
- 2 BPA Fan (U1.35-P2-F1)
- 3 Processor Subsystem Fan 2, (U1.18-F2)

- 4 Processor Subsystem Fan 1, (U1.18-F1)
- 5 Processor Subsystem Fan 3, (U1.18-F3)
- 6 Processor Subsystem Fan 4, (U1.18-F4)

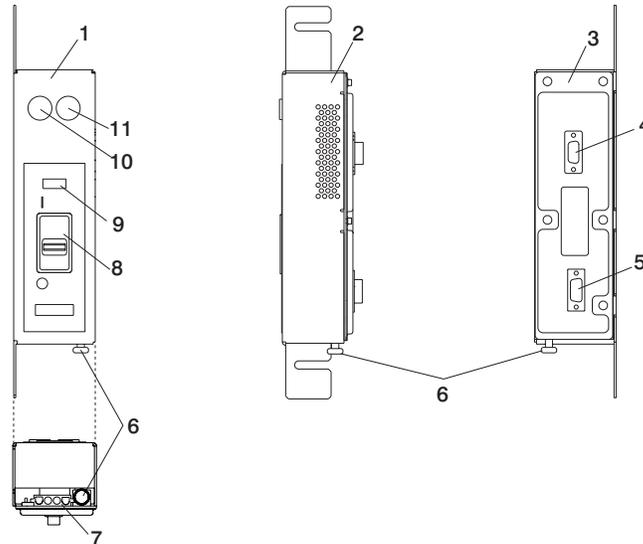
UEPO Switch

The UEPO (Unit Emergency Power Off) switch is accessible through the external cover. The switch contains a room emergency power off (EPO) interlock connector and bypass switch, a dual element rack service amber LED (one element driven per bulk power controller, a service complete button (white) and start service button (green), an off button and four thermistors for BPC ambient temperature sensing. The UEPO switch is shown in the following figure.

| 1 UEPO Front Panel | 7 J02 Connector |

At the system level, the UEPO switch is connected to each of the two BPCs through two interface connectors. The switch can be concurrently replaced by forcing the BPCs into UEPO bypass mode, using the small slide switches on the face of the BPCs. The switch is mounted in the side pocket area of the rack and remains stationary when the front cover of the system is opened. The service buttons are used by service personnel to repair the power subsystem. If the system is off when the service complete button is pressed, the system will power on. A sliding plastic cover over the red switch prevents it from being accidentally activated in the customer environment.

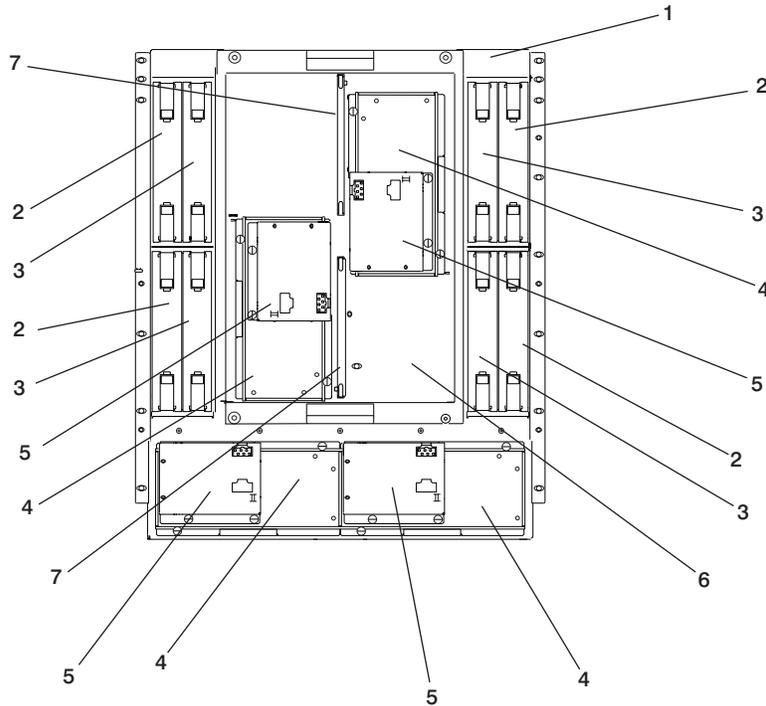
406/81 Processor Subsystem Front View

- 1 Processor Subsystem Chassis
- 2 Outer Memory Book
- 3 Inner Memory Book
- 4 Fan

- 5 Fan Controller
- 6 Fan Chassis
- 7 Fan Filter

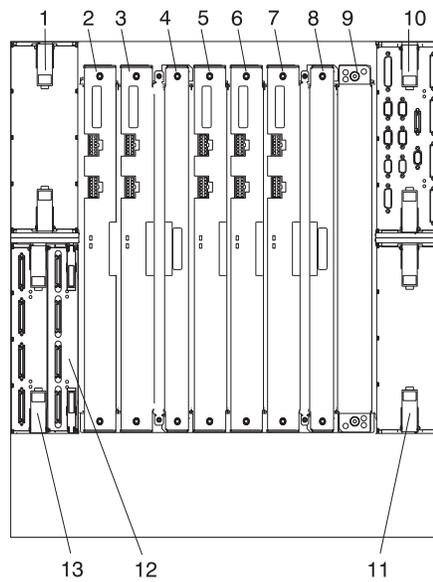
406/81 Processor Subsystem Rear View

- 1** I/O Book – Slot 1
- 2** DCA Book 1
- 3** DCA Book 2
- 4** Capacitor Book
- 5** DCA Book 3
- 6** DCA Book 4
- 7** DCA Book 5

- 8** Capacitor Book
- 9** DCA Book 6 (32-way, 1.7 GHz MCMs)
- 10** I/O book - Slot 0
- 11** I/O Book 3 - Slot 3
- 12** I/O Book 2 - Slot 2 (Inner Connectors)
- 13** I/O Book 2 - Slot 2 (Outer Connectors)

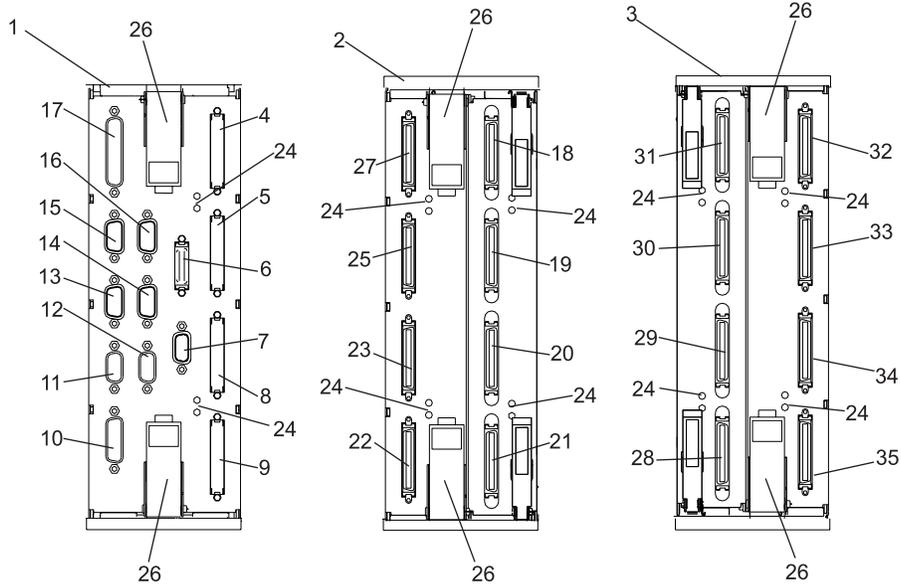
I/O Book Connector Locations

| <p>1 Primary I/O Book, Slot 0 (U1.18-P1-H2)</p> <p>2 Secondary I/O Book, Slot 1 (U1.18-P1-H1), Slot 2 (U1.18-P1-H3)</p> <p>3 Third I/O Book, Slot 3 (U1.18-P1-H4)</p> <p>4 I/O Book Slot 0 (A0) (U1.18-P1-H2/Q1)</p> <p>5 I/O Book Slot 0 (A1) (U1.18-P1-H2/Q2)</p> <p>6 Operator Panel (U1.18-P1-H2/Q7)</p> <p>7 BPC Y-cable* connector U1.18-P1-H2/Q8 or U1.18-P1-H2/Q9</p> <p>8 I/O Book Slot 0 (B0) (U1.18-P1-H2/Q3)</p> <p>9 I/O Book Slot 0 (B1) (U1.18-P1-H2/Q4)</p> <p>10 Diskette Drive (U1.18-P1-H2/Q10)</p> <p>11 HMC 1 (U1.18-P1-H2/S3)</p> <p>12 HMC 2 (U1.18-P1-H2/S4)</p> <p>13 Serial Port 1 (U1.18-P1-H2/S1)</p> <p>14 Serial Port 2 (U1.18-P1-H2/S2)</p> <p>15 SPCN 0 (Manufacturing use only) (U1.18-P1-H2/Q5)</p> <p>16 SPCN 1 (Manufacturing use only) (U1.18-P1-H2/Q6)</p> <p>17 Debug (Manufacturing use only)</p> <p>18 I/O Book Slot 2 (D1) (U1.18-P1-H3/Q5)

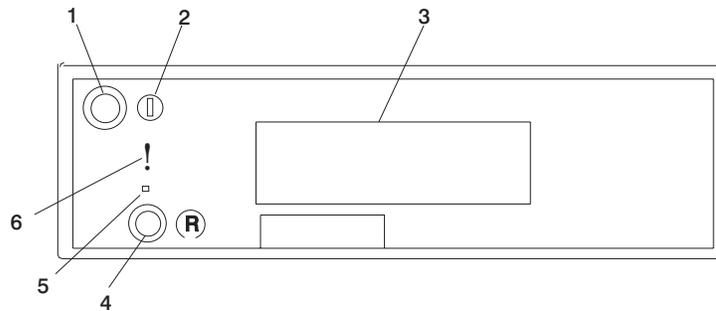
Media Subsystem Operator Panel

| 1 Power on/off button | 4 Reset button |

Note: You must activate the service processor reset button very carefully. Using an insulated paper clip is recommended. Unbend the clip so that it has a straight section about two inches long. Insert the clip straight into the hole, keeping the clip perpendicular to the plastic bezel. When you engage the test reset switch, you should feel the detent of the switch. After you press the switch, the service processor resets and then shuts down the system.

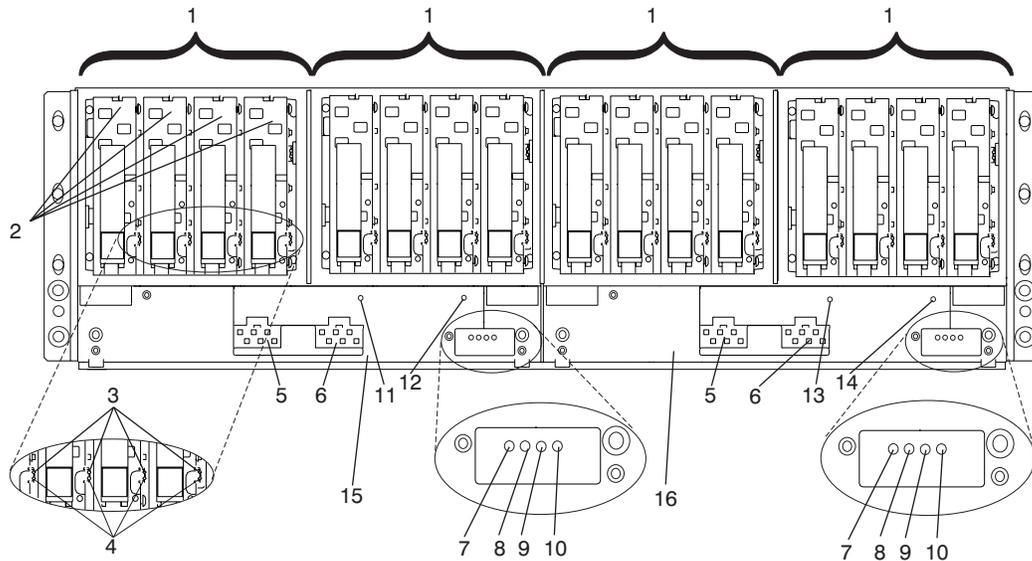
406/1D I/O Subsystem Front View

| 1 DASD 4-Pack | 9 Drawer Fault/Identify LED (Amber) |

Note: The fan fault LEDs shown in the preceding illustration indicate if an internal fan has a fault. The fan assemblies inside are positioned from left to right behind the DASD 4-packs in order of fan assembly 1, fan assembly 2, fan assembly 3, and fan assembly 4.

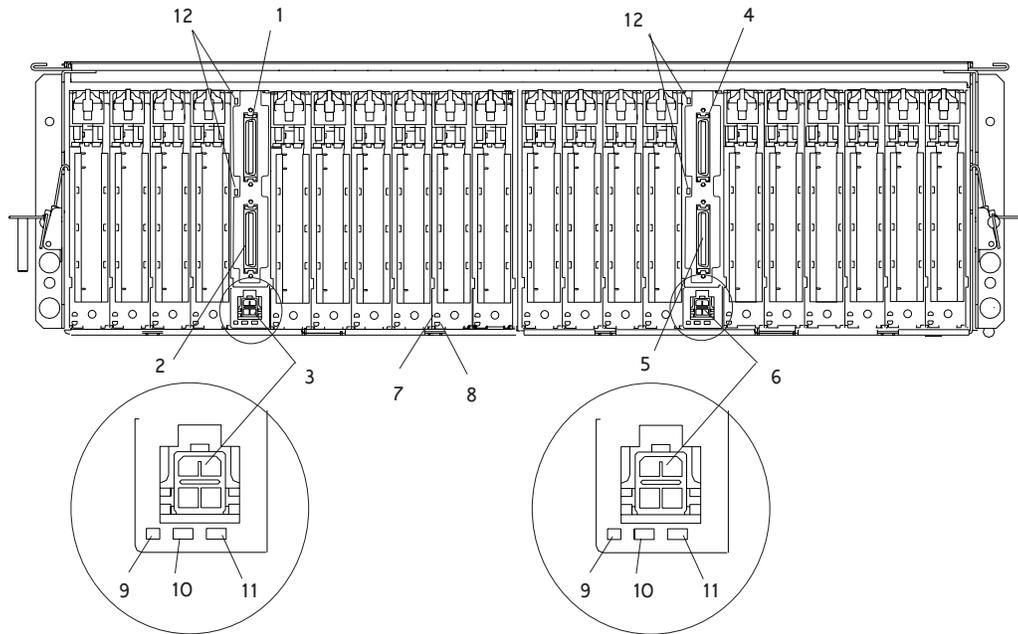
406/1D I/O Subsystem Rear View

| 1 I/O port connector 1 (Ux.y-P1/Q2) | 7 I/O Card Power On LED (Green) |

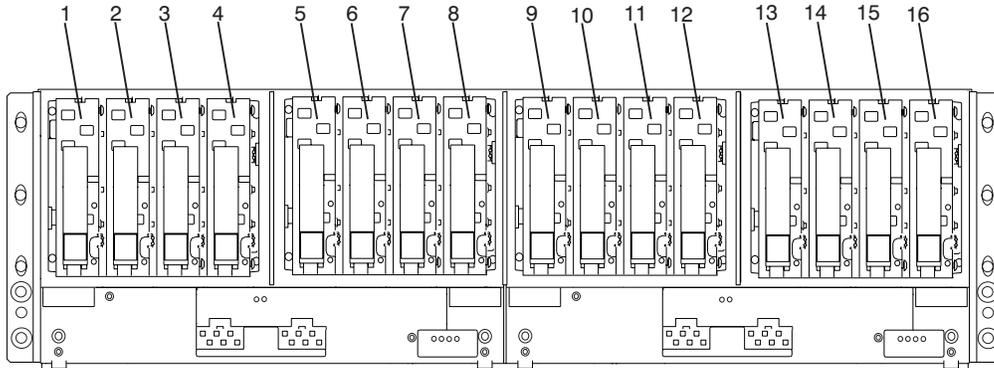
406/1D I/O Subsystem DASD Locations

1 Ux.y-P2/Z2-A8	9 Ux.y-P1/Z2-A8
2 Ux.y-P2/Z2-A9	10 Ux.y-P1/Z2-A9
3 Ux.y-P2/Z2-Aa	11 Ux.y-P1/Z2-Aa
4 Ux.y-P2/Z2-Ab	12 Ux.y-P1/Z2-Ab
5 Ux.y-P2/Z1-A8	13 Ux.y-P1/Z1-A8
6 Ux.y-P2/Z1-A9	14 Ux.y-P1/Z1-A9
7 Ux.y-P2/Z1-Aa	15 Ux.y-P1/Z1-Aa
8 Ux.y-P2/Z1-Ab	16 Ux.y-P1/Z1-Ab

1. In the preceding table, x is equal to the rack number and y is equal to the I/O subsystem position in the rack. The SCSI ID for each drive is set when the drive is installed. Each I/O subsystem can have up to four DASD 4-packs installed. The SCSI IDs for the drives in each 4-pack are 8, 9, a, and b, from left to right.
2. The DASD attachment locations are as follows:
 - DASD 1, 2, 3, 4 are attached to Ux.y-P3 DASD backplane.
 - DASD 5, 6, 7, 8 are attached to Ux.y-P4 DASD backplane.
 - DASD 9, 10, 11, 12 are attached to Ux.y-P5 DASD backplane.
 - DASD 13, 14, 15, 16 are attached to Ux.y-P6 DASD backplane.

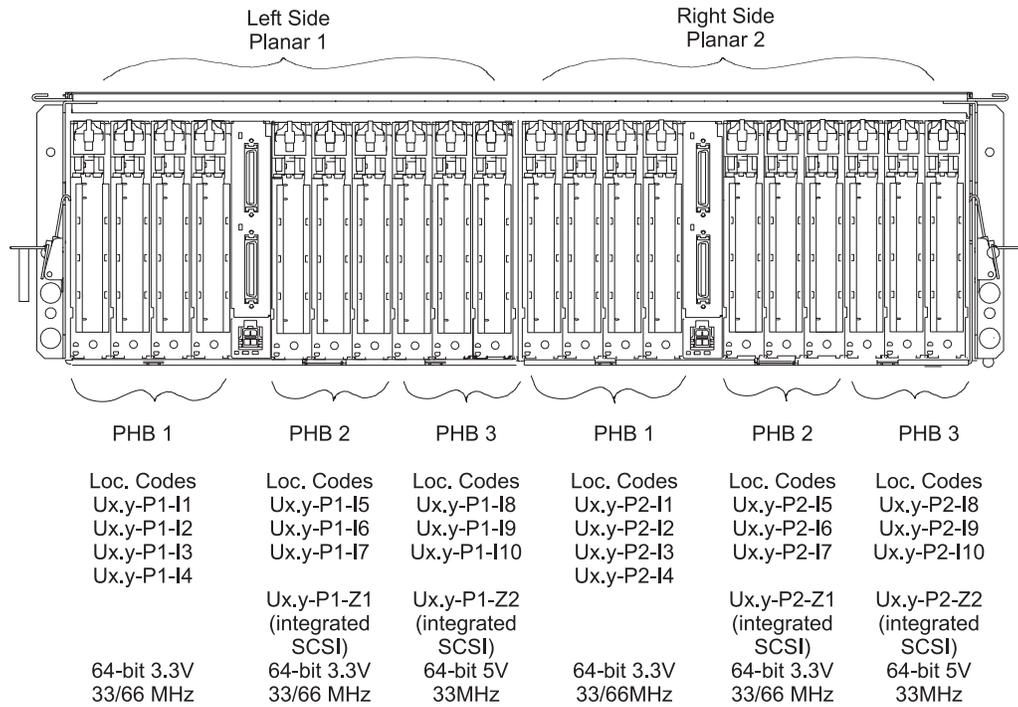
I/O Subsystem PCI and PCI-X PHB and PCI and PCI-X Slot Locations

Ux.y - HMC location code
reference wherein x = rack
location and y = drawer position.

PHBs 2 and 3 on both planars contain integrated SCSI adapters
(slots P1-Z1, P1-Z2, P2-Z1, P2-Z2).

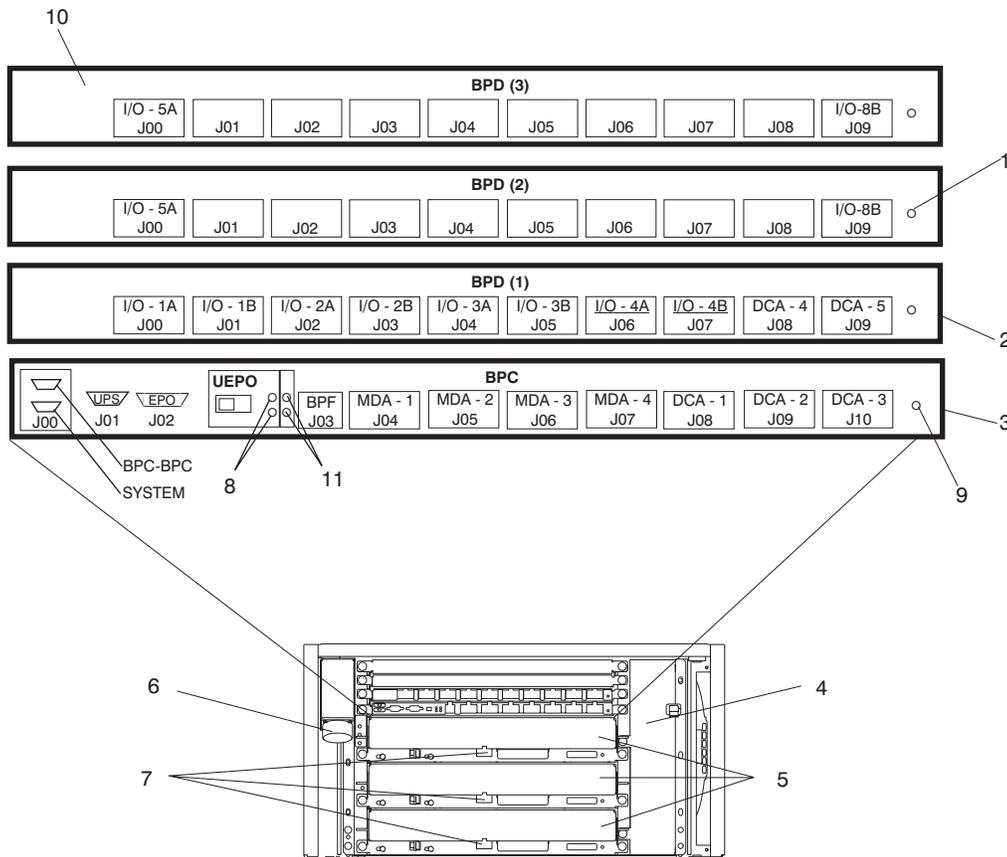
Power Subsystem Locations

Note: Use the table located in “I/O Subsystem Power Distribution Cabling” on page 33 to identify the connector ids for BPD 2 and BPD 3.

Note: BPD (2) connectors J04 and J05 (I/O-4A/J04 and I/O-4B/J05 in the preceding figure) are for I/O subsystem 4 when the IBF is installed.

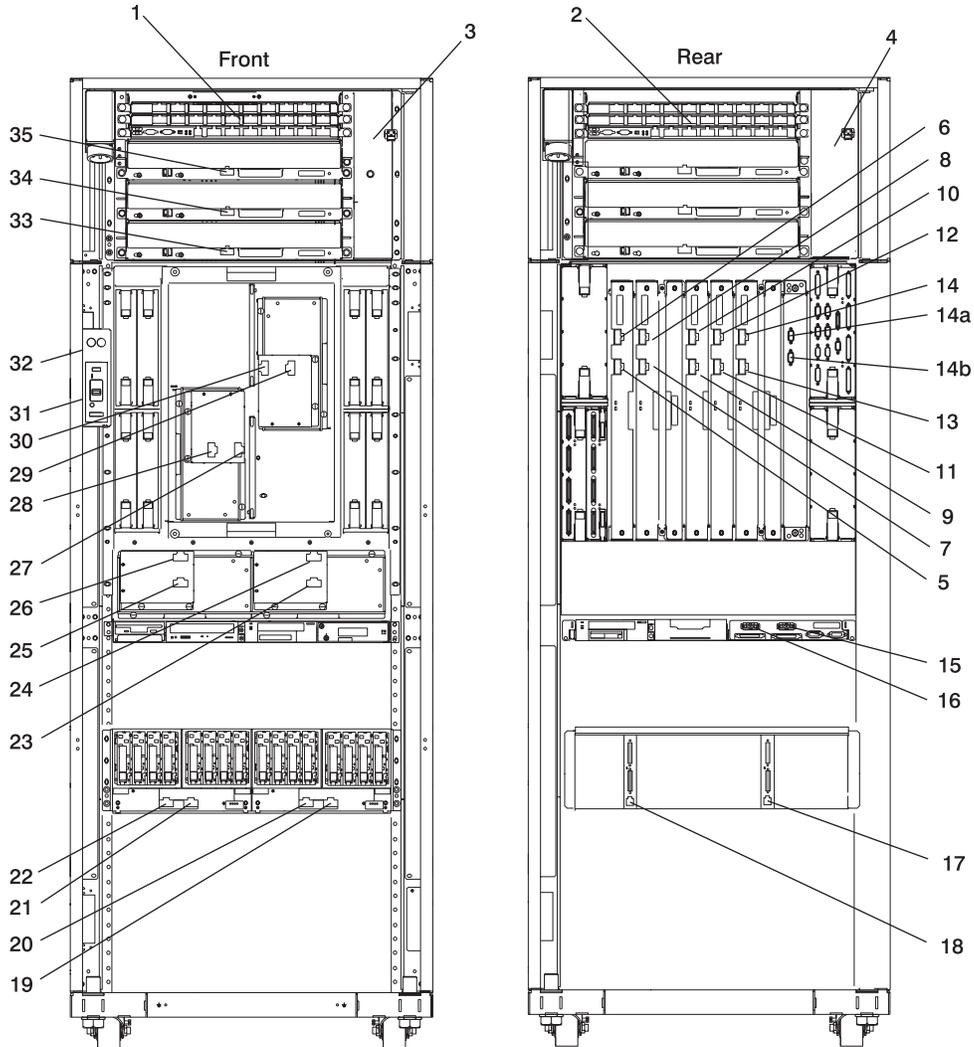
Power Distribution Cabling

Power to the I/O subsystems, DCAs, Fans, and IBFs is connected from the bulk power distribution connectors to each subsystem through cables. The cable connectors are labeled on each end. The following describes the cables that connect from the BPC BPDs, and BPRs to the DCAs, fans, power supplies, I/O subsystems, and integrated battery features.

Key	From	To	Description	Label Color
1	Bulk Power BPE A Side		Bulk power enclosure on the A side of the system	
2	Bulk Power BPE B Side		Bulk power enclosure on the B side of the system	
3	A35-BPC-J03	A35-P1FAN (BPF-A)	A35-BPC-P03 to Bulk Power Fan P1-F1	Red with white stripe
4	B35-BPC-J03	B35-P2FAN (BPF-B)	B35-BPC-P03 to Bulk Power Fan P2-F1	Red
5	B35-BPC-J08	DCA-1 J01	B35-BPC-P08 to DCA-1-P01	Red
6	A35-BPC-J08	DCA-1 J00	A35-BPC-P08 to DCA-1-P00	Red with white stripe
7	B35-BPC-J09	DCA-2 J01	B35-BPC-P09 to DCA-2-P01	Red
8	A35-BPC-J09	DCA-2 J00	A35-BPC-P09 to DCA-2-P00	Red with white stripe
9	B35-BPC-J10	DCA-3 J01	B35-BPC-P10 to DCA-3-P01	Red
10	A35-BPC-J10	DCA-3 J00	A35-BPC-P10 to DCA-3-P00	Red with white stripe
11	B35-BPD-J08	DCA-4 J01	B35-BPD1-P08 to DCA-4-P01	Red
12	A35-BPD-J08	DCA-4 J00	A35-BPD1-P08 to DCA-4-P00	Red with white stripe
13	B35-BPD-J09	DCA-5 J01	B35-BPD1-P09 to DCA-5-P01	Red
14	A35-BPD-J09	DCA-5 J00	A35-BPD1-P09 to DCA-5-P00	Red with white stripe

14a	A35-BPD-J06	DCA-6-J00*	A35-BPD1-P06 to DCA-6-P01 (32-way, 1.7 GHz)	Red with white stripe
14b	A35-BPD-J06	DCA-6-J01*	A35-BPD1-P06 to DCA-6-P00(32-way, 1.7 GHz)	Red
15, 17	B17-Media-J02	I/O Subsystem 1B-J01	I/OB9-P01 to Media P02	
16, 18	B17-Media-J00	I/O Subsystem 1B-J00	I/OB9-P00 to Media P00	
19, 20, 21, 22	B35-BPDx-Jxx See "I/O Subsystem Power Distribution Cabling" on page 33 for I/O subsystem power cabling.	I/O Subsystem See "I/O Subsystem Power Distribution Cabling" on page 33 for I/O subsystem power cabling.	B35-BPDx-P0x to I/O Subsystem #x	
23	B35-BPC-J05	A09-MDA2-J02	A35-BPC-P05 to (AMD2-P01) J02	Red
24	A35-BPC-J05	A09-MDA2-J01	B35-BPC-P05 to (AMD2-P00) J01	Red with white stripe
25	B35-BPC-J04	A09-MDA1-J02	A35-BPC-P04 to (AMD1-P01) J02	Red

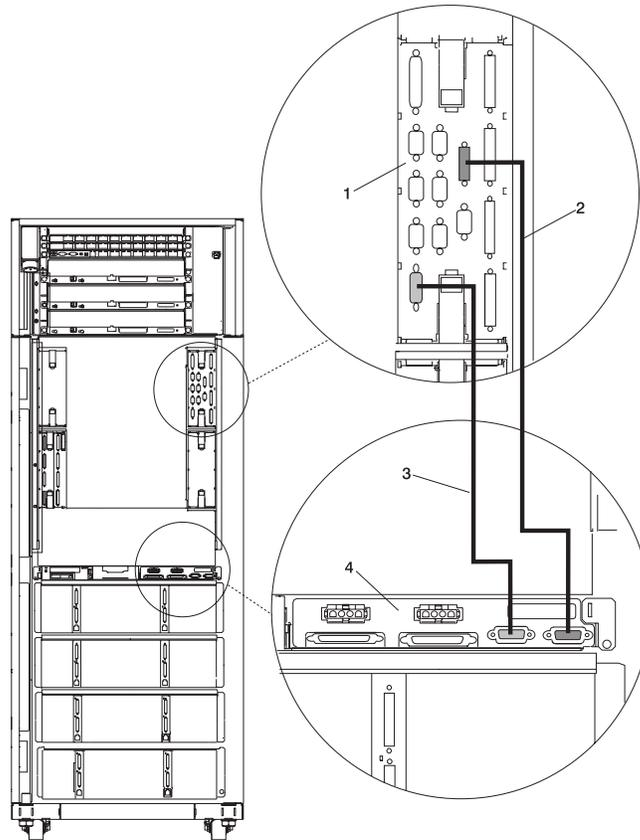
Operator Panel Cable and Diskette Drive Cable to the Media Subsystem (Rear View)

- 1 Primary I/O Book
- 2 Cable Connecting the Operator Panel to the Media Subsystem

- 3 Diskette Drive Data Cable
- 4 Media Subsystem

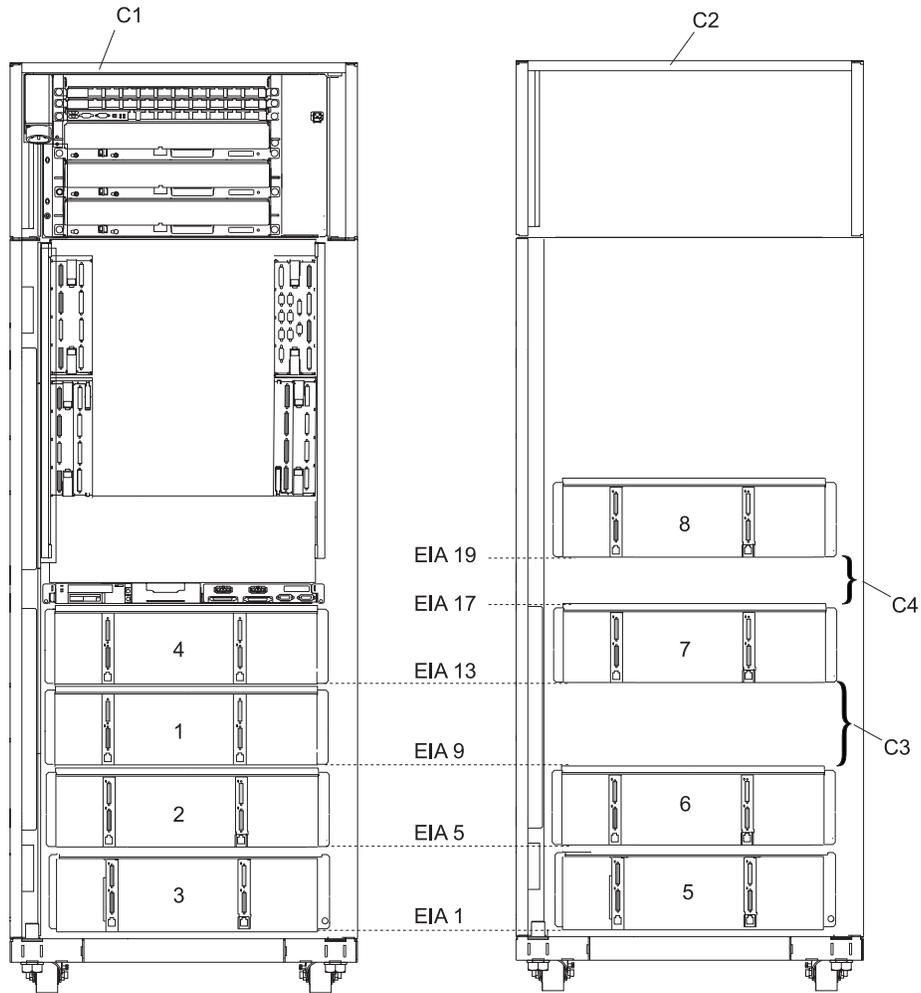
I/O Subsystem Positions, Fully Populated Primary and Secondary Rack (Rear View without IBF)

- C1** Primary Rack
- C2** Secondary Rack
- C3** Blank Space
- C4** Blank Space
- 1** First I/O Subsystem
- 2** Second I/O Subsystem

- 3** Third I/O Subsystem
- 4** Fourth I/O Subsystem
- 5** Fifth I/O Subsystem
- 6** Sixth I/O Subsystem
- 7** Seventh I/O Subsystem
- 8** Eighth I/O Subsystem

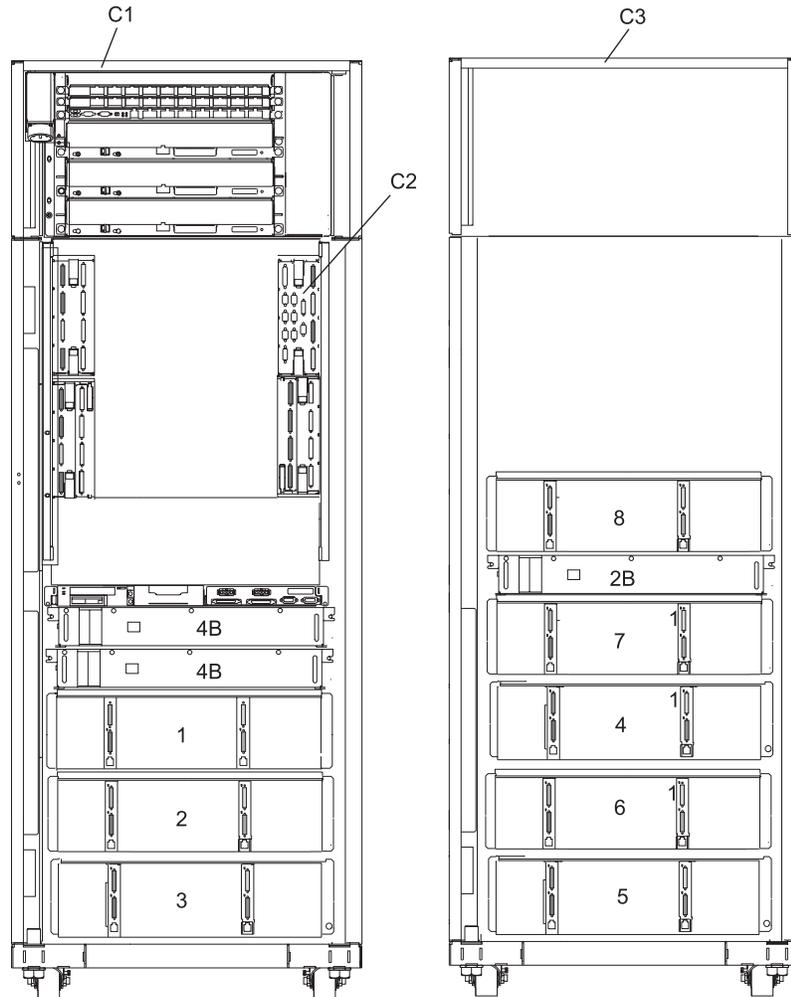
I/O Subsystem Positions, Fully Populated Primary and Secondary Rack (Rear View with IBFs)

- C1** Primary Rack
- C2** Primary I/O Book (Book 0)
- C3** Secondary Rack
- 1** First I/O Subsystem
- 2** Second I/O Subsystem
- 3** Third I/O Subsystem
- 4** Fourth I/O Subsystem

- 4B** Four IBFs (primary rack), Position 4
- 5** Fifth I/O Subsystem
- 6** Sixth I/O Subsystem
- 7** Seventh I/O Subsystem
- 2B** Two IBFs (secondary rack)
- 8** Eighth I/O Subsystem

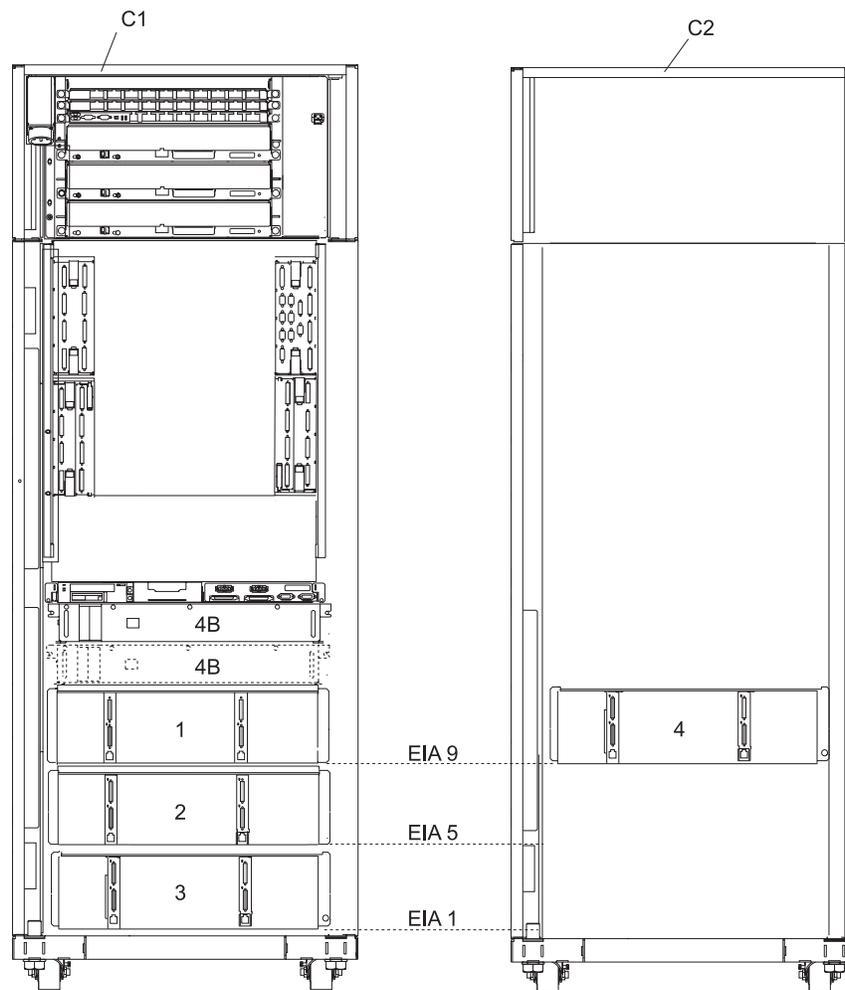
Placement of Subsystem 4 in a Two-Rack Configuration (Rear View with IBF)

- C1** Primary Rack
- C2** Secondary Rack
- 1** First I/O Subsystem
- 2** Second I/O Subsystem

- 3** Third I/O Subsystem
- 4** Fourth I/O Subsystem
- 4B** Four IBFs

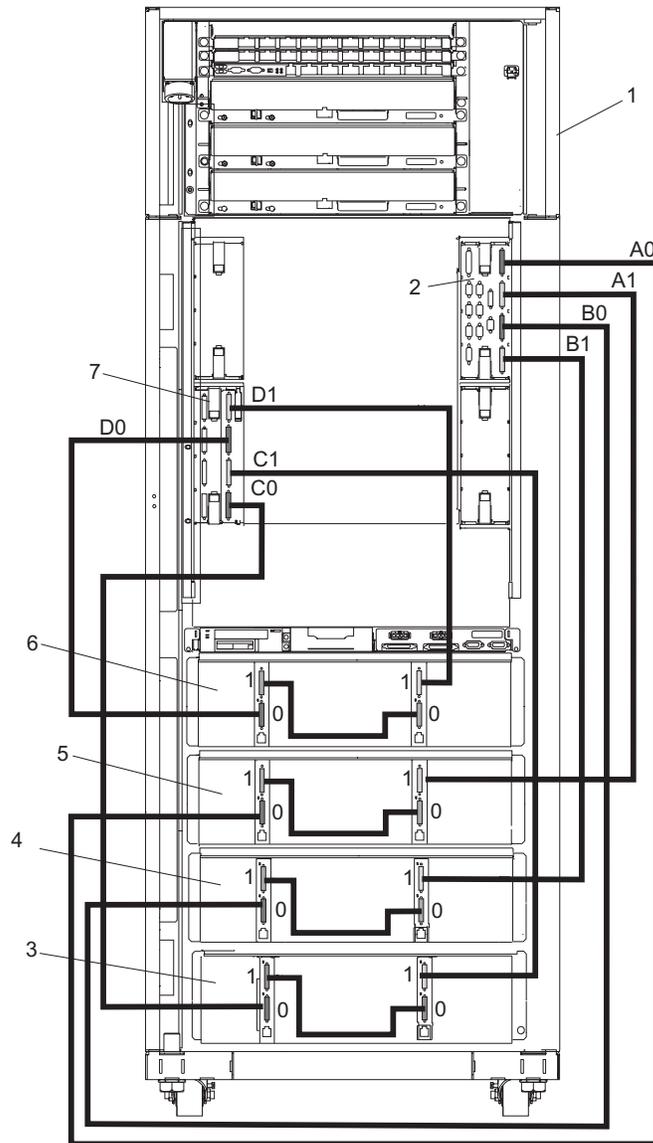
I/O Subsystems (1 Through 4 without IBFs) RIO Cabling to I/O Books, Two I/O Planar Loop Configuration, 2, 3, or 4 MCMs Only

Note: The following figure applies to CECs with RIO, or thumbscrew retention, connections.

| 1 Primary Rack | 5 First I/O Subsystem |

The maximum data rate for the RIO I/O planar is 500 MB per second, and for the RIO-2 I/O planar, the maximum data rate is 2 GB per second. However, in the event of a cable failure, there is no redundant path for the 2 GB per second RIO-2 I/O planar. Restoring the redundant path for the RIO-2 planar reduces the data rate to 1 GB per second. I/O subsystems with a RIO I/O planar in one side and a RIO-2 I/O planar in the other side with 2 I/O planar loop connections are not allowed.

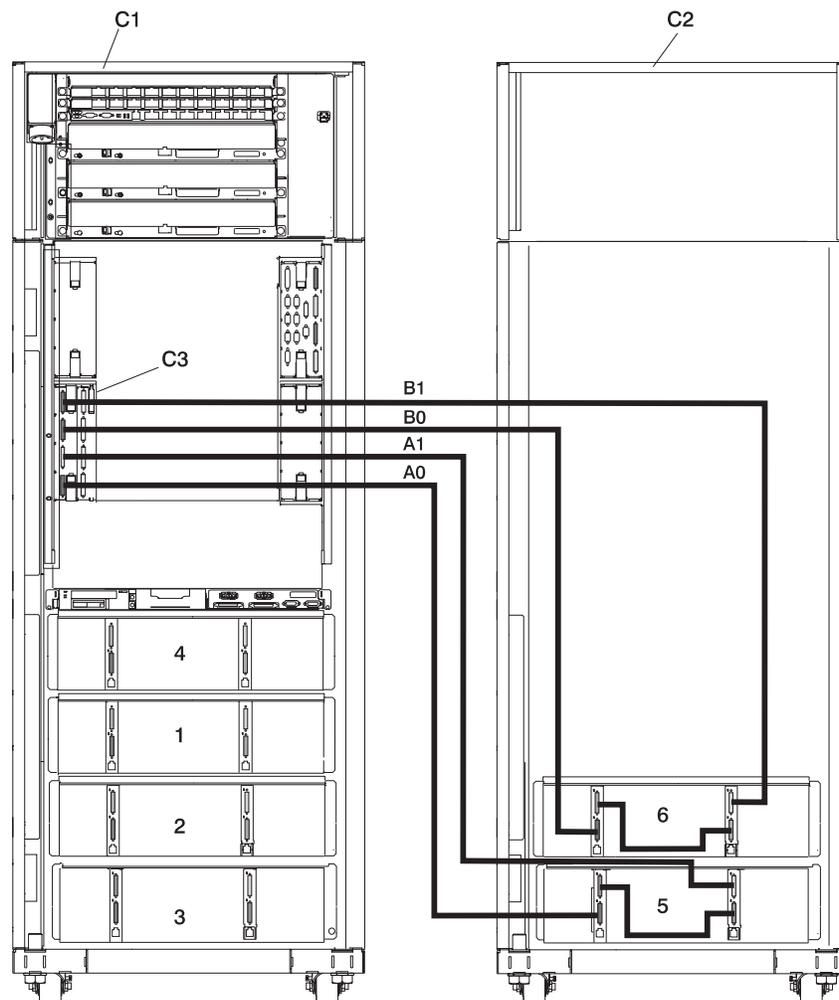
Shown Without IBFs

Note: The following figure applies to CECs with RIO, or thumbscrew retention, connections.

- C1 Primary Rack
- C2 Secondary Rack
- C3 Secondary I/O Book

- 5 Fifth I/O Subsystem
- 6 Sixth I/O Subsystem

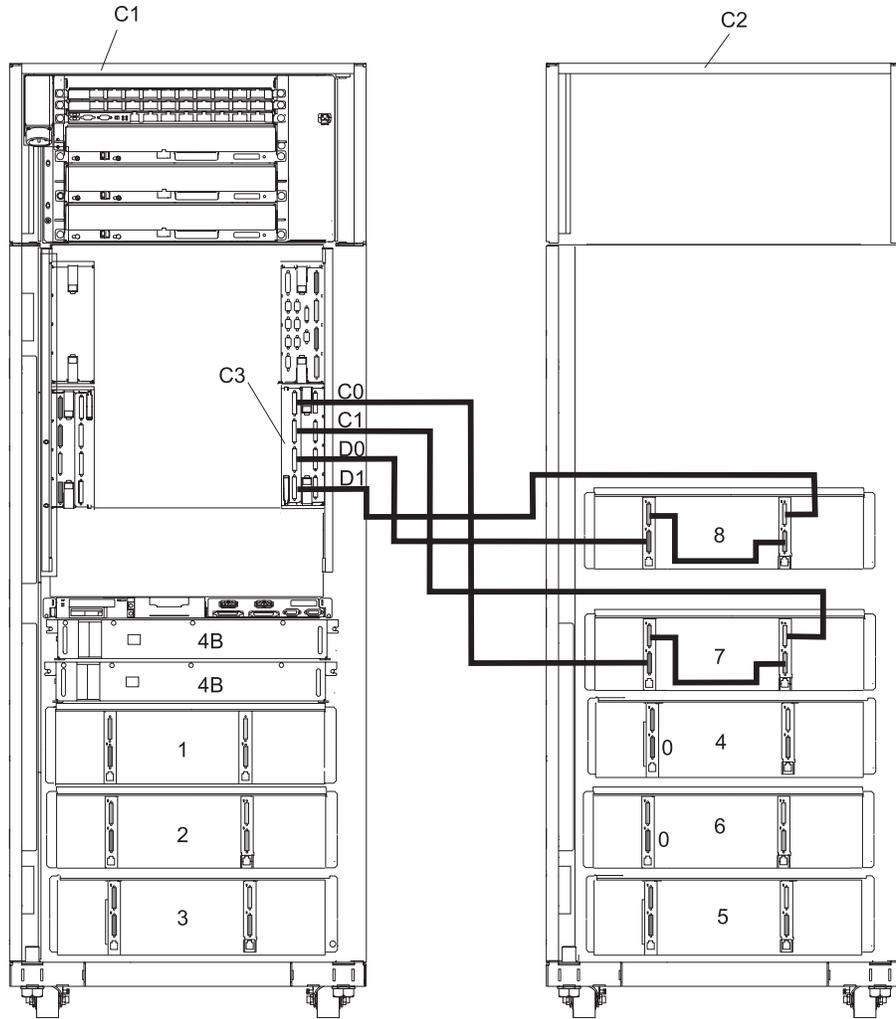
Shown with IBFs

Note: The following figure applies to CECs with RIO, or thumbscrew retention, connections.

| C1 Primary Rack | 4 Fourth I/O Subsystem |

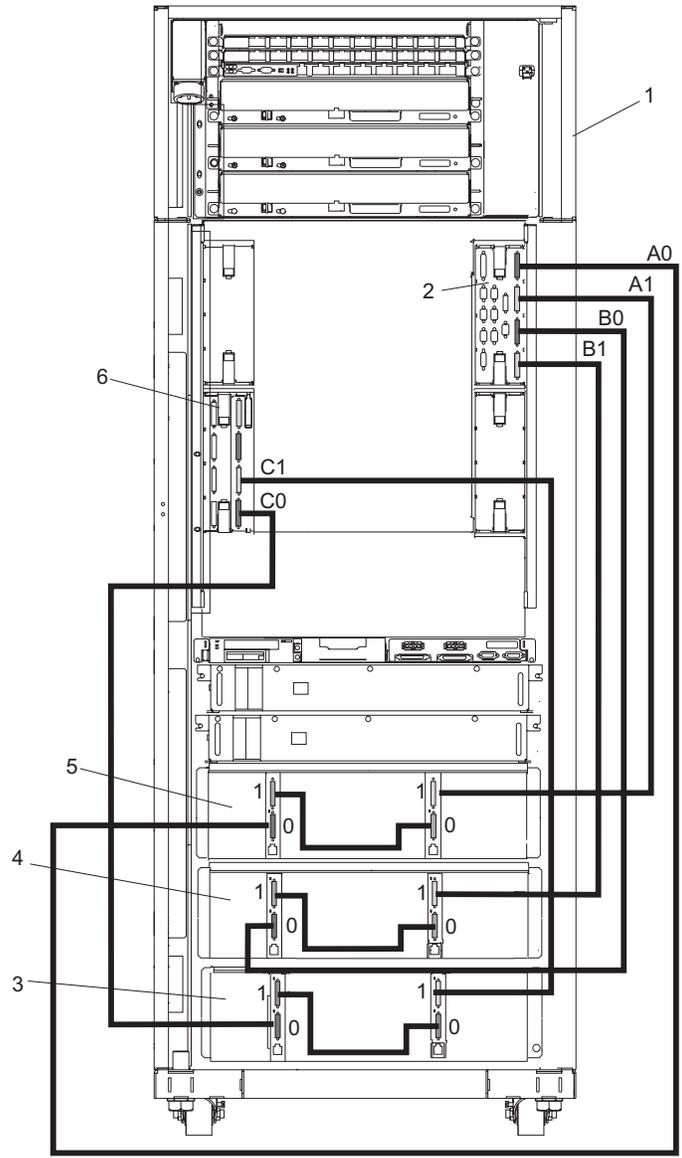
I/O Subsystems (1 through 3 with IBFs) RIO Cabling to I/O Books, Two I/O Planar Loop Configuration, 2, 3, or 4 MCMs Only

Note: The following figure applies to CECs with RIO, or thumbscrew retention, connections.

- 1 Primary Rack
- 2 Primary I/O Book
- 3 Third I/O Subsystem
- 4 Second I/O Subsystem
- 5 First I/O Subsystem
- 6 Secondary I/O Book

- A0 Connection to I/O Book (Book 0)
- A1 Connection to I/O Book (Book 0)
- B0 Connection to I/O Book (Book 0)
- B1 Connection to I/O Book (Book 0)
- C0 Connection to I/O Book (Book 2)
- C1 Connection to I/O Book (Book 2)

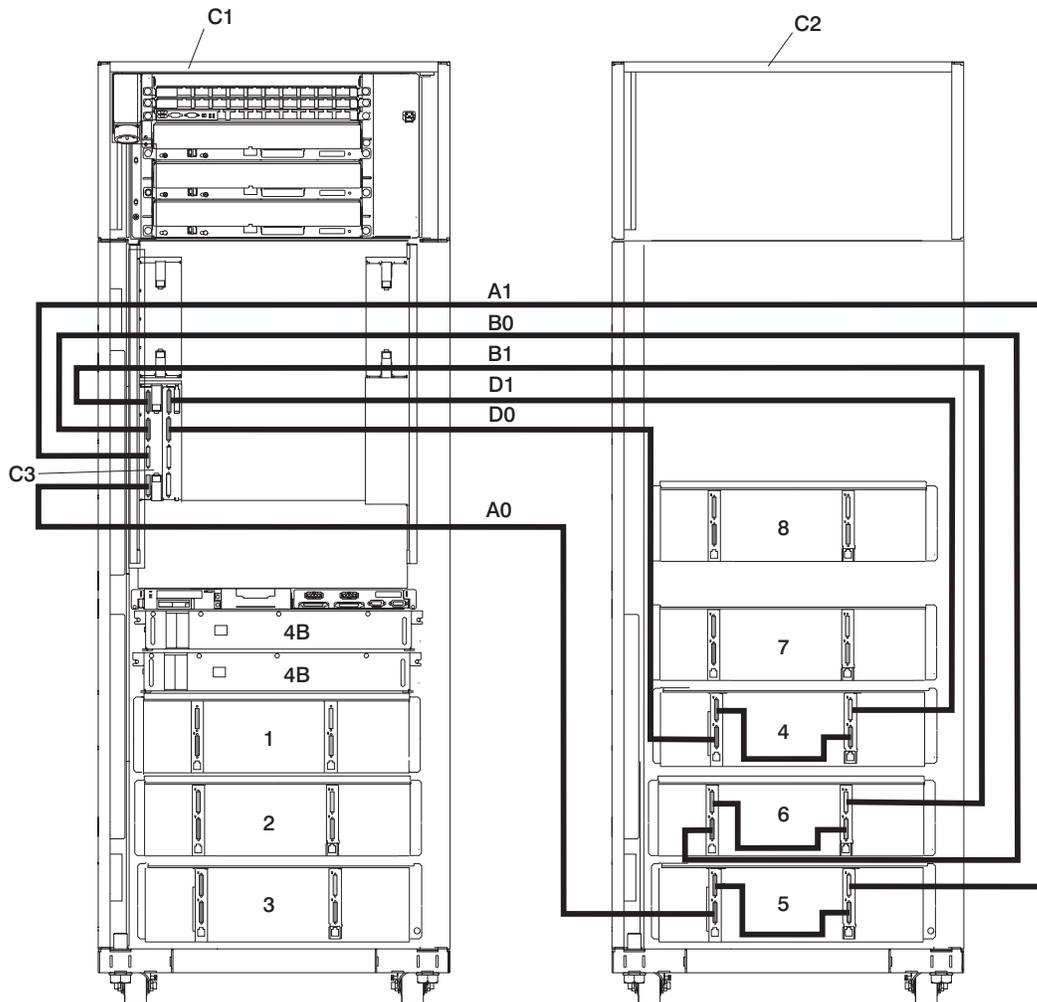
I/O Subsystems (4 through 6 with IBFs) RIO Cabling to I/O Books, Two I/O Planar Loop Configuration, 3 or 4 MCMs Only

Note: The following figure applies to CECs with RIO, or thumbscrew retention, connections.

- C1** Secondary Rack
- C2** Primary Rack
- C3** Secondary I/O Book in I/O Slot 3
- C4** Secondary I/O Book in Slot 2
- 1** First I/O Subsystem
- 2** Second I/O Subsystem
- 3** Third I/O Subsystem
- 4** Fourth I/O Subsystem
- 4B** Integrated Battery Feature (IBF)
- 5** Fifth I/O Subsystem

- 6** Sixth I/O Subsystem
- 7** Seventh I/O Subsystem
- 8** Eighth I/O Subsystem
- A0** Connection to I/O Book (Book 2)
- A1** Connection to I/O Book (Book 2)
- B0** Connection to I/O Book (Book 2)
- B1** Connection to I/O Book (Book 2)
- D0** Connection to I/O Book (Book 2)
- D1** Connection to I/O Book (Book 2)

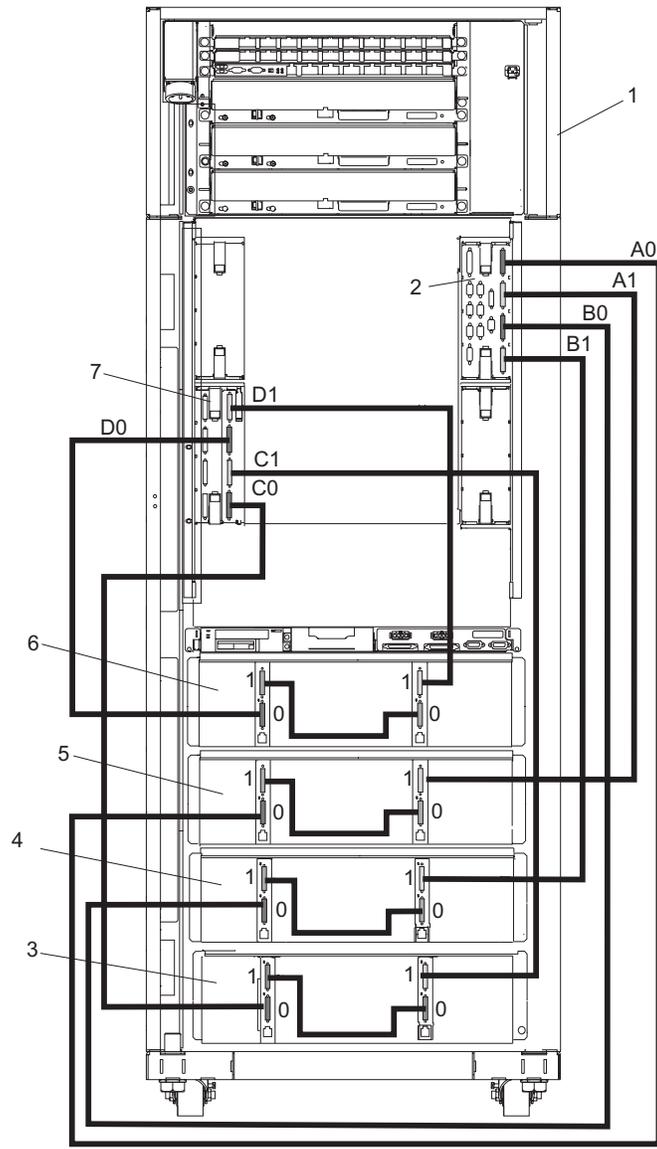
I/O Subsystems (1 Through 4 without IBFs) RIO-2 Cabling to I/O Books, Two I/O Planar Loop Configuration, 2, 3, or 4 MCMs Only

Note: The following figure applies to CECs with RIO-2, or bayonette retention, connections.

| 1 Primary Rack | 5 First I/O Subsystem |

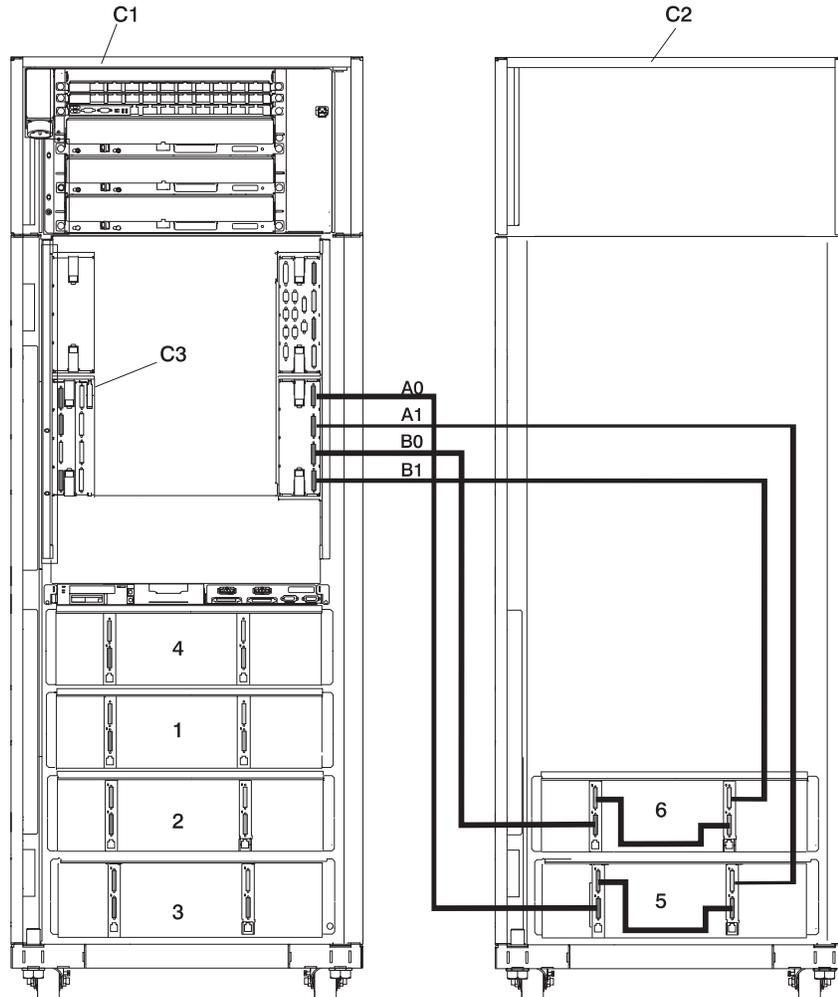
Shown Without IBFs

Note: The following figure applies to CECs with RIO-2, or bayonette retention, connections.

C1 Primary Rack

C2 Secondary Rack

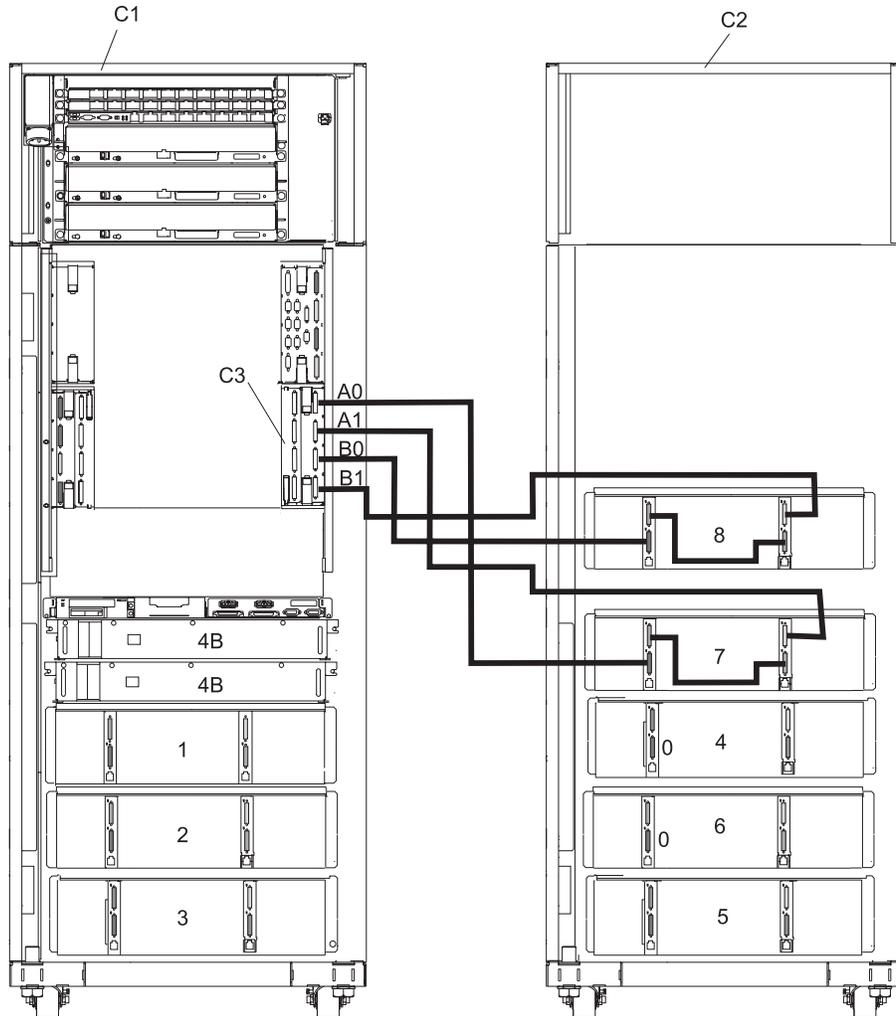
Shown with IBFs

Note: The following figure applies to CECs with RIO-2, or bayonette retention connections.

| <ul style="list-style-type: none"> C1 Primary Rack C2 Secondary Rack C3 Third I/O Book (Book 3) <ul style="list-style-type: none"> 1 First I/O Subsystem 2 Second Subsystem 3 Third I/O Subsystem 4 Fourth I/O Subsystem 4B Two IBFs (maximum), Position 4 | <ul style="list-style-type: none"> 5 Fifth I/O Subsystem 6 Sixth I/O Subsystem 7 Seventh I/O Subsystem 8 Eighth I/O Subsystem A0 Connection to I/O Book (Book 3) A1 Connection to I/O Book (Book 3) B0 Connection to I/O Book (Book 3) B1 Connection to I/O Book (Book 3) |

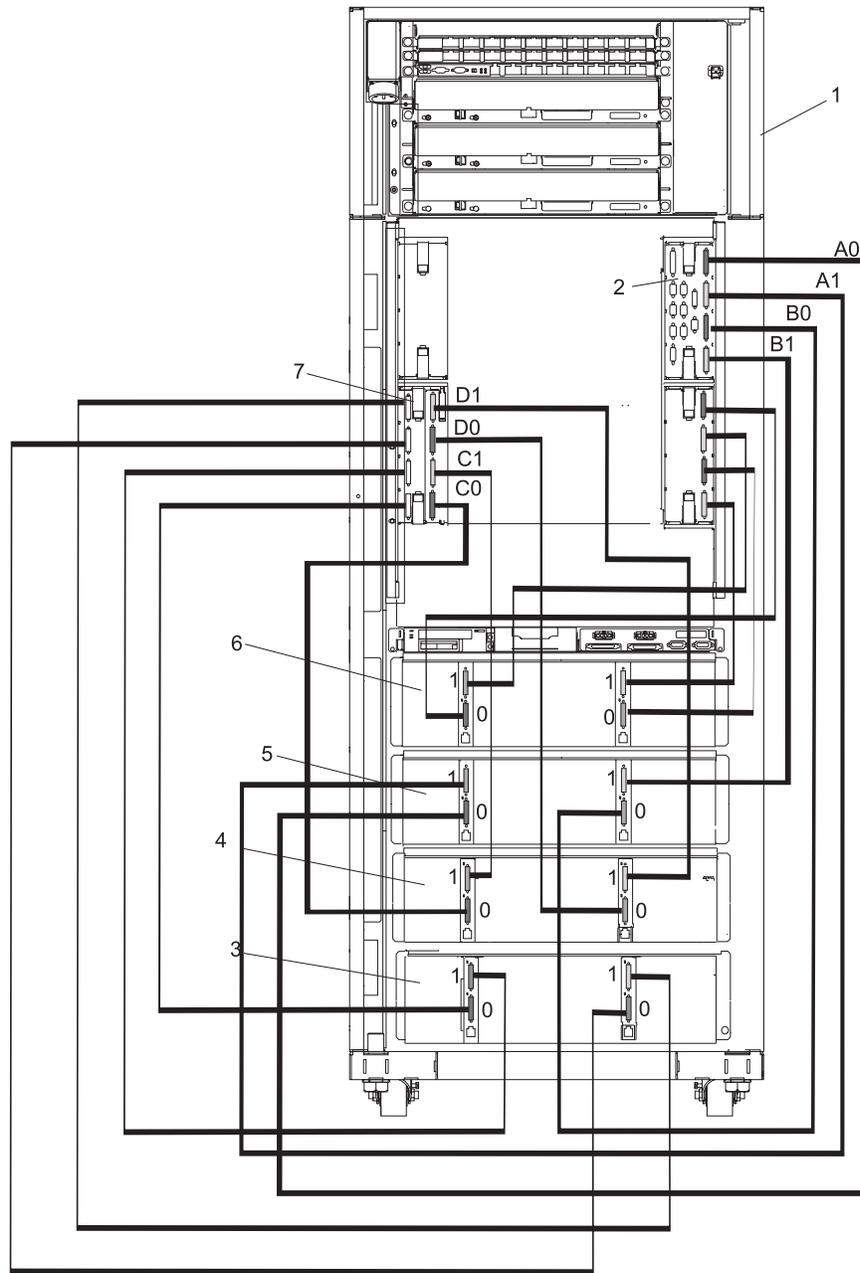
I/O Subsystems (1 Through 4 without IBFs) RIO-2 Cabling to I/O Books, One I/O Planar Loop Configuration, 3 or 4 MCMs Only

Note: The following figure applies to CECs with RIO-2, or bayonette retention, connections.

- 1 Primary Rack
- 2 Primary I/O Book
- 3 Third I/O Subsystem
- 4 Second I/O Subsystem

- 5 First I/O Subsystem
- 6 Fourth I/O Subsystem
- 7 Secondary I/O Book
