Bull ESCALA PL 3200R

Service Guide

Hardware

March 2004

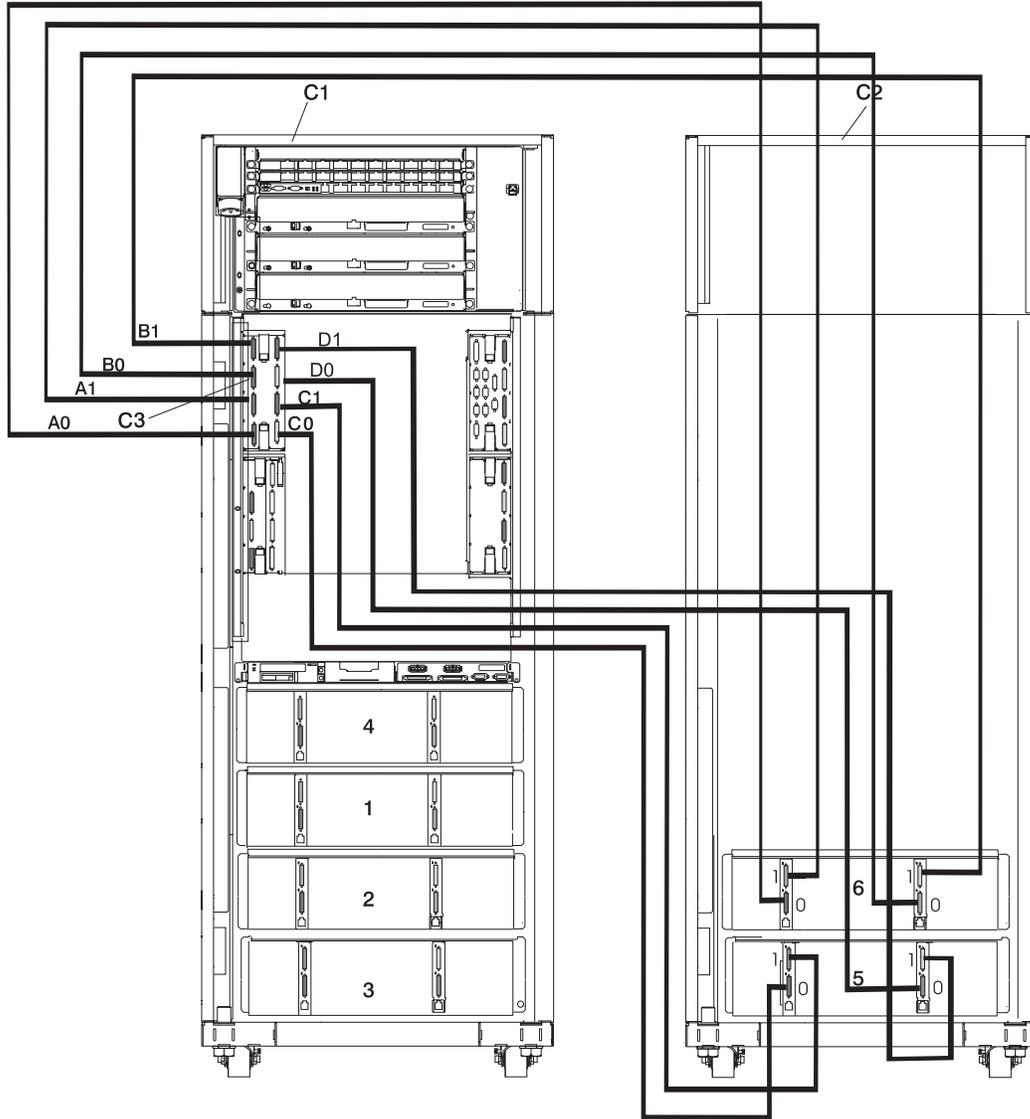
Shown Without IBFs

Note: The following figure applies to CECs with RIO-2, or bayonette retention, connections.

C1 Primary Rack

C2 Secondary Rack

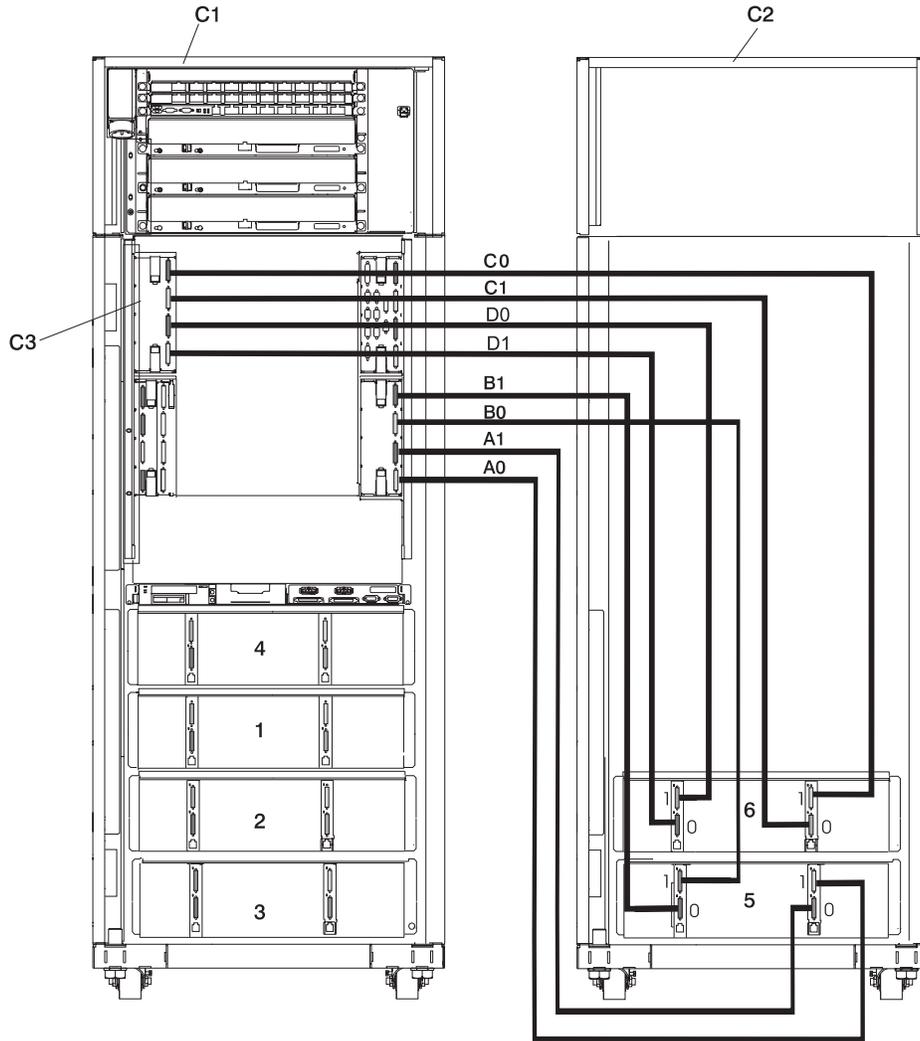
Shown Without IBFs

Note: The following figure applies to CECs with RIO-2, or bayonette retention, connections.

C1 Primary Rack

C2 Secondary Rack

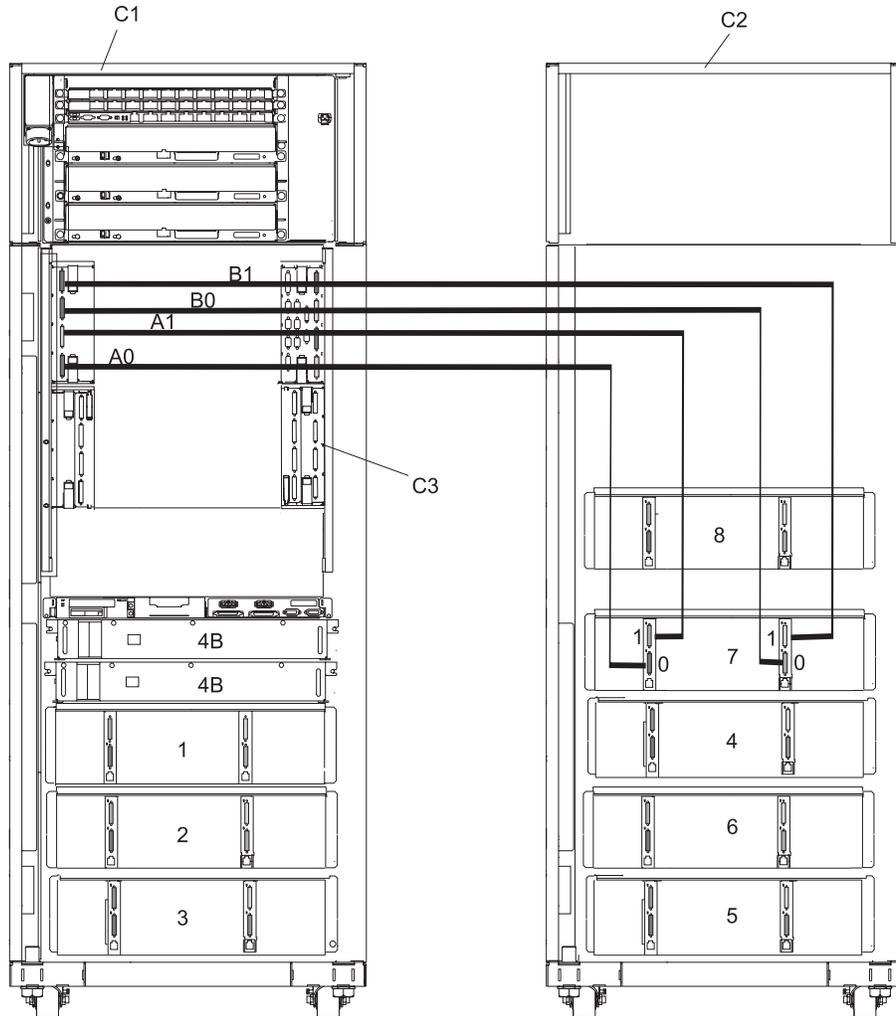
Shown with IBFs

Note: The following figure applies to CECs with RIO-2, or bayonette retention, connections.

| C1 Primary Rack | 4 Fourth I/O Subsystem |

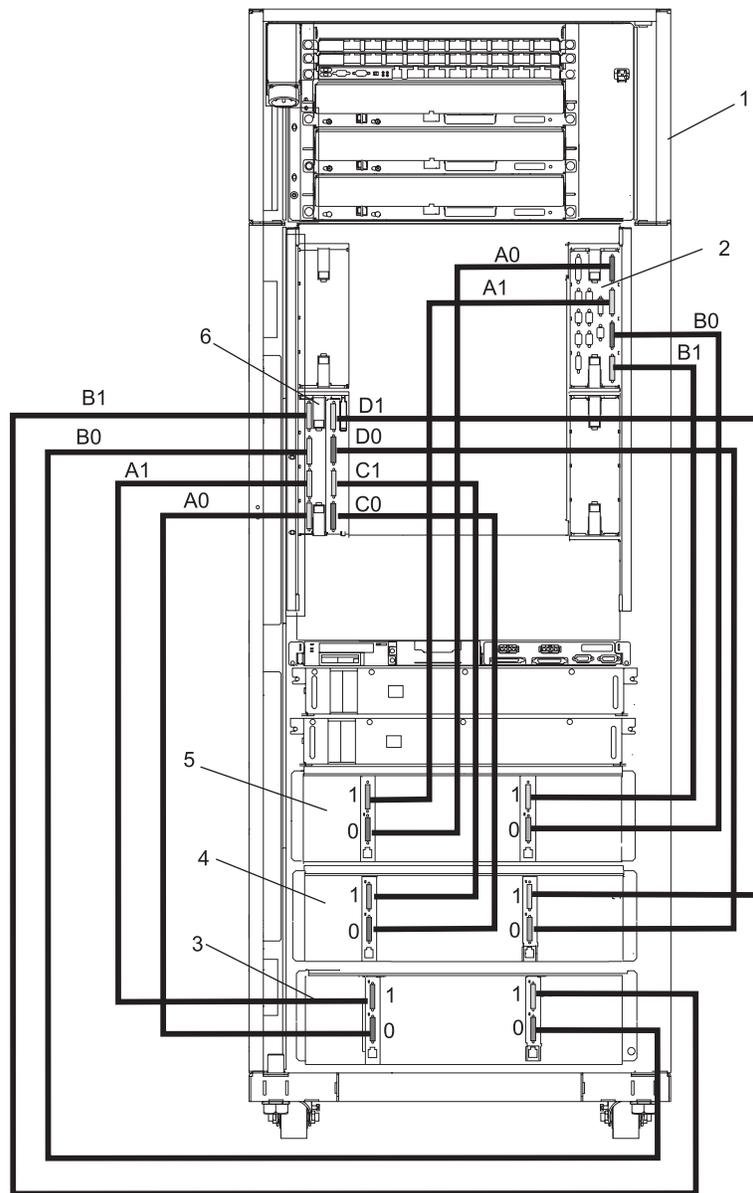
I/O Subsystems (1 through 3 with IBFs) RIO-2 Cabling to I/O Books, One I/O Planar Loop Configuration, 3 or 4 MCMs Only

Note: The following figure applies to CECs with RIO-2, or bayonette retention, connections.

- 1 Primary Rack
- 2 Primary I/O Book
- 3 Third I/O Subsystem
- 4 Second I/O Subsystem
- 5 First I/O Subsystem
- 6 Secondary I/O Book

- A0 Connection to I/O Book (Book 0)
- A1 Connection to I/O Book (Book 0)
- B0 Connection to I/O Book (Book 0)
- B1 Connection to I/O Book (Book 0)
- C0 Connection to I/O Book (Book 2)
- C1 Connection to I/O Book (Book 2)

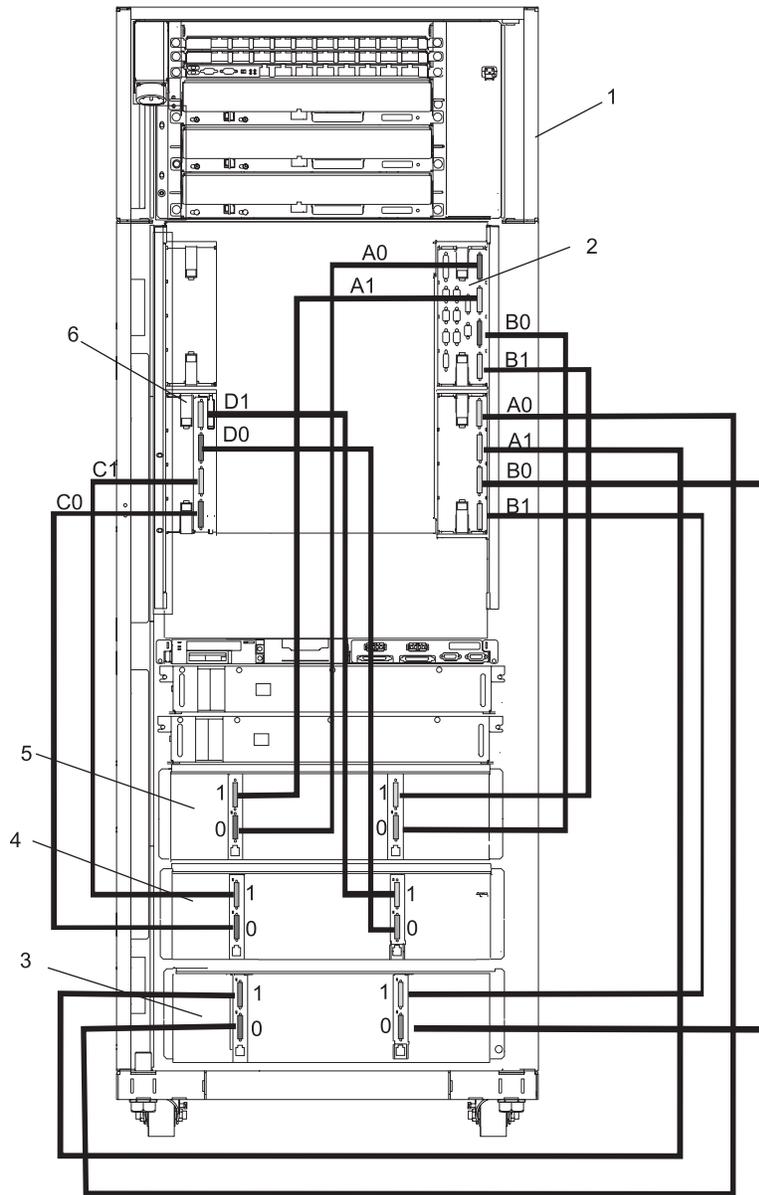
I/O Subsystems (1 through 3 with IBFs) RIO-2 Cabling to I/O Books, One I/O Planar Loop Configuration, 2 MCMs Only

Note: The following figure applies to CECs with RIO-2, or bayonette retention, connections.

- 1 Primary Rack
- 2 Primary I/O Book
- 3 Third I/O Subsystem
- 4 Second I/O Subsystem
- 5 First I/O Subsystem
- 6 Secondary I/O Book

- A0 Connection to I/O Book (Book 0)
- A1 Connection to I/O Book (Book 0)
- B0 Connection to I/O Book (Book 0)
- B1 Connection to I/O Book (Book 0)
- C0 Connection to I/O Book (Book 2)
- C1 Connection to I/O Book (Book 2)

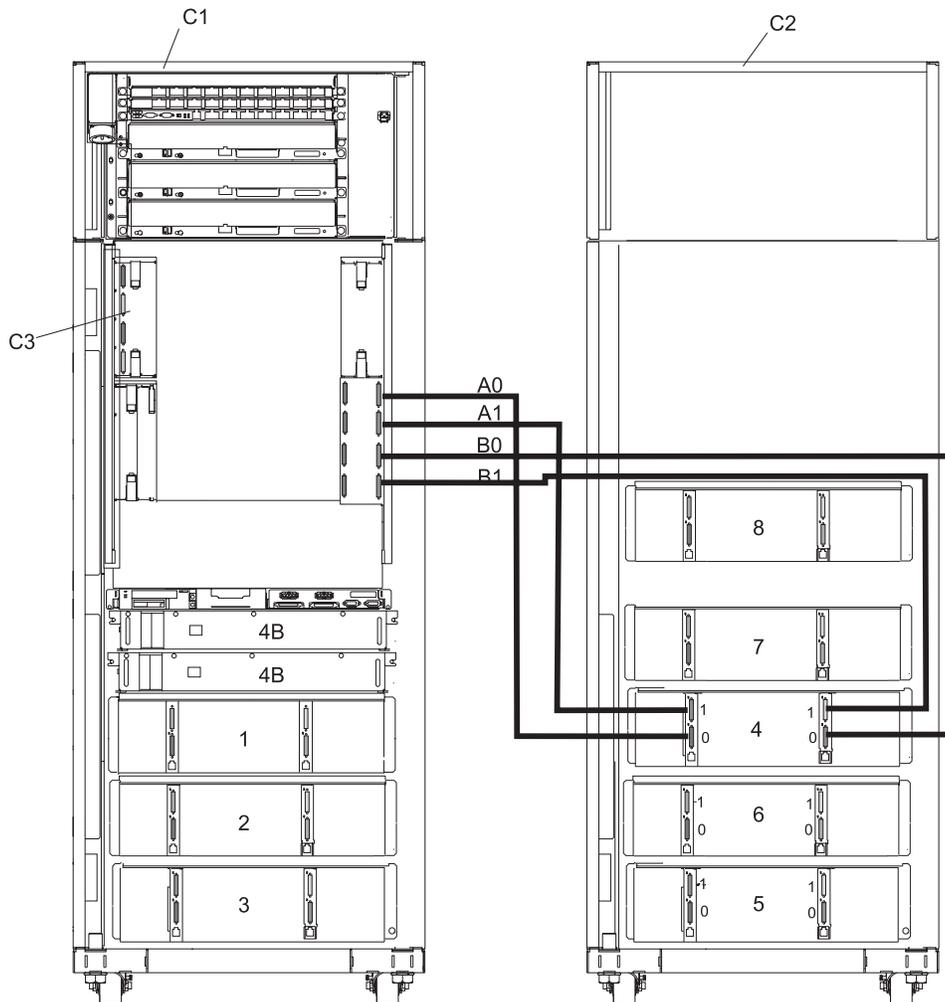
I/O Subsystem (4 with IBFs Installed) RIO-2 Cabling to I/O Book 3, One I/O Planar Loop Configuration, 3 or 4 MCMs Only

Note: The following figure applies to CECs with RIO-2, or bayonette retention, connections.

- C1** Secondary Rack
- C2** Primary Rack
- C3** Secondary I/O Book in I/O Slot 3
- C4** Secondary I/O Book in Slot 2
- 1** First I/O Subsystem
- 2** Second I/O Subsystem
- 3** Third I/O Subsystem
- 4** Fourth I/O Subsystem
- 4B** Integrated Battery Feature (IBF)
- 5** Fifth I/O Subsystem

- 6** Sixth I/O Subsystem
- 7** Seventh I/O Subsystem
- 8** Eighth I/O Subsystem
- A0** Connection to I/O Book (Book 2)
- A1** Connection to I/O Book (Book 2)
- B0** Connection to I/O Book (Book 2)
- B1** Connection to I/O Book (Book 2)
- D0** Connection to I/O Book (Book 2)
- D1** Connection to I/O Book (Book 2)

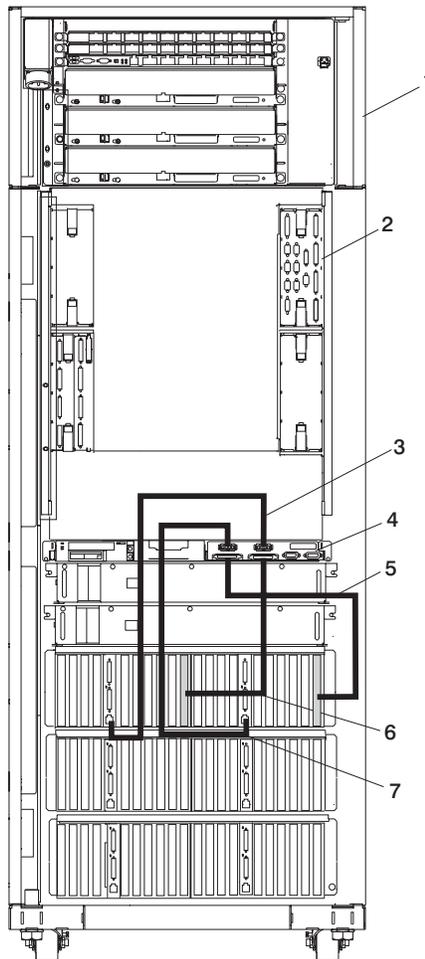
Power and SCSI Cables to the Media Subsystem

| 1 Primary Rack | 5 SCSI Cable for Media Subsystem Rear Drives |

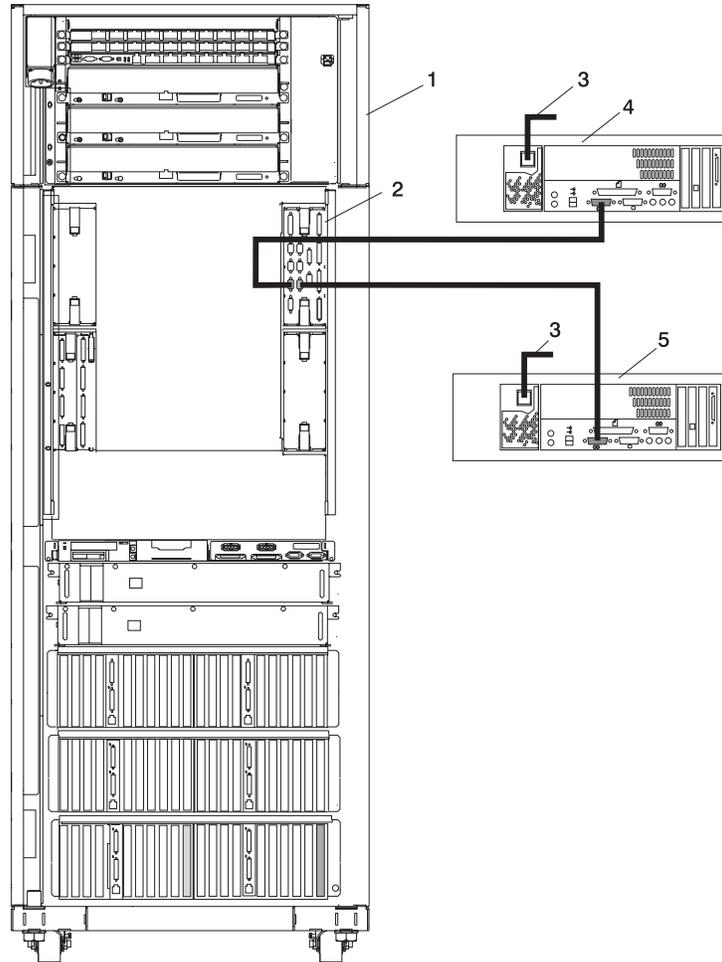
Hardware Management Console (HMC) to the Primary I/O Book

To connect your HMC to the 406/90, connect the serial cable into serial port 1 located on the back of the HMC. Connect the other end of the serial cable into the HMC1 connector located on the primary I/O book in the managed system. The following illustration shows the location of the serial ports on the back of the HMC and the HMC connectors located on the processor subsystem.

1 Primary Rack

2 Primary I/O Book

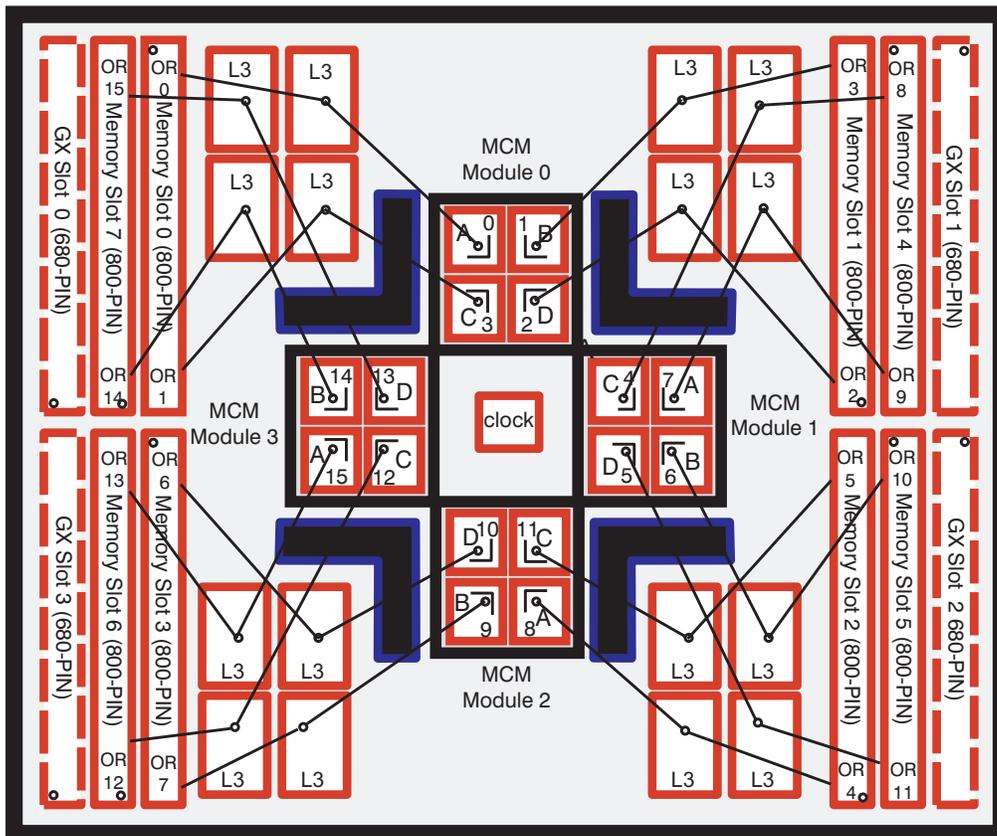
Memory to Processor Relationships

The following illustration shows the relationship between the memory riser cards, L3 cache, and the MCM modules:

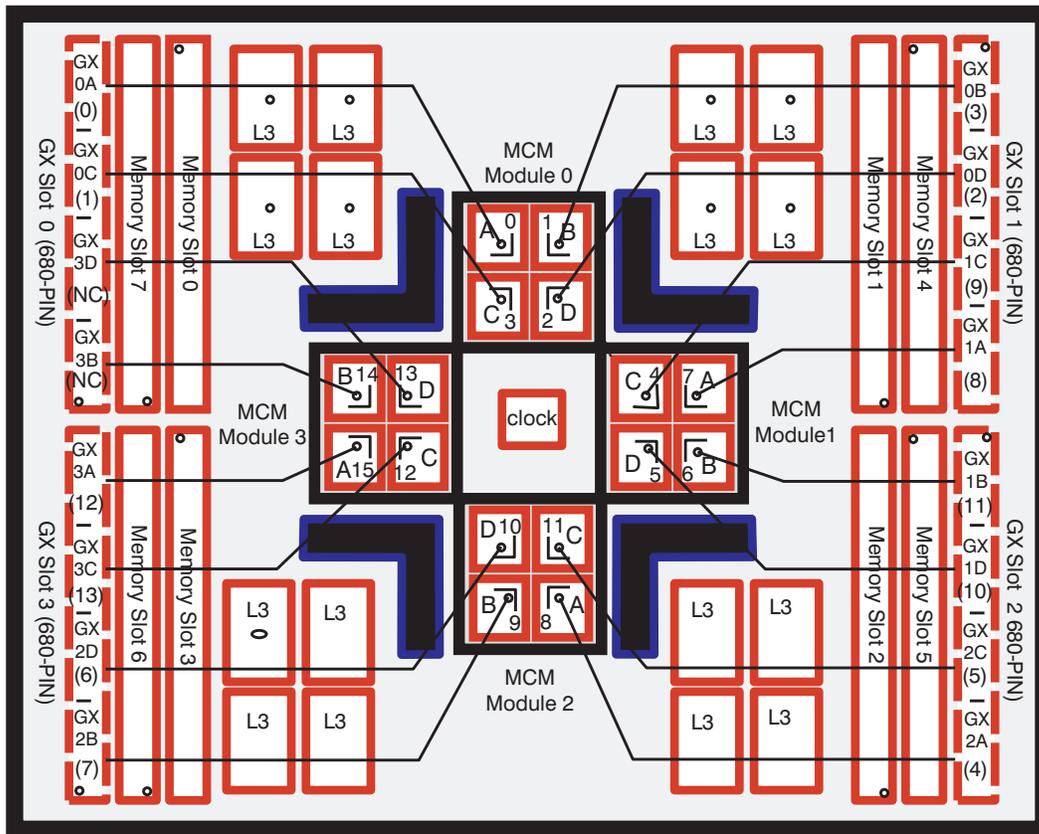
I/O to Processor Relationships

The following illustration shows the relationship between the I/O books, L3 cache, and the MCM modules:

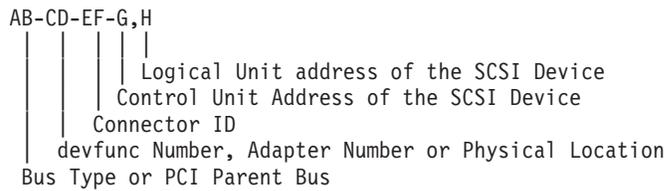
SCSI Devices

For SCSI devices, the location code is defined as follows:

Where:

- AB-CD-EF are the same as non-SCSI devices.
- G defines the control unit address of the device. Values of 0 to 15 are valid.
- H defines the logical unit address of the device. Values of 0 to 255 are valid.

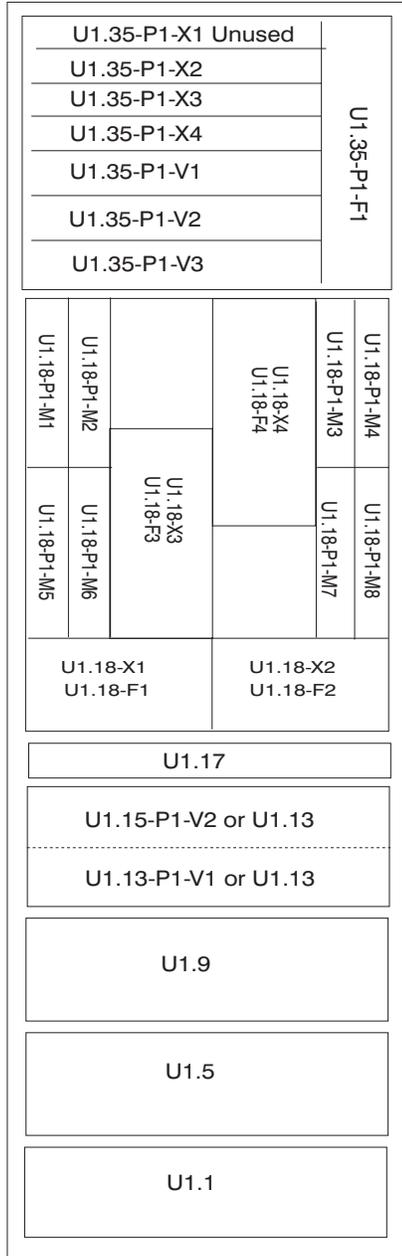
FRONT

The following illustrations show the location codes that are used to identify the major functional units in the 406/90 primary and secondary racks. The following figure shows the primary rack locations.

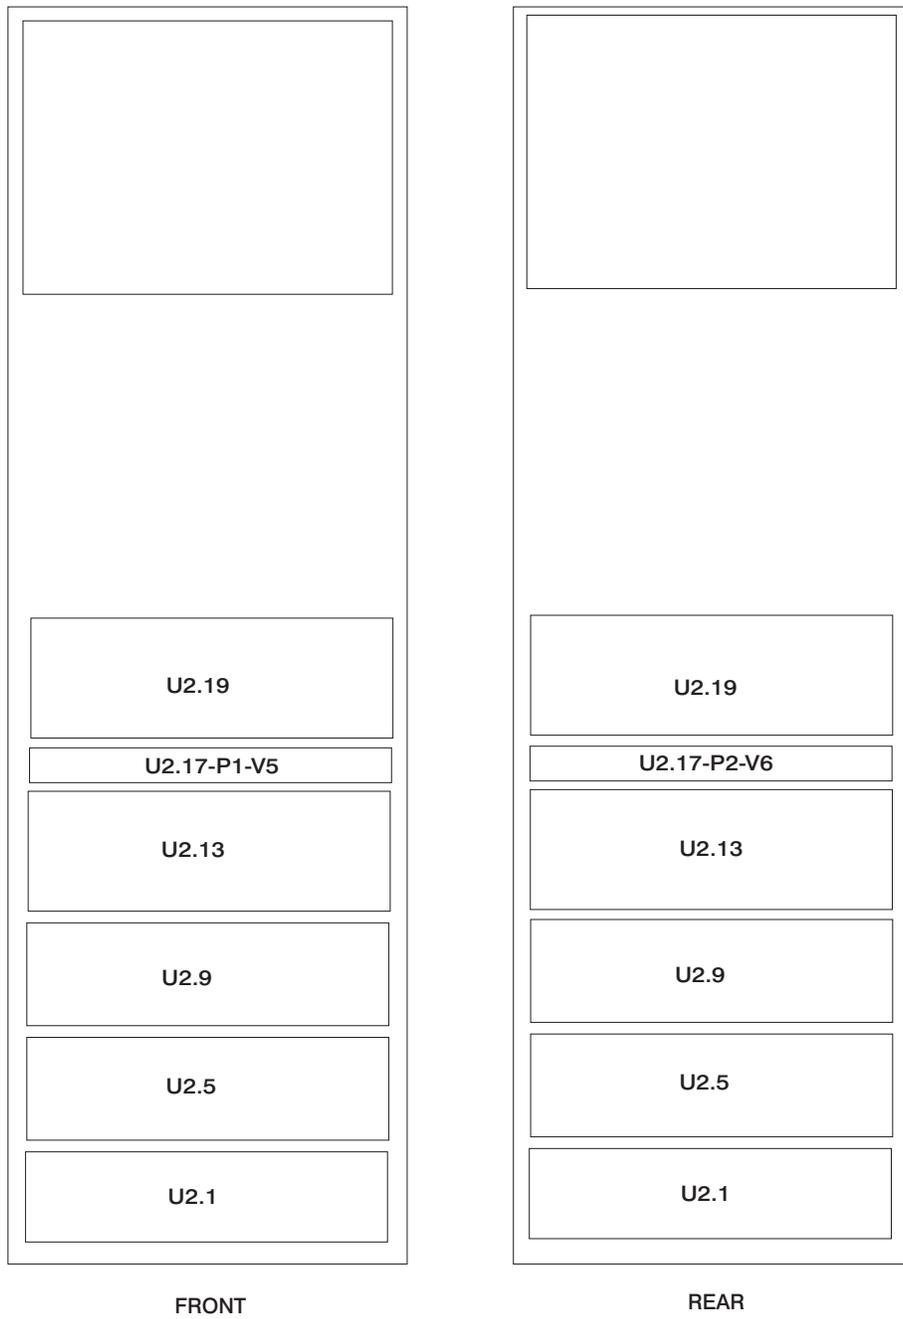
The following figure shows the secondary rack locations.

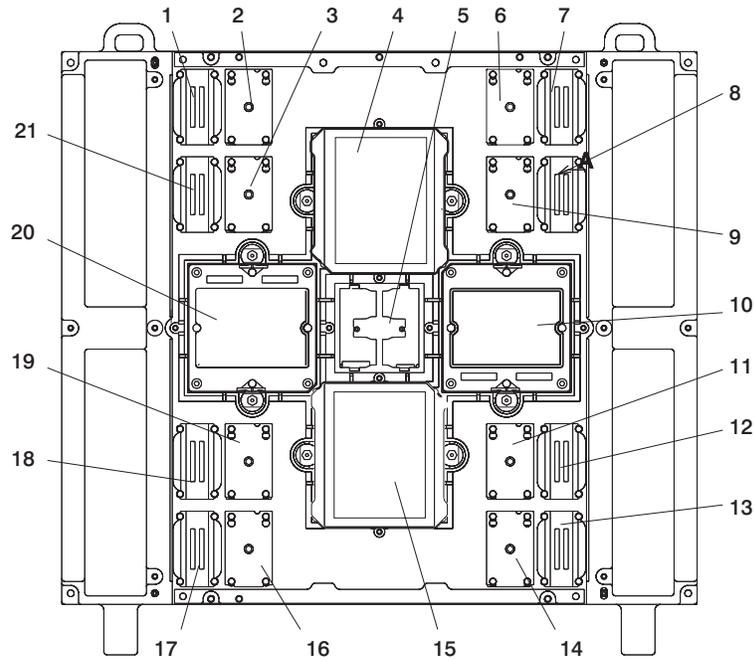
The following illustration shows the location codes that are used to identify the MCM modules and L3 modules (located behind fans 3--U1.18-P1-F3 and 4--U1.18-P1-F4).

| 1 L3, Location: U1.18-P1-C5 | 12 L3, Location: U1.18-P1-C16 |

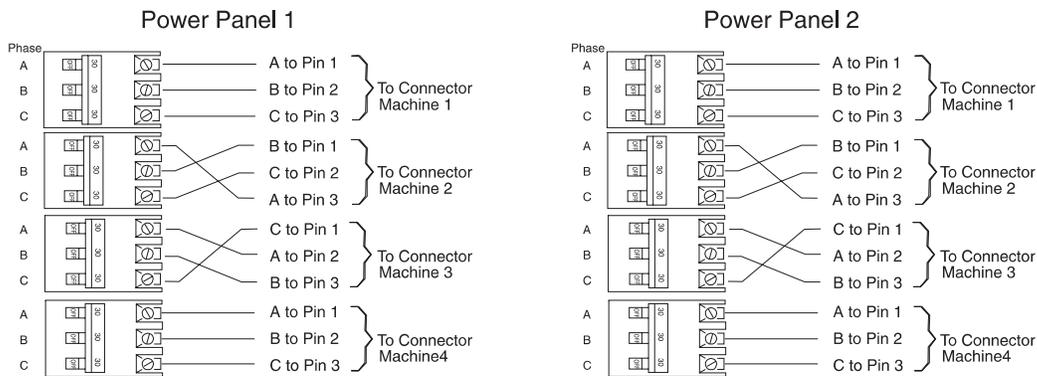
- With two BPRs per BPA, two of the three phases will draw an equal amount of current, and will be, nominally, 57.8% of the current on the third phase.
- With one BPR per BPA, two of three phases will carry an equal amount of current, with no current drawn on the third phase. The following figure is an example of feeding several loads of this type from two power panels in a way that balances the load among the three phases.

The method illustrated in the preceding figure requires that the connection from the three poles of each breaker to the three phase pins of a connector be varied. Some electricians may prefer to maintain a consistent wiring sequence from the breakers to the connectors. The following figure shows a way to balance the load without changing the wiring on the output of any breakers. The three-pole breakers are alternated with single-pole breakers, so that the three-pole breakers do not all begin on Phase A.

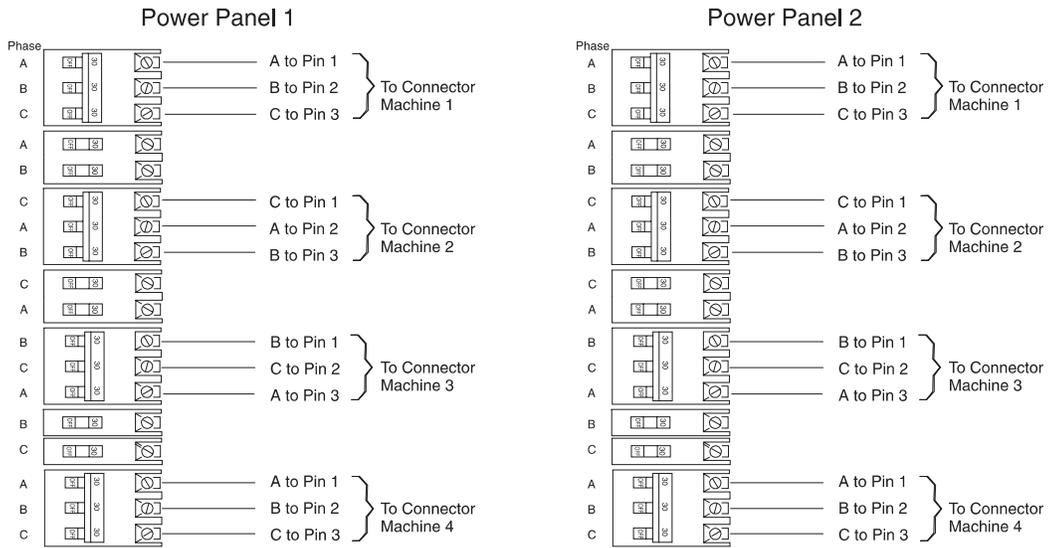
The following figure shows another way of distributing the unbalanced load evenly. Using this method, the three-pole breakers are alternated with two-pole breakers.

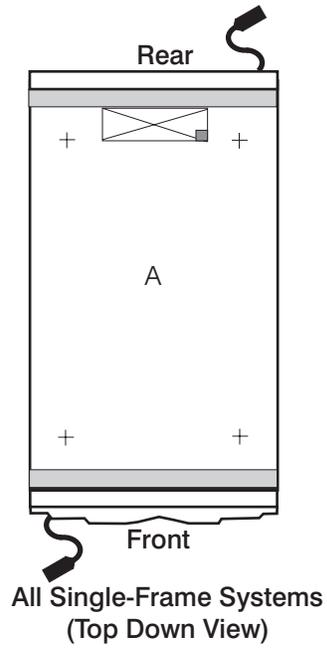
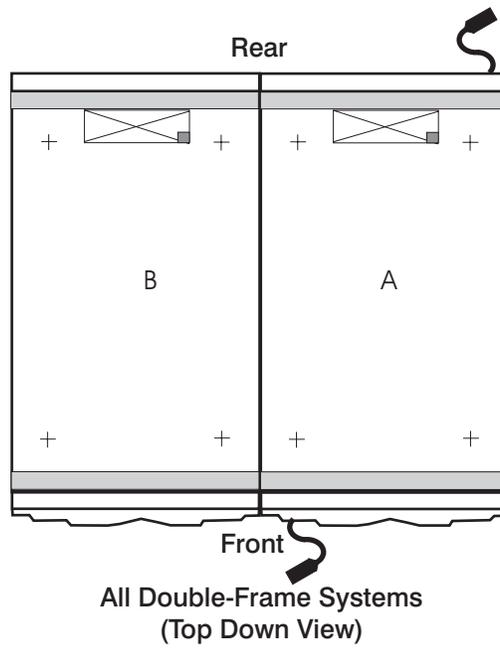
Power Cord Configuration: The power cords exit the system from different points of the frame as indicated in the following illustration.

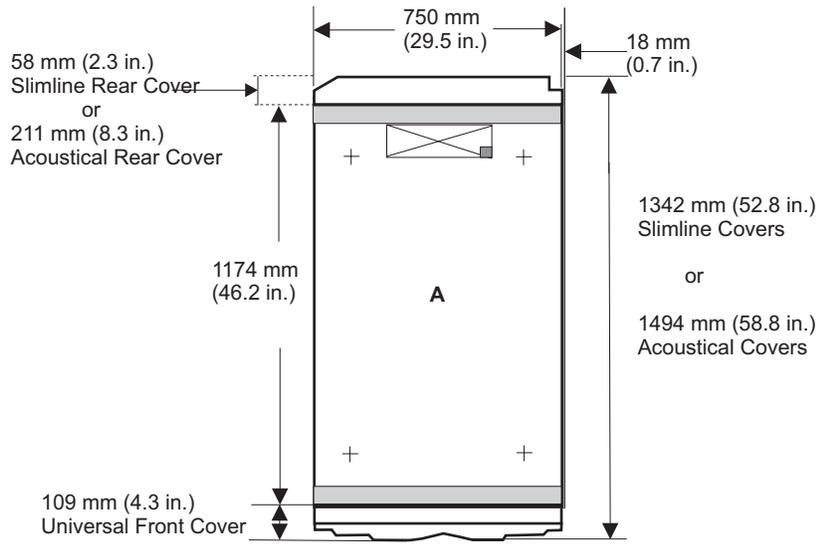
Plan Views

The following illustration shows dimensional planning information for single-frame systems and double-frame systems.

FRONT

FRAME ENTRY/EXIT	DIMENSION	
	(mm)	(in.)
FRONT	117 by 403	4.6 by 15.9
REAR	117 by 403	4.6 by 15.9

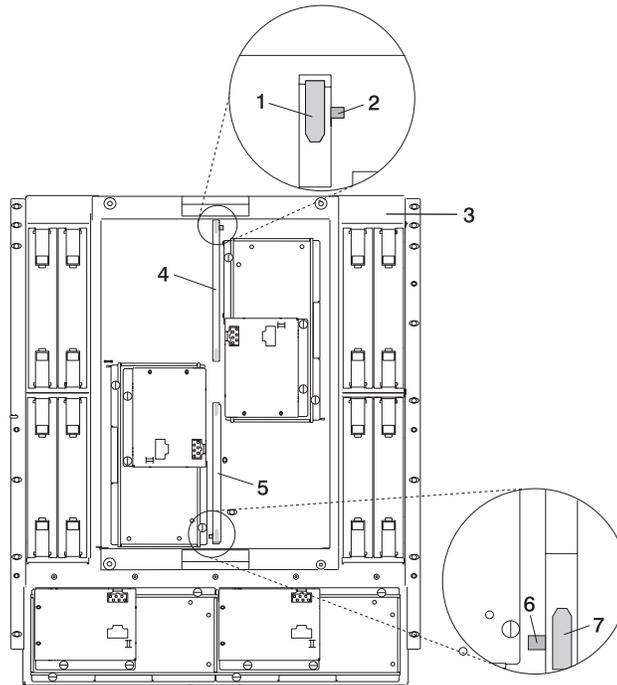
To remove the air filters from the processor subsystem, grasp the finger tabs located on the air filter and pull the air filter straight out from the processor subsystem.

- 1 Top Filter Pull Tab
- 2 Top Filter Key
- 3 Processor Subsystem
- 4 Top Filter

- 5 Bottom Filter
- 6 Bottom Filter Key
- 7 Bottom Filter Pull Tab

To replace an air filter in the processor subsystem, slide the air filter into the slot. The filter is keyed to ensure correct orientation.

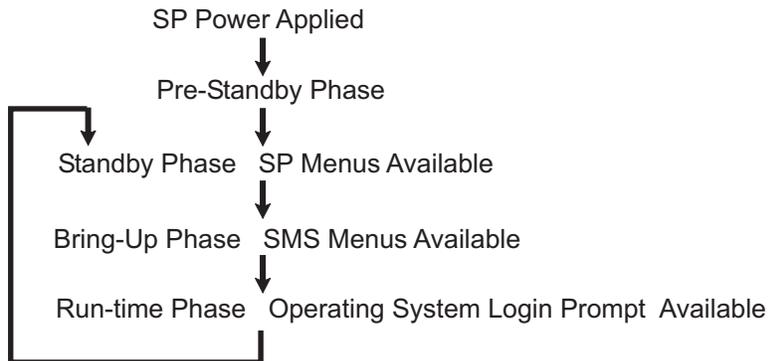
Service Processor Operational Phases

This section provides a high-level flow of the phases of the service processor.

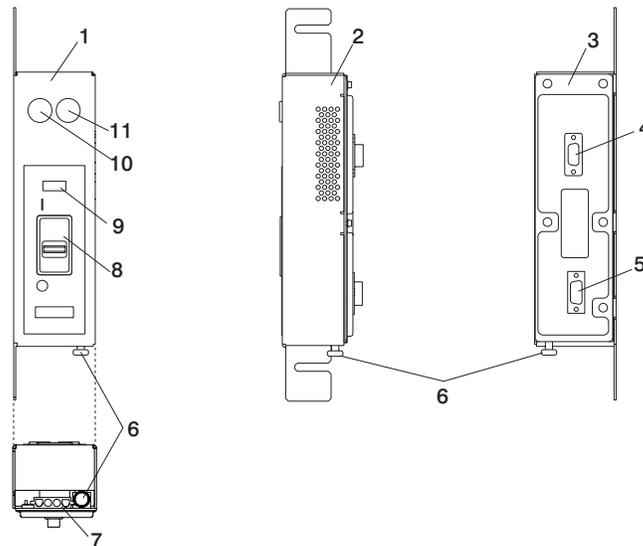
Unit Emergency Power Off (UEPO) Card Assembly

| 1 Simplified UEPO Front Panel | 7 J02 Connector (White) |

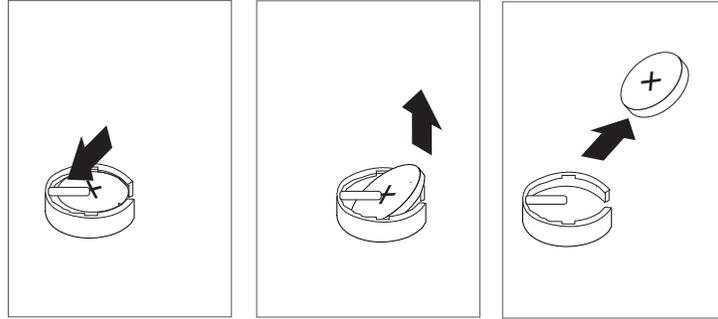
4. Use one finger to gently press the top edge of the battery in and down from the battery socket. Then use your thumb and index finger to pull the battery out of the socket, as shown in the following illustration.

Replace in reverse order. Insure that the battery polarity is correct: place the battery in the socket with the positive side facing out.

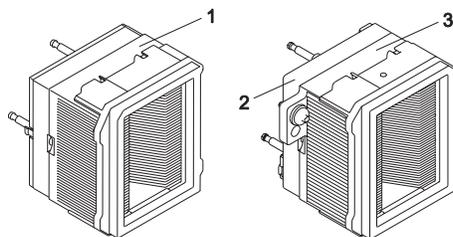
5. Determine the type of MCM modules used on your system. The following illustration shows the difference between the aluminum heatsink and copper heatsink MCMs.

- 1 MCM (with aluminum heatsink)
- 2 MCM Alignment Hole (on copper heatsink MCMs only)
- 3 MCM (with copper heatsink)

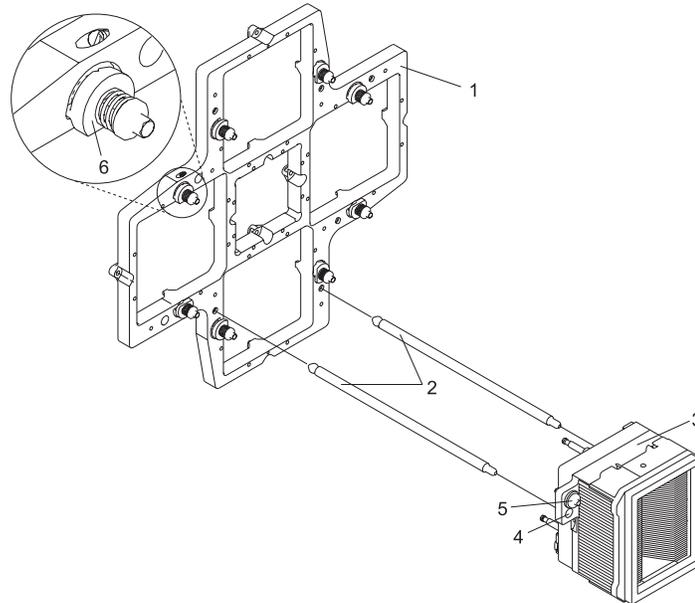
8. Beginning with the upper most module to be removed, loosen the two captive heatsink bushing screws until they are free floating. See the following illustration for heatsink bushing screw locations.
9. Insert the two steel alignment rods through the MCM alignment holes and into the aluminum stiffener. See the following illustration for MCM clearance hole locations.

1 Aluminum Backplane Stiffener

2 Steel Alignment Rods

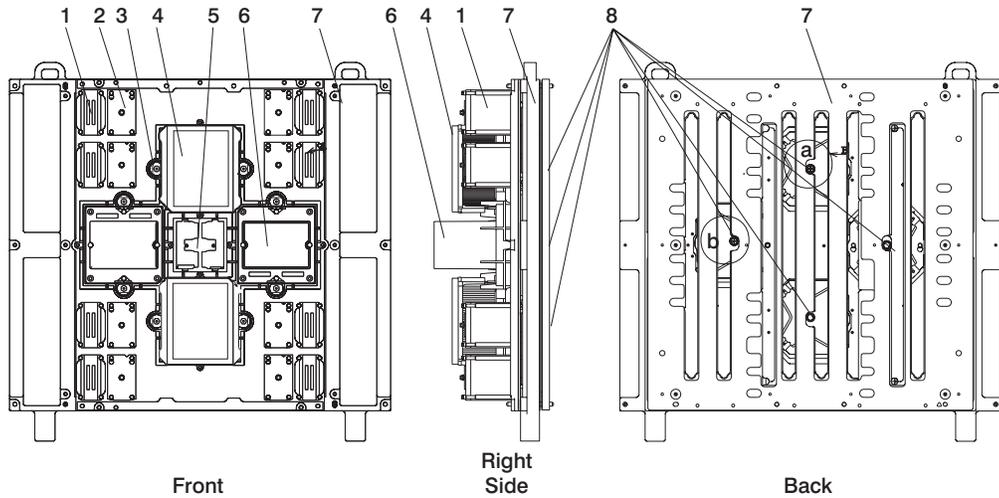
12. Ensure that the actuation bolt behind the MCM module is in the down position.

| <ul style="list-style-type: none"> 1 L3 Filler 2 L3 Module Assembly 3 MCM Locking Cam 4 MCM Heatsink / Module Assembly | <ul style="list-style-type: none"> 5 System Clock Card 6 MCM Filler or Pass Through Card 7 System Board 8 Actuation Bolt |

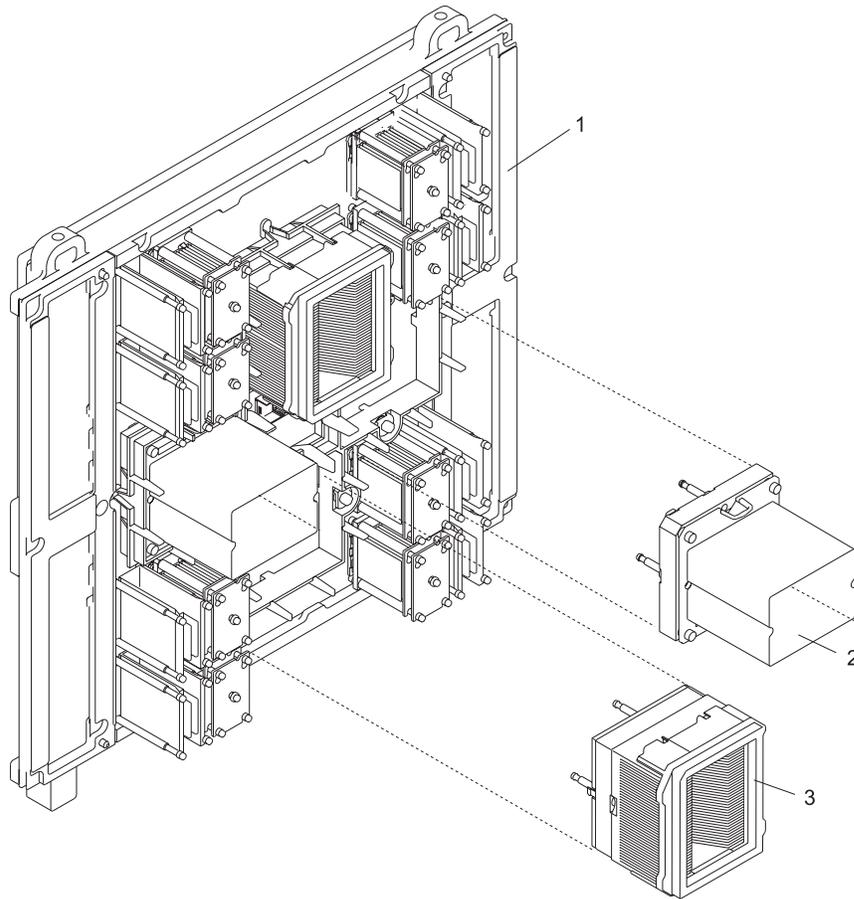
19. With both hands, grasp the module across the narrow span of the heatsink cap, and pull the MCM module from the system board and place it, posts-down, on the ESD mat.

- 1 Processor Backplane
- 2 MCM (aluminum heatsink version)
- 3 MCM Pass Through

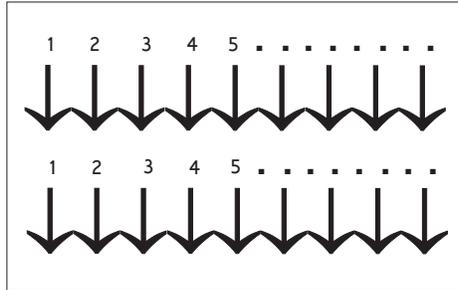
Attention: Each time an MCM module is removed from system backplane, the LGA site where the module connects *must* be cleaned. With the brush supplied with the replacement kit, use only downward strokes, starting in the upper-left location. Using firm pressure, brush left to right, top to bottom, using overlapping strokes as shown in the following illustration.

The brush must be discarded after cleaning only one LGA site.

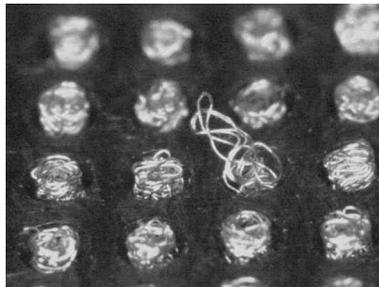
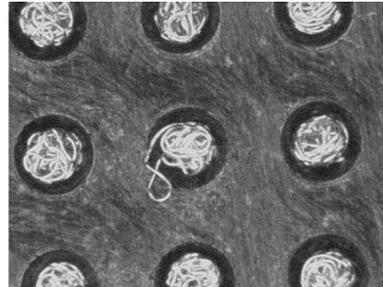
22. Each time an MCM module (or pass through) is installed, the associated interposer *must* be inspected. Inspect the MCM (or pass through) interposer, using a magnifying glass (part number 11P4747). If either of the following conditions occur, the interposer is not acceptable and the module must be returned:

Shorts If the button, a loop of the button wire, or an individual button wire lead extends more than three times the width of the wire outside of a connector hole chamfer (top side) or counter bore pin indent (bottom side).

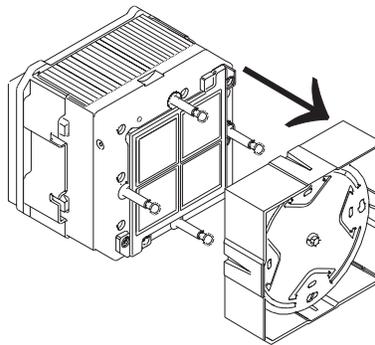
3. Loosen the captive bolt in the center of the protective cover and remove the cover from the new MCM module, as shown in the following illustration.

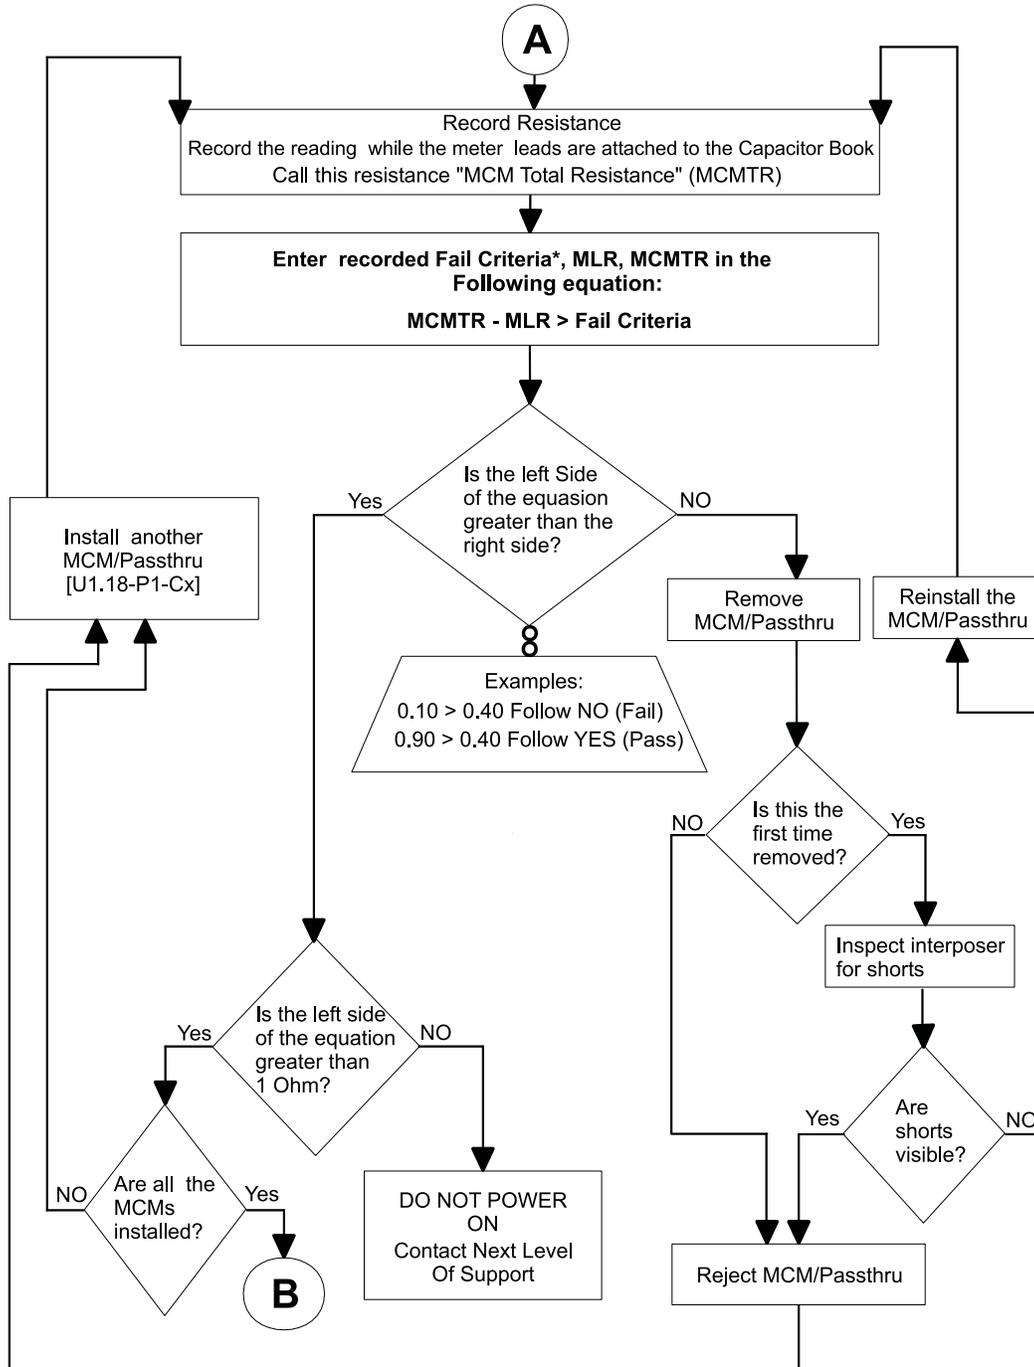
MCM Installation Shorts Test, Step 2:

Performing this test ensures that a short circuit was not created when installing an MCM or a pass through module. Follow the procedure to install and use a multimeter and capacitor book (part number 44P2471 or later) during MCM replacement.

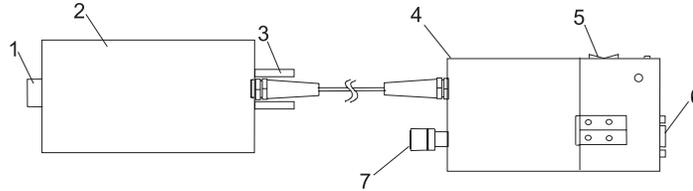
1. Plug the LGA-ST test head on the test box into the 9-pin female self-test D-shell, located on the LGA-ST control box, which looks similar to the following:

| 1 Tester D-shell | 5 Toggle switch |

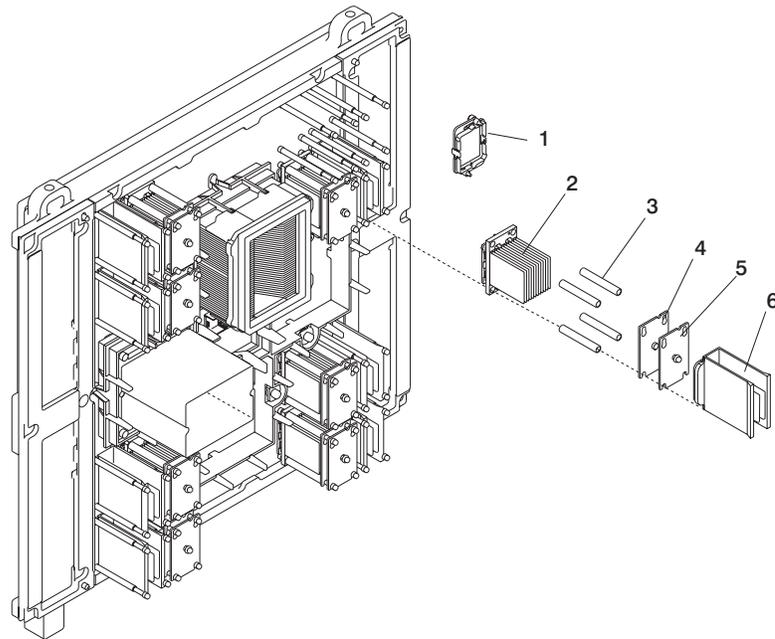
5. Use a 5-mm nut driver to loosen the set screw in the center of the L3 module spring plates as shown in the following illustration..

- 1 Protective Cover
- 2 L3 Cache Module and Heatsink
- 3 Load Posts

- 4 Rear Spring Plate
- 5 Front Spring Plate with Set Screw
- 6 L3 Filler (Used if no L3 cache module is installed)

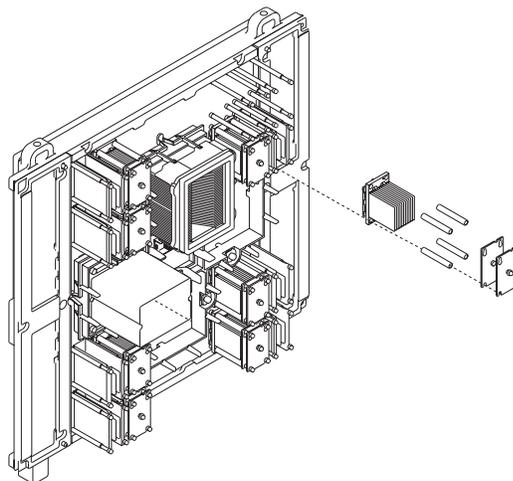
6. Slide both plates up and pull them away from the L3 cache module.
7. Remove the sleeves from the posts.
8. Use a disposable lint-free cloth to clean the sleeves.
9. Pull the L3 cache module straight back off the posts, and place it with the interposer, facing down in the four-position tray from the tool kit.

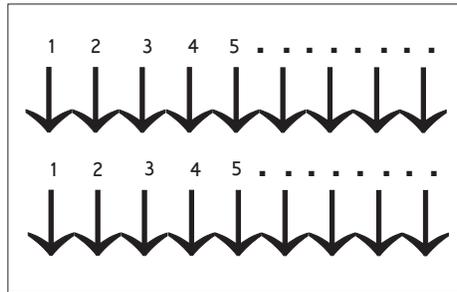
Attention: Each time an L3 cache module is removed from the system backplane, the LGA site where the module connects *must* be cleaned. With the brush supplied with the replacement kit, use only downward strokes, starting in the upper left corner. Move left to right, top to bottom, using overlapping strokes as shown in the following illustration.

The brush must be discarded after cleaning four L3 sites.

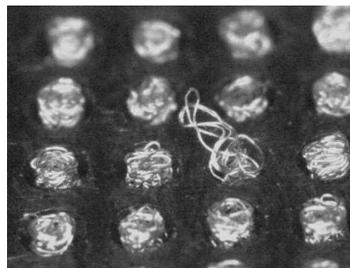
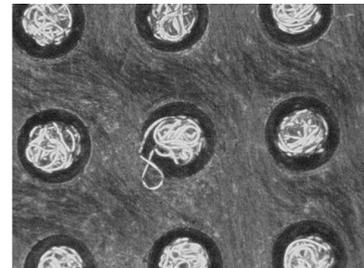
Shorts

If the button, a loop of the button wire, or an individual button wire lead extends more than three times the width of the wire outside of a connector hole chamfer (top side) or counter bore pin indent (bottom side).

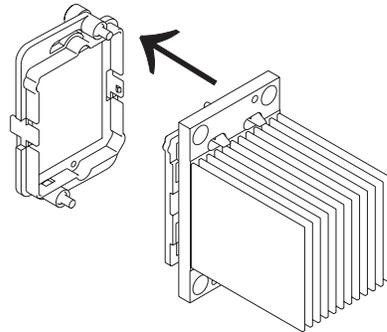
3. Loosen the captive thumbscrews on the protective cover, and remove the cover from the new L3 cache module as shown in the following illustration.

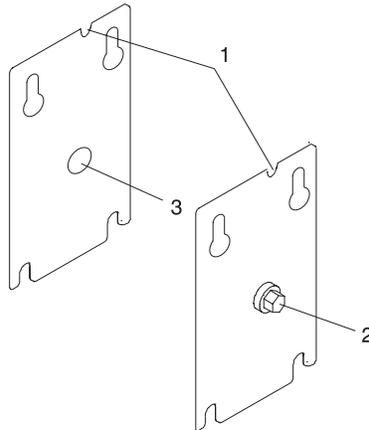
- Be sure to align the notches at the upper right corner of each spring plate as shown in the following illustration. Replace the spring plates that you removed earlier with the new spring plates provided with the L3 cache module kit.

- 1 Notch on upper right corner
- 2 5-mm set screw
- 3 Reinforced center
