Bull ESCALA PL 3200R

Service Guide

Hardware

March 2004

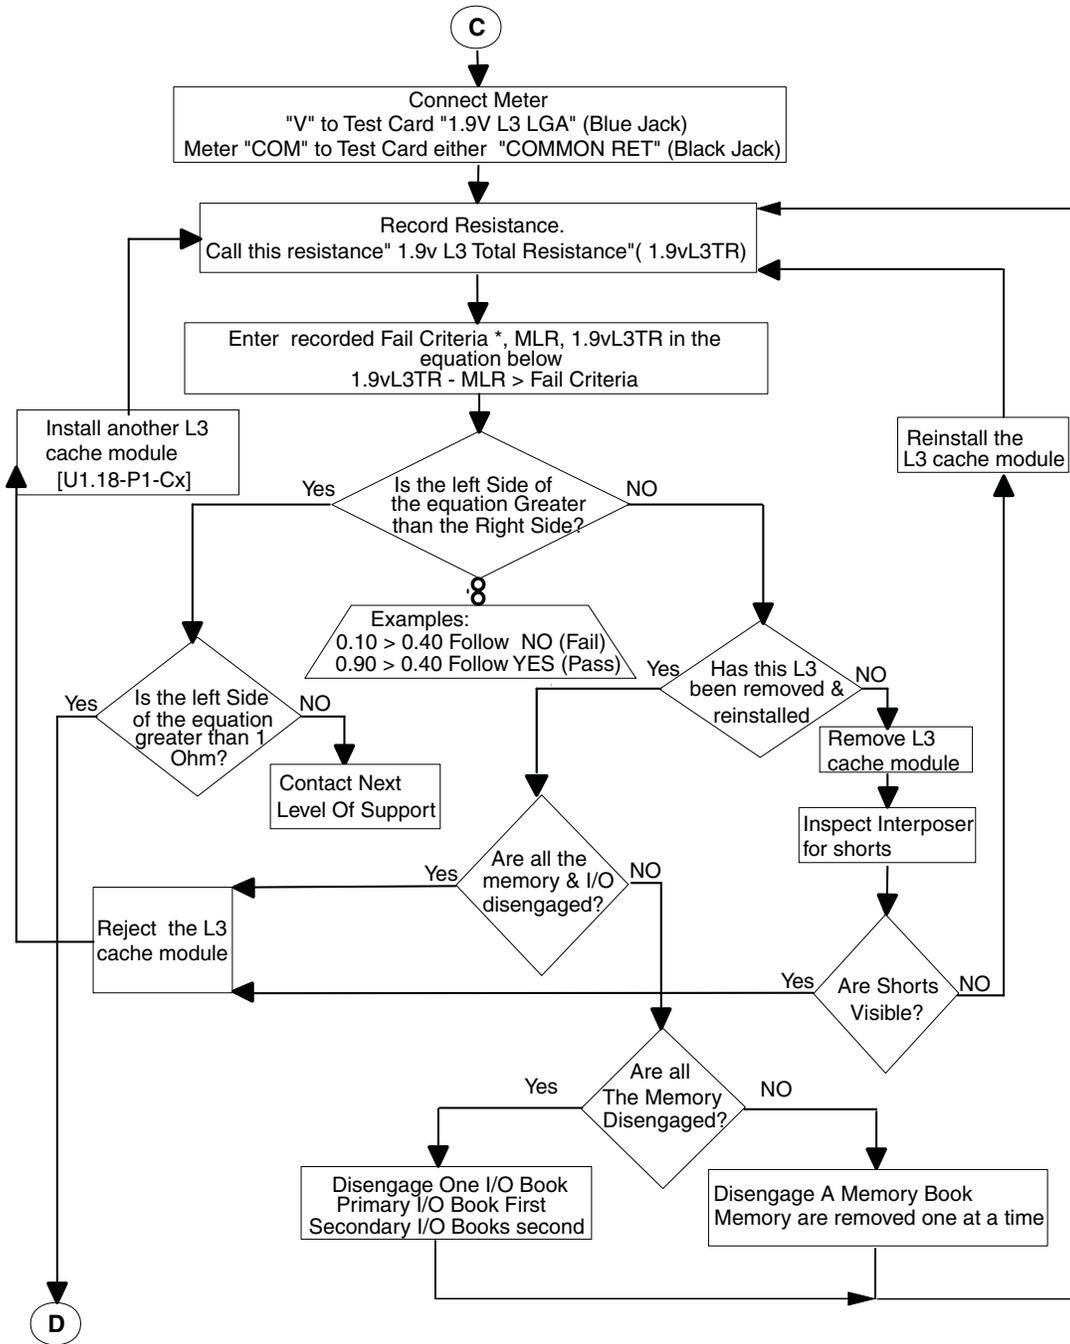
L3 Cache Shorts Test, Step 2:

Performing this test ensures that a short circuit was not created when an L3-cache module is installed. Follow this procedure to install and use the MCM/L3 module short-circuit test tool (part number 44P0209) and a multimeter during L3-cache module replacement.

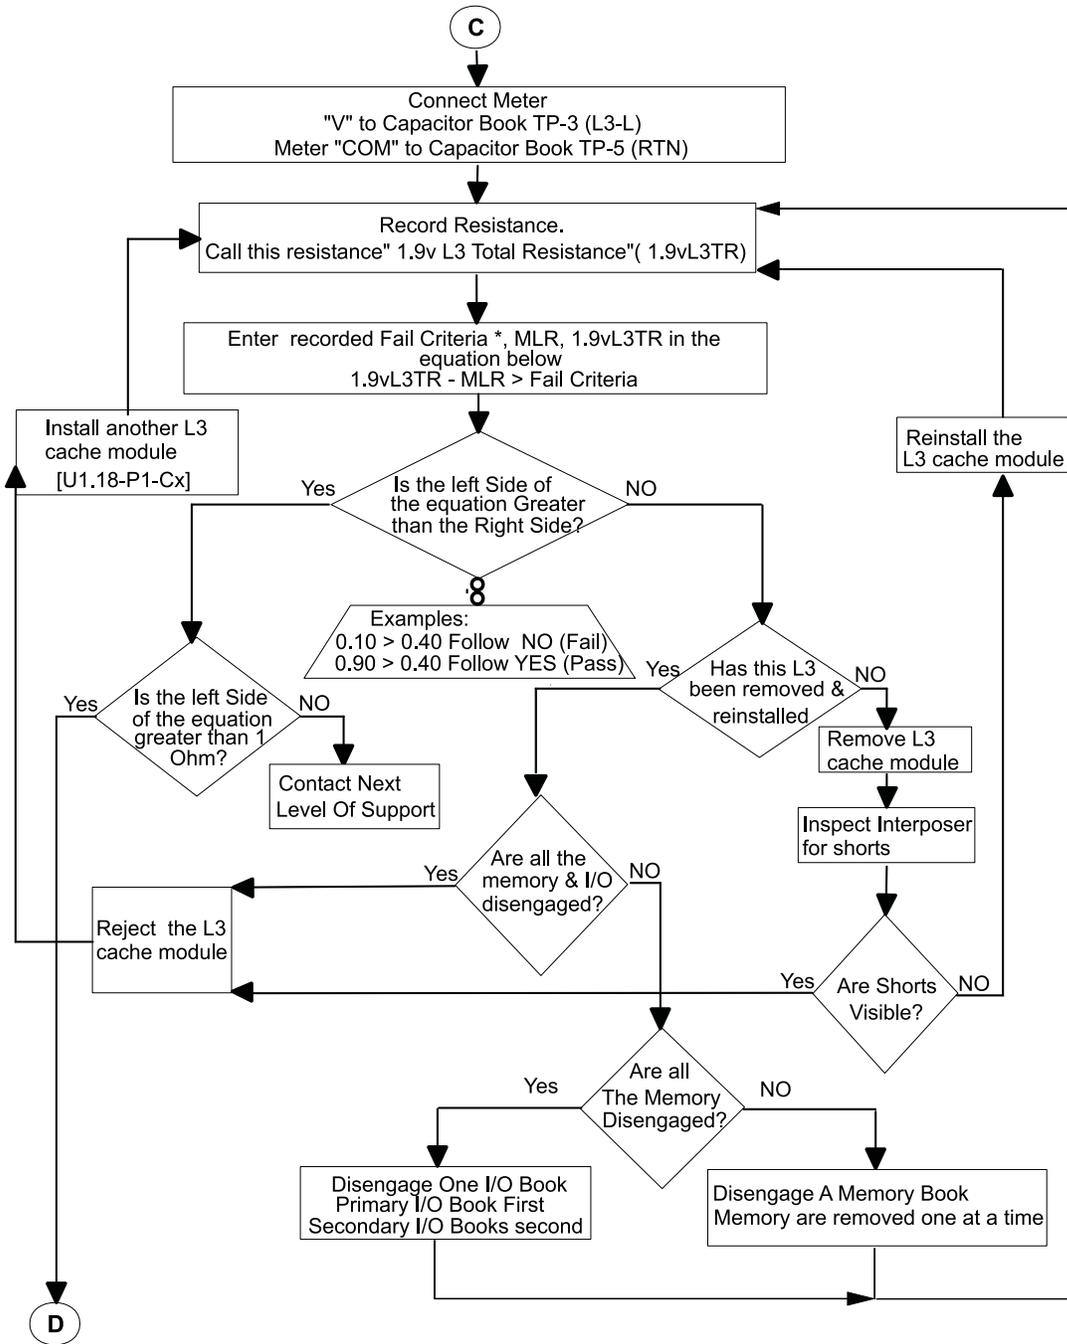
L3 Cache Shorts Test, Step 2:

Performing this test ensures that a short circuit was not created when an L3-cache module is installed. Follow this procedure to install and use the capacitor book (part number 44P2471) and a multimeter during L3-cache module replacement.

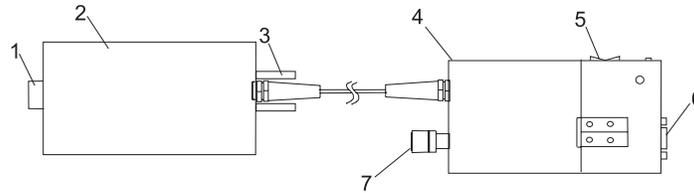
1. Plug the LGA-ST test head on the test box into the 9-pin female self-test D-shell, located on the LGA-ST control box, which looks similar to the following:

| <ol style="list-style-type: none"> 1 Test head 2 Test box 3 Jack screw 4 Control box | <ol style="list-style-type: none"> 5 Toggle switch 6 Self-test D-shell 7 Battery access |

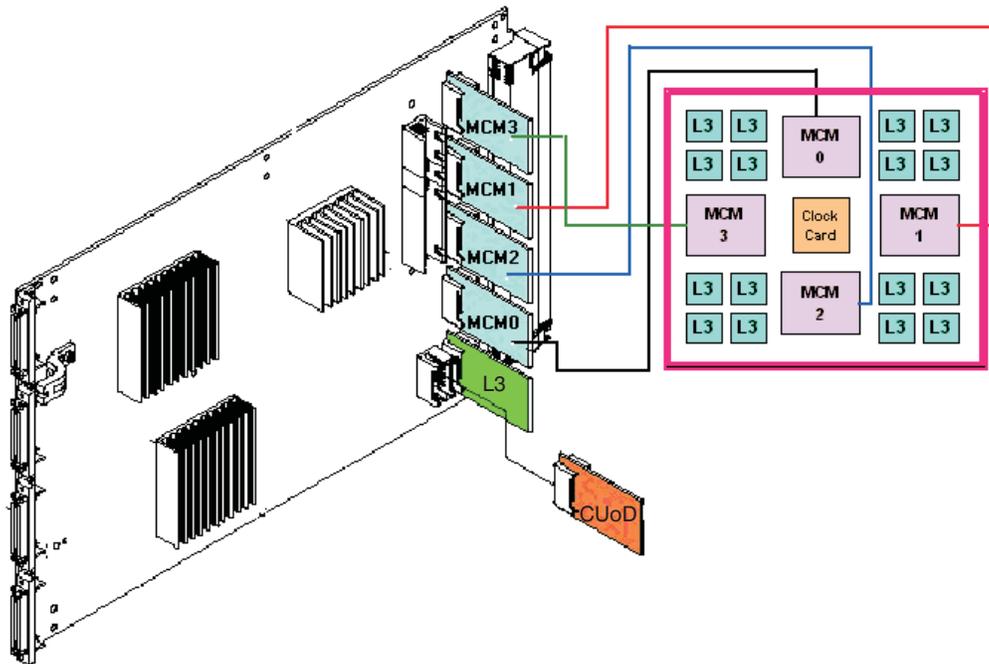
1. Remove the primary I/O book (see “I/O Books and I/O Blanks” on page 854).
2. Use a T10 torx screw to remove the short cover near the connectors.
3. Locate the VPD card that must be replaced.

4. Remove the VPD card for the associated MCM or L3 modules.

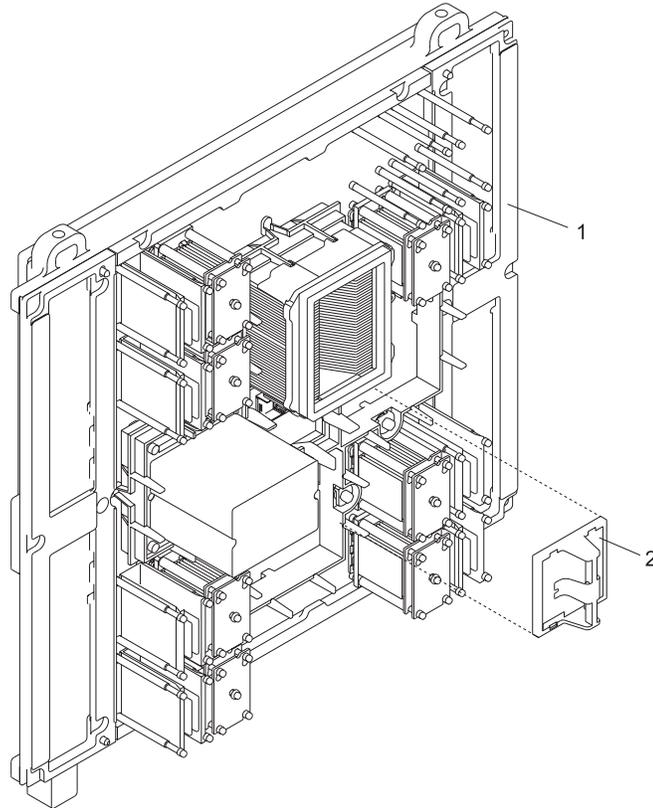
1. Turn off power as described in “Powering Off and Powering On the System” on page 838.
2. Remove the fan chassis. See “Fan Chassis” on page 912.
3. Squeeze the tabs on the clock card, and pull the card straight out as shown in the following illustration.

- 1 Processor Backplane
2 System Clock Card

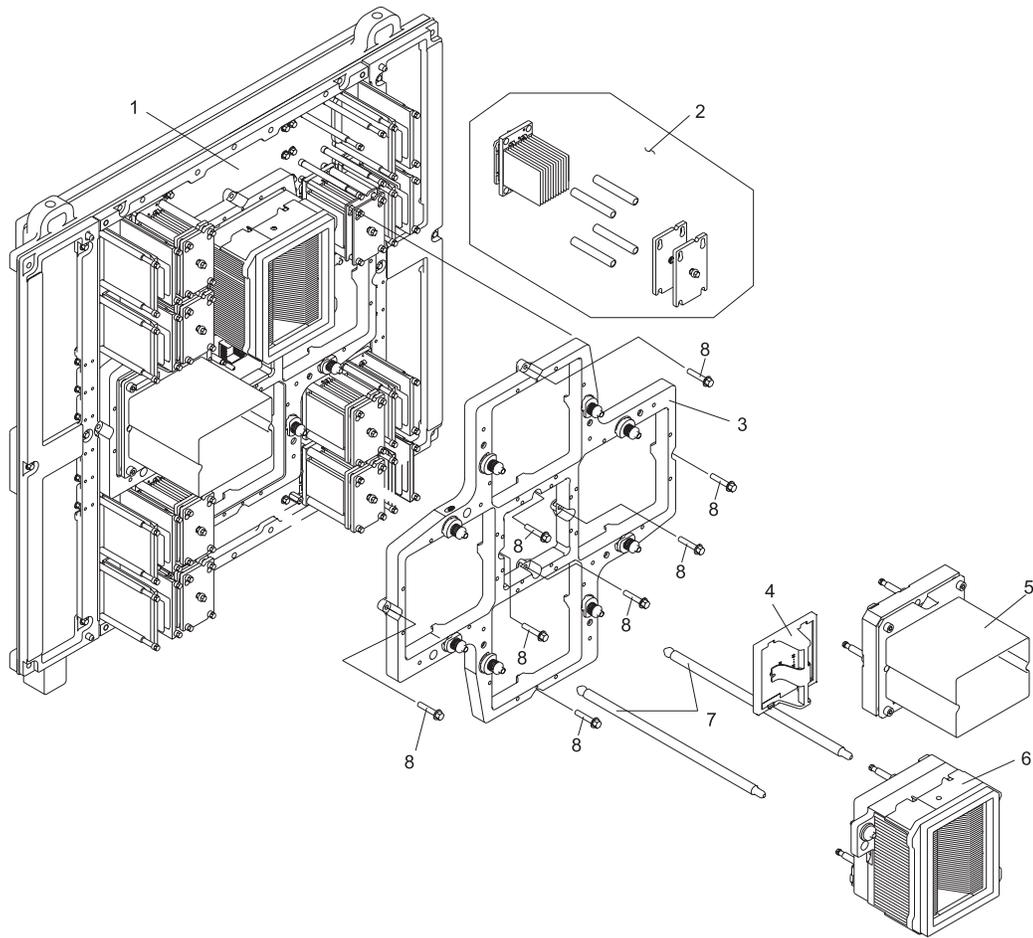
8. Carefully remove the aluminum stiffener and put it in a safe place.

- 1 System Backplane
- 2 L3 Cache Assembly
- 3 Aluminum Backplane Stiffener
- 4 MCM Alignment Rods

- 5 Clock Card
- 6 MCM pass through Module
- 7 MCM with VPD Card Kit
- 8 Aluminum Backplane Stiffener Retaining Screws (quantity 8)

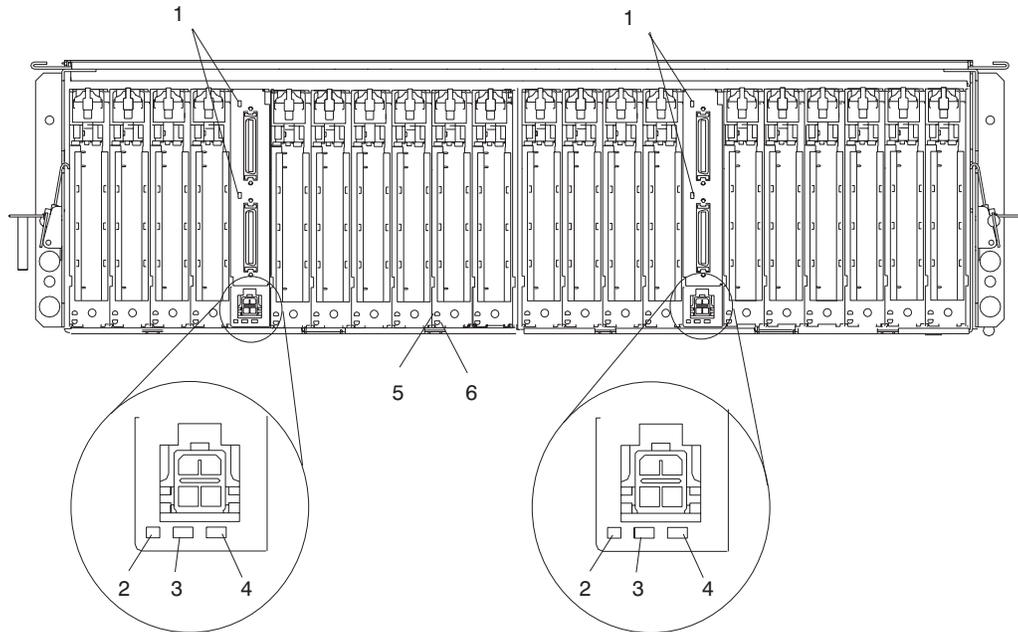
I/O Subsystem PCI Slot LED Definitions

| 1 I/O LED (Currently Unused) | 4 I/O Subsystem Backplane Power On (Green) |

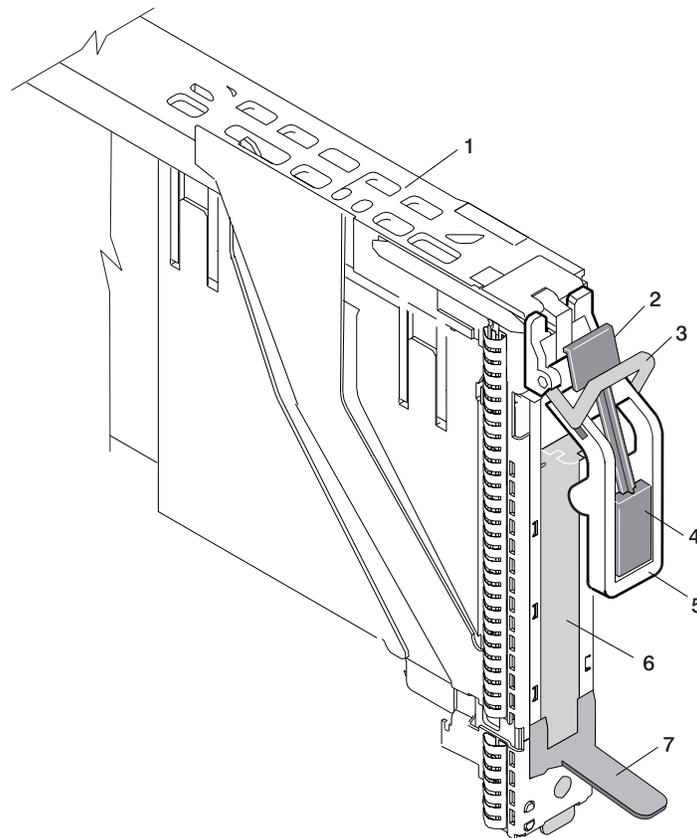
The following illustration shows the PCI adapter cassette.

- 1 PCI Adapter Cassette
- 2 Handle-Release Lever Latch
- 3 Locking Bar
- 4 Handle Release Lever
- 5 Handle
- 6 PCI Adapter Tailstock Tab
- 7 Adapter Cassette Pull Tab

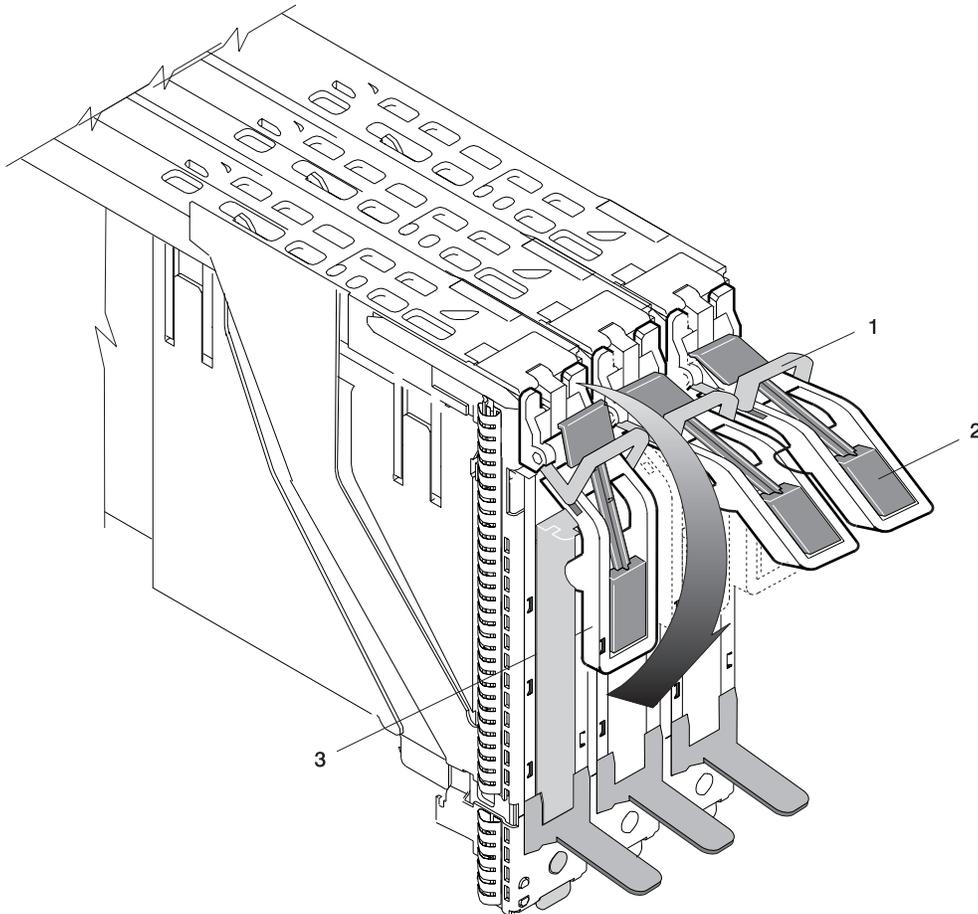
1. Determine which PCI adapter cassette you are removing.
2. Disconnect any cables that are connected to the PCI adapter.
3. Press the handle release lever, then push the handle to the down position. See the following illustration.

- 1 Locking Bar
- 2 Handle Release Lever
- 3 Handle in the Down Position

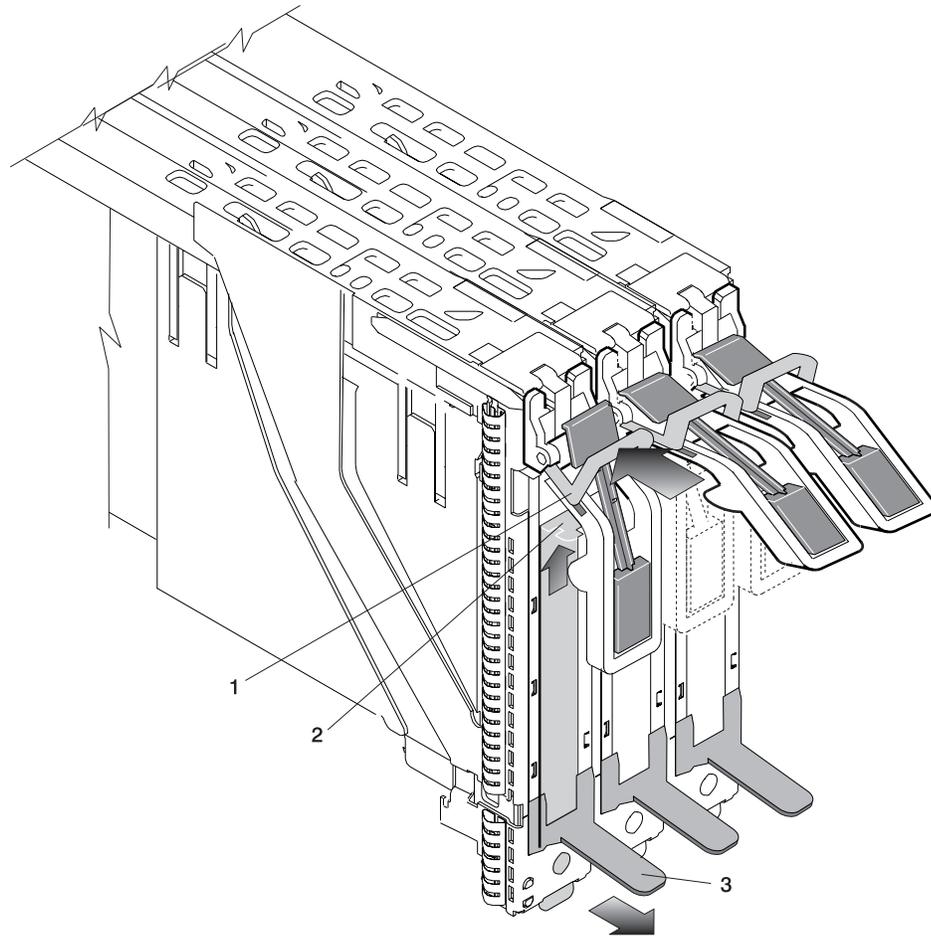
4. Push in the locking bar until it clicks into the locked position. See the following illustration.

Note: In this position, the locking bar locks the handle in the down position and prevents it from being pulled up while the PCI adapter cassette is being removed.

- 1 Locking Bar
- 2 PCI Adapter Tailstock Tab
- 3 Adapter Cassette Pull Tab

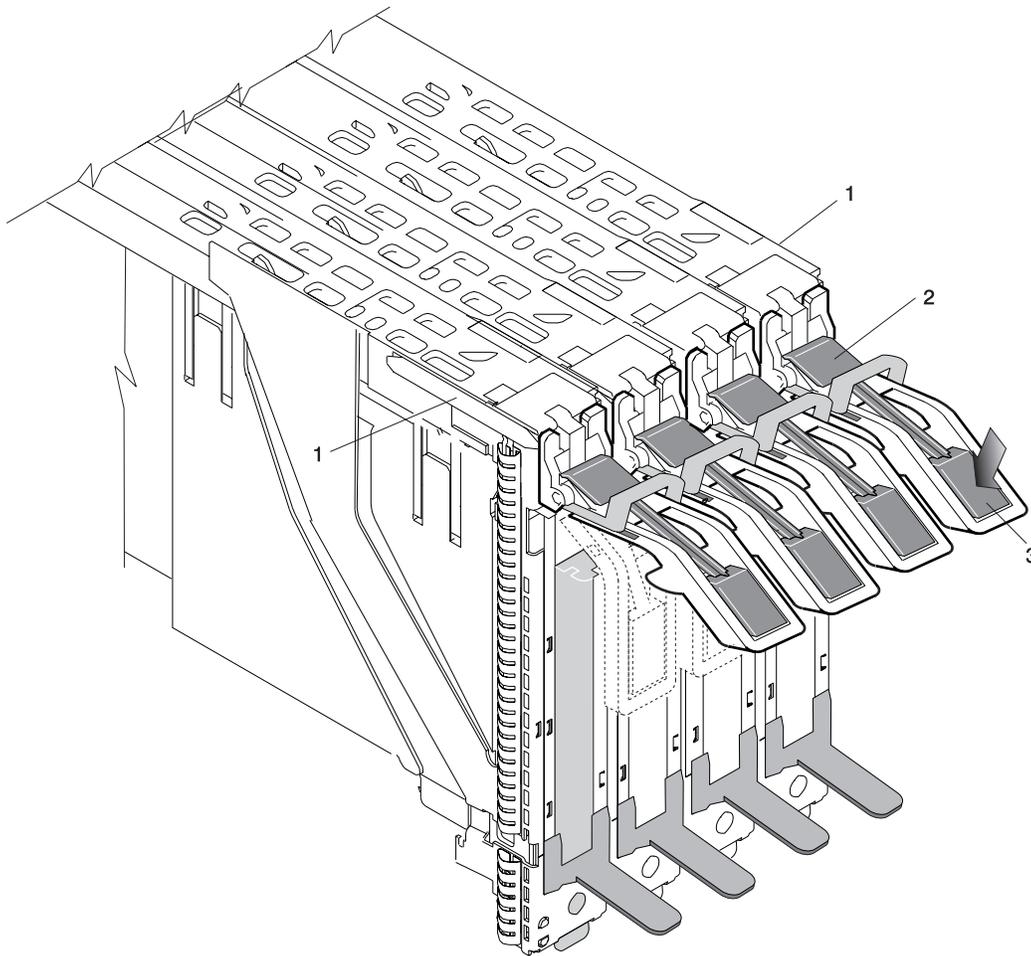
1. Depress the handle release lever located in the center of the PCI adapter cassette handle. Move the handle down completely to the fully down position. See the following illustration.

- 1 Cassette Dovetail Rails
- 2 Handle-Release Lever Latch
- 3 Handle Release Lever

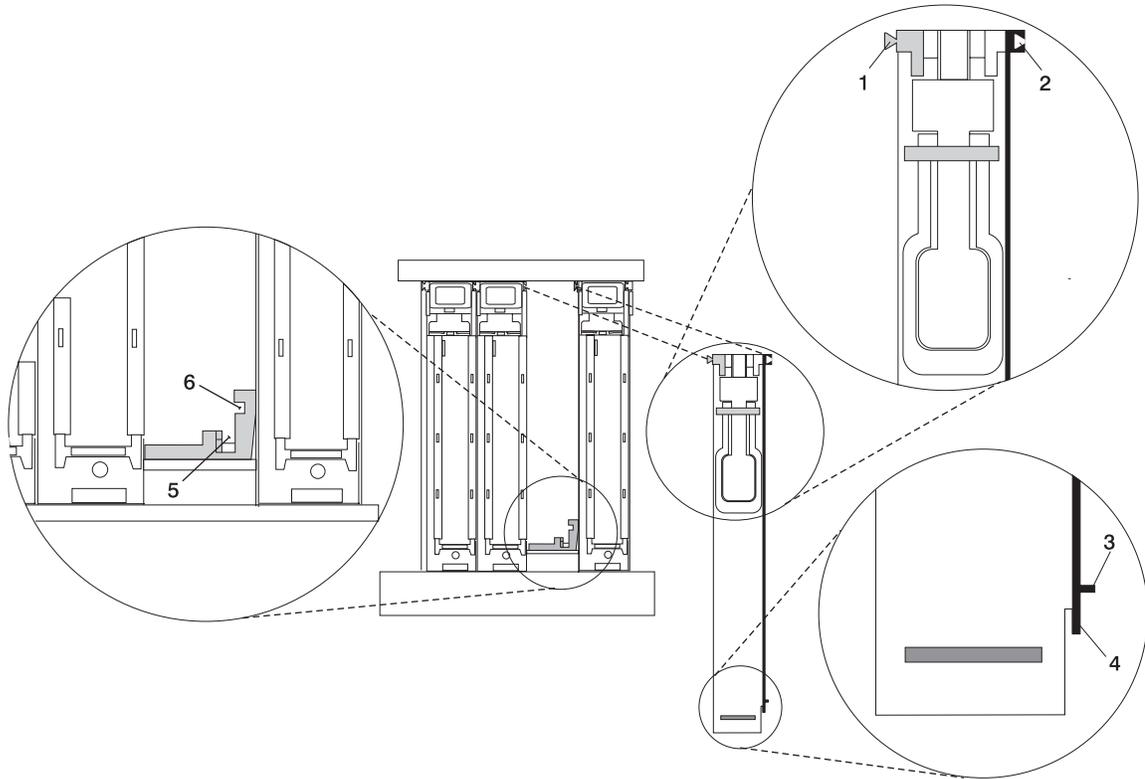
3. Examine the PCI adapter slot opening carefully, and note the location of the dovetail rails and the cassette guide rails. A flashlight can be used to enable you to see the dovetail rails and the cassette guide rail slots, as shown in the following illustration.

- 1 Cassette Left Dovetail Rail
- 2 Cassette Right Dovetail Rail
- 3 Cassette Side Guide Rail

- 4 Cassette Bottom Guide Rail
- 5 Side Guide Rail Slot on System Board
- 6 Bottom Guide Rail Slot on System Board

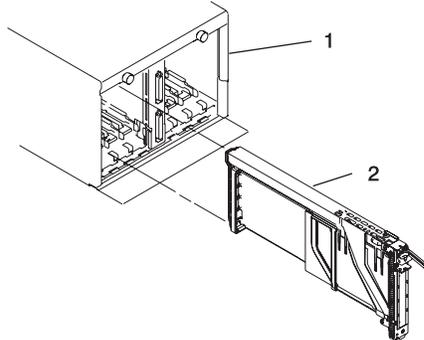
- e. Slide the cassette partially into the guide.
- f. Ensure that the dovetail on the top track aligns with its mating component(s) on both sides.

1 I/O Subsystem

2 PCI Adapter Cassette

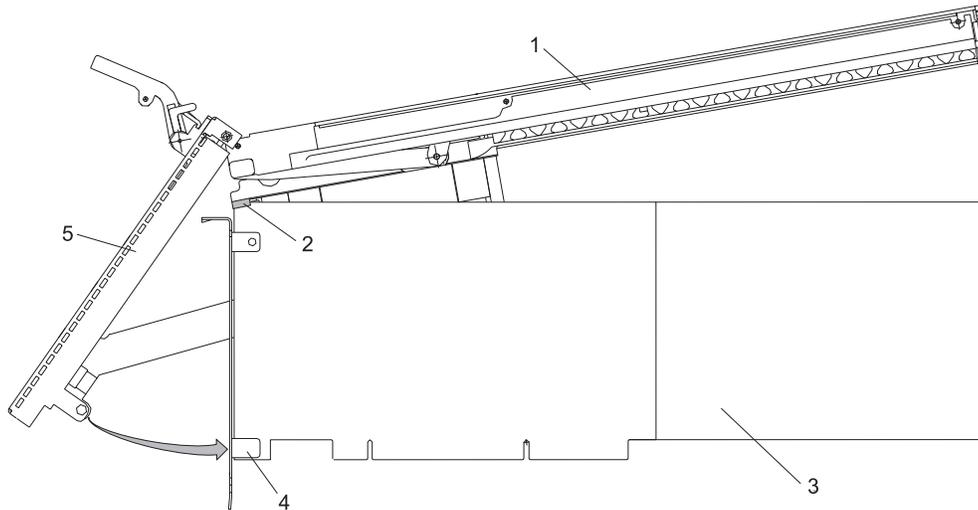
- a. If the adapter card is full-height (that is, taller than the tailstock of the card), do the following:
 - 1) Place the top corner of the PCI card so that it seats in the top front clip, as shown in the following diagram:

- 1 Cassette Top Linkage Bracket
- 2 Top Front Clip
- 3 Long Adapter

- 4 Front Heel Clip
- 5 Adapter Cassette Bezel

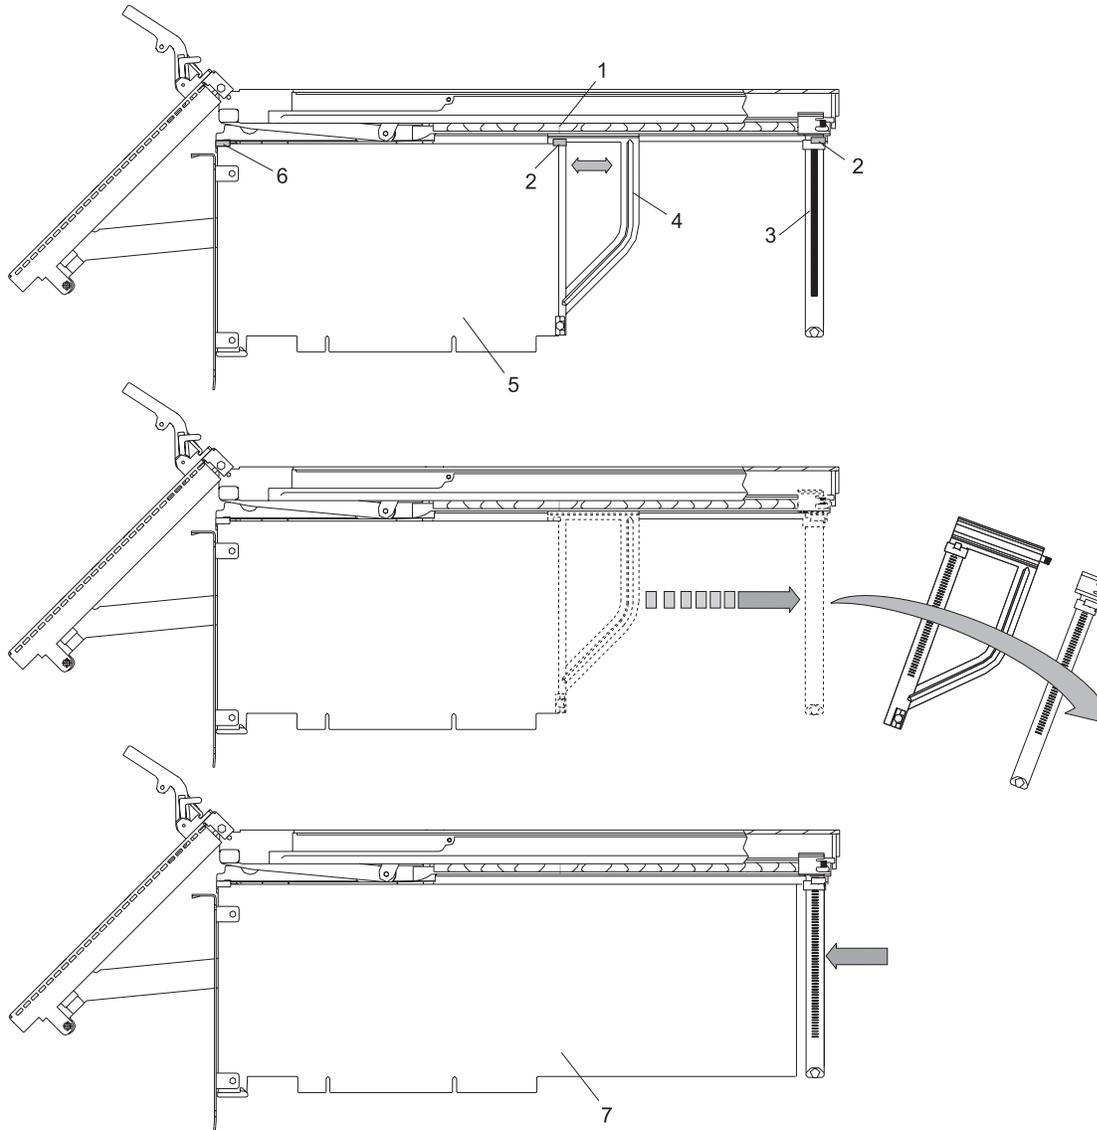
4. If the new PCI adapter does not extend beyond the mark at the top of the linkage subassembly, attach the appropriate short card arm card. If the adapter extends beyond this mark, attach the long card arm to the support arm of the linkage subassembly as follows:

| 1 Mark at the Top of Linkage Subassembly | 5 Short Adapter |

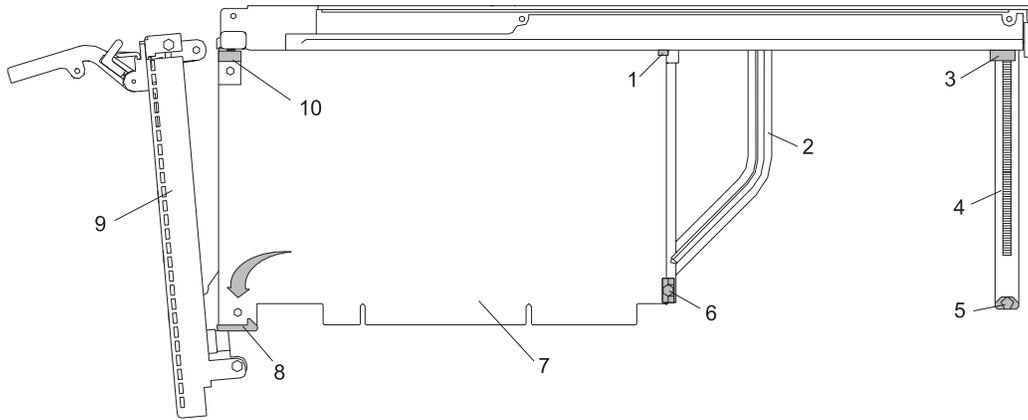
- c. Press the lower clip under the bottom edge of the card. The bottom of the clip should be even with the bottom of the card.
- d. Slide the top rear clip of the card arm downward to engage the top corner of the card. The card should now be securely stabilized in all the clips, as shown in the following illustration.

| 1 Short Card Arm Top Clip | 6 Short Card Arm Bottom Clip |
| 5 Long Card Arm Bottom Clip | 10 Front Top Clip |

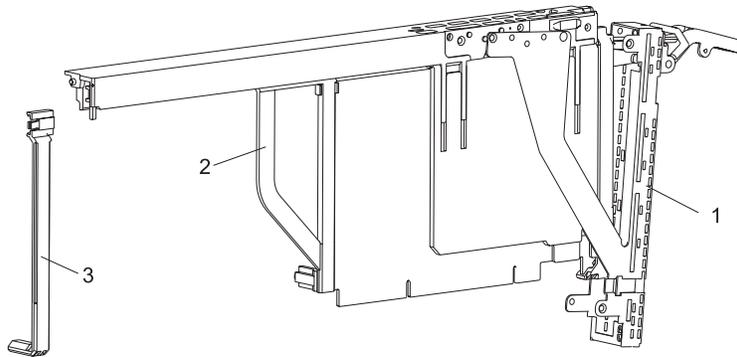
- 5. Tilt the top of the bezel away from the PCI card while lowering the bottom of the tailstock into bottom of the bezel, as shown in the following illustration.

- 1 Adapter Cassette Bezel
- 2 Short Card Arm
- 3 Long Card Arm

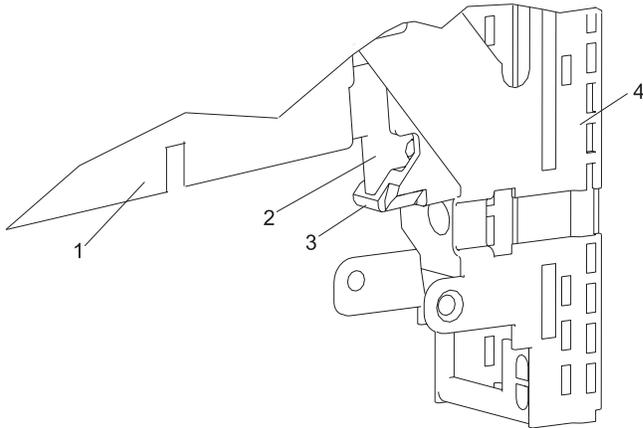
6. When the lower corner of the card is fully seated into the bezel, rotate the top of the bezel over the tailstock of the card.

- 1 Adapter Card
- 2 Adapter Card (Lower Corner)
- 3 Front Bottom Clip
- 4 Adapter Cassette Bezel

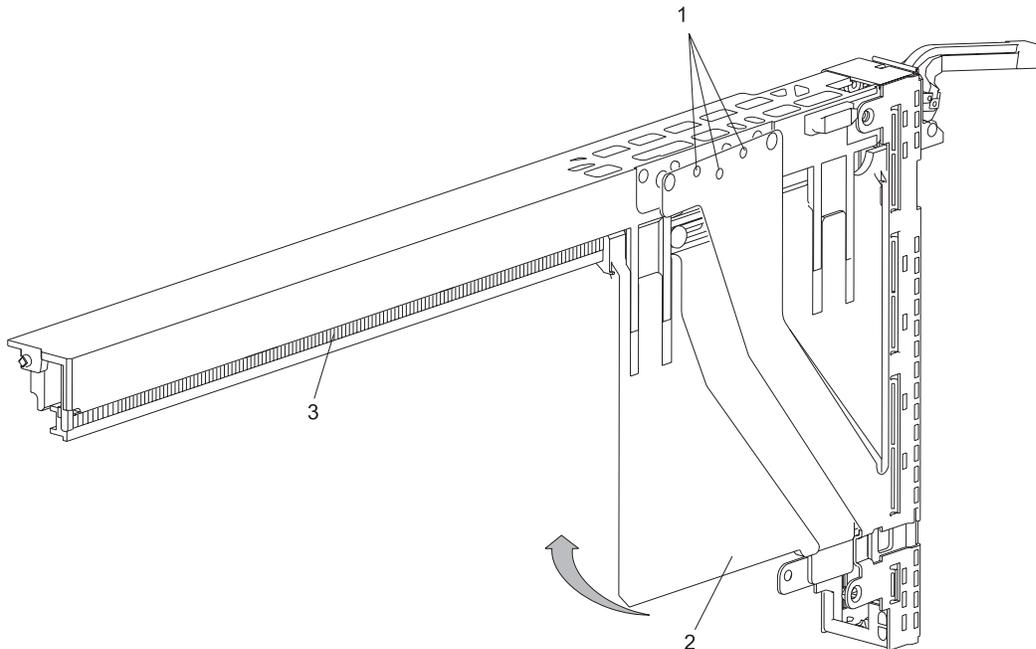
7. Position the bezel fully onto the assembly by snapping the three small holes on bezel arm over the three small embossments on the linkage assembly, as shown in the following illustration.

- 1 Alignment Studs
- 2 Adapter Card
- 3 ESD Surface

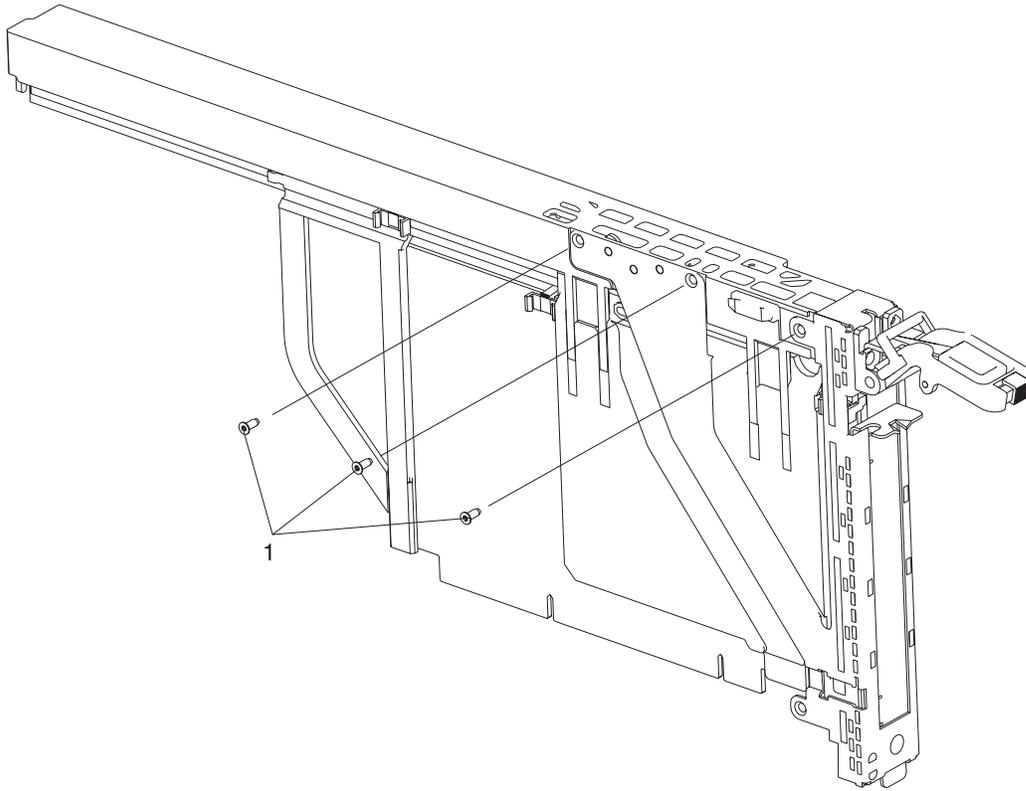
- Secure the bezel arm to the linkage assembly with three small screws in the sequence shown in the following illustration.

1 Retaining Screws

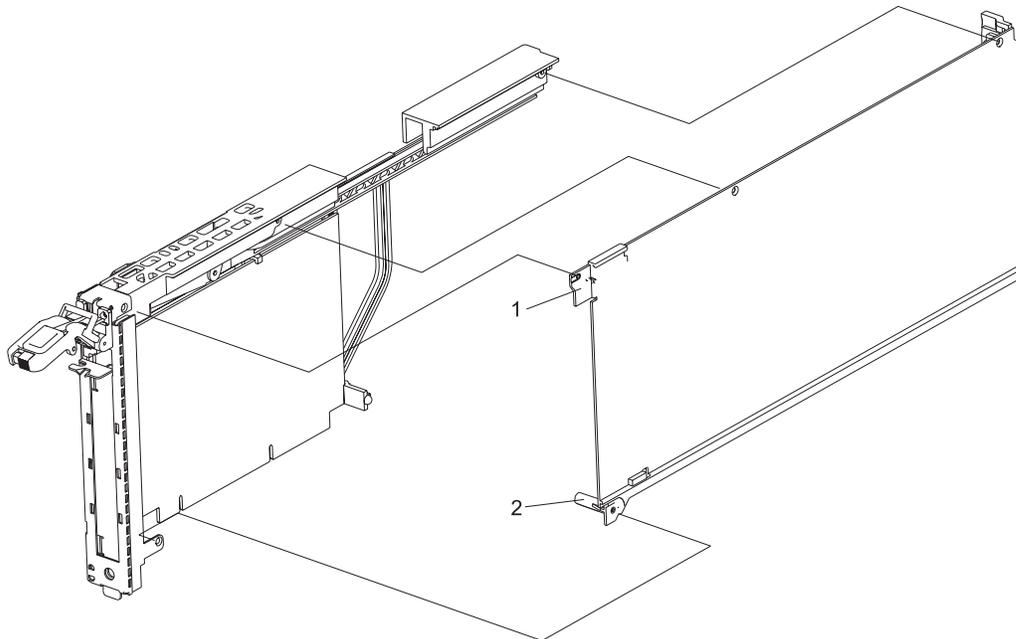
- With the tailstock to the left on a flat surface, position the cover over the linkage assembly.
- Tuck the top and bottom tabs at the left of the cover under the bezel.

1 Front Top Tab

2 Front Bottom Tab

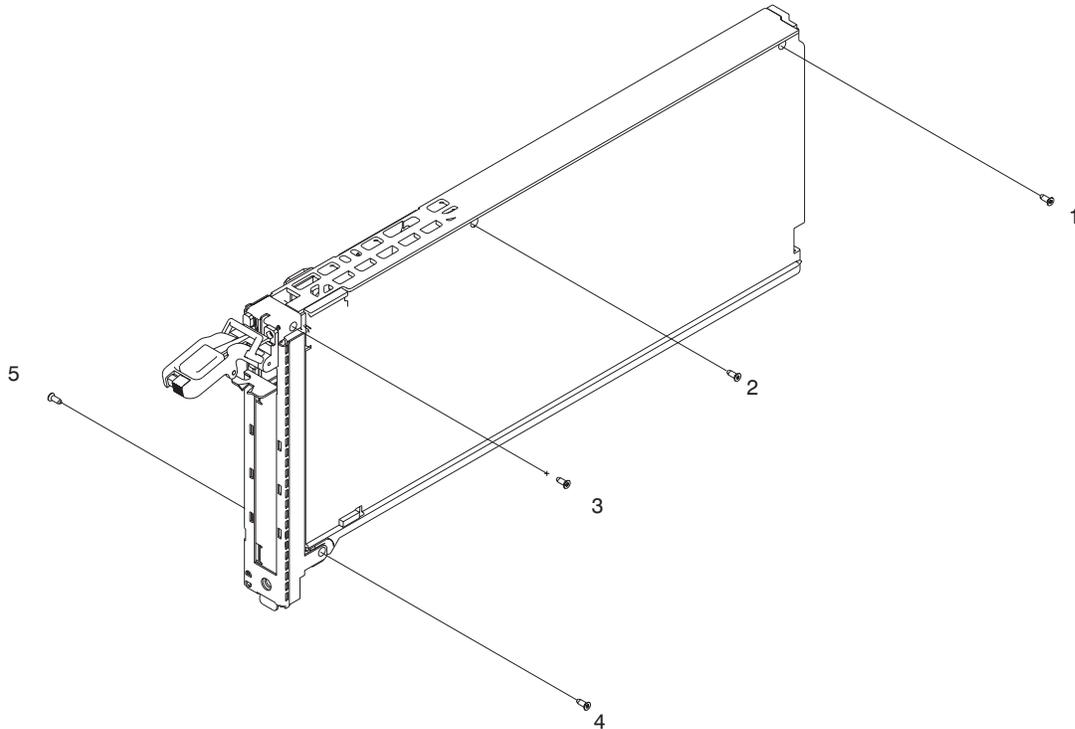
11. Snap the top-right corner of the cover over the guide bump on the linkage assembly.
12. Align the holes at the top of the cover with those in the linkage subassembly and screw the cover to the linkage subassembly in the sequence shown in the following illustration.

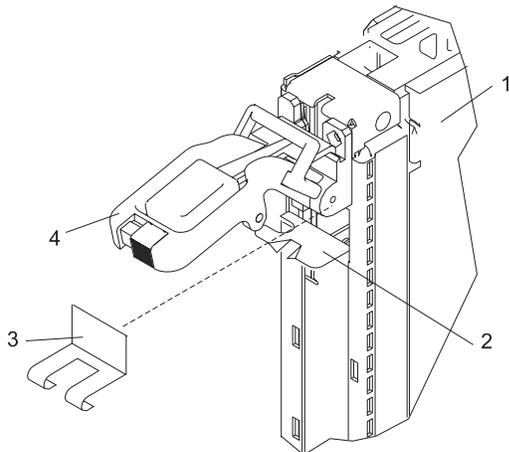
13. Snap the tailstock clip onto the tailstock by rotating it onto the bracket while inside the bezel opening.

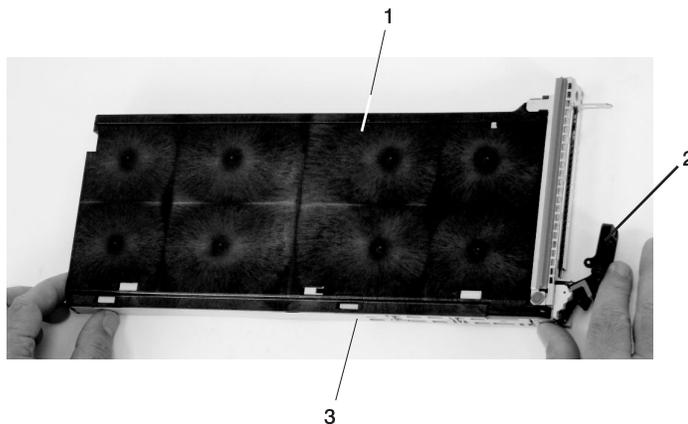
1. Place the PCI adapter cassette assembly on a flat work surface with the cover facing up, and the top of the adapter facing you. See the following illustration.

1 Cover
2 Handle

3 Top of Cover

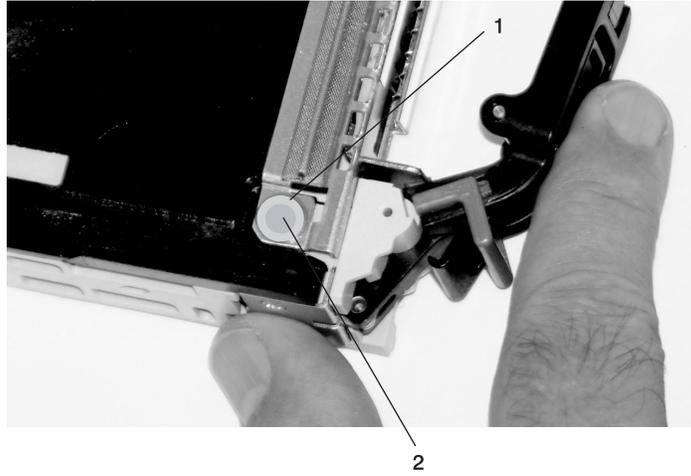
- Using two fingers, remove the bushing-lock pin from the bushing. The bushing-lock pin can be removed by pulling it out of the bushing with your fingernails.

- 1 Bushing
- 2 Bushing-Lock Pin

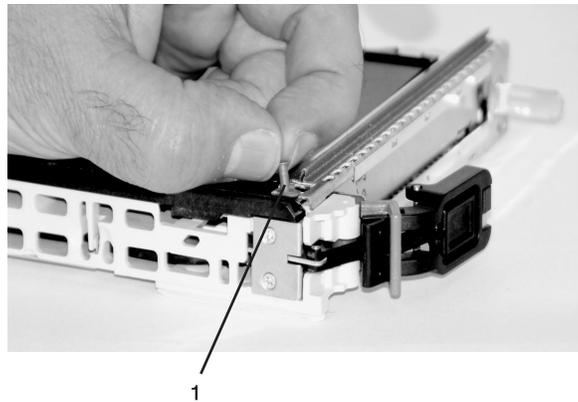
- 1 Bushing-Lock Pin

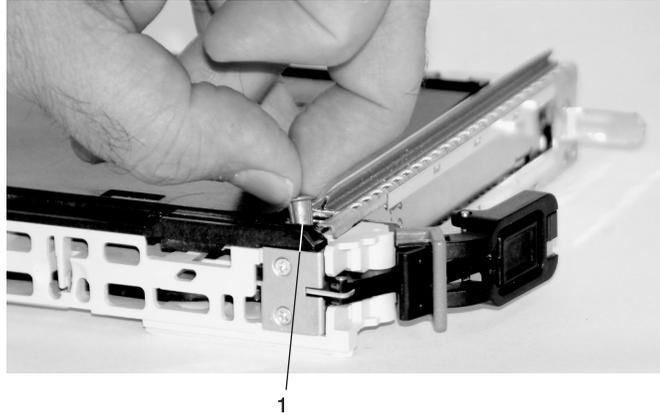
3. Remove the bushing. The bushing can be removed by pulling it out of the PCI adapter cassette assembly with your fingernails.

1 Bushing

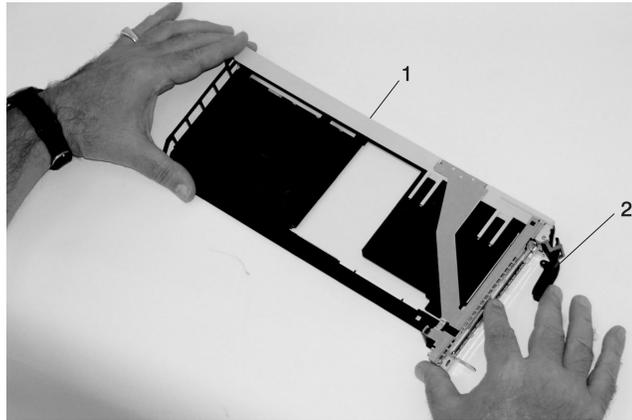
4. Turn over the PCI adapter cassette assembly so that the top is facing away from you.

1 Top of Adapter
2 Handle

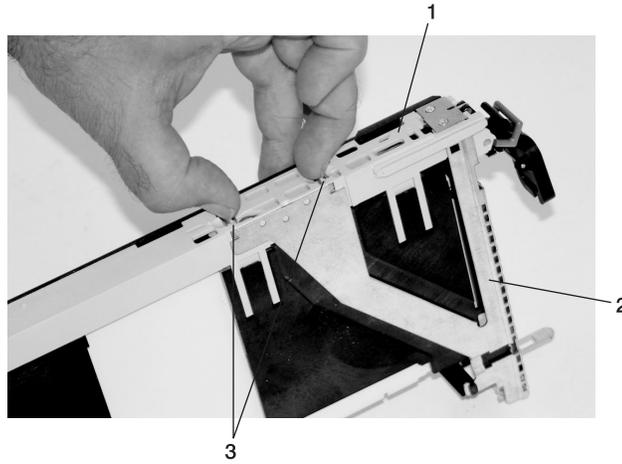
a. Locate the plastic latch fingers in the top part of the cassette.

- 1 Top of Cassette
- 2 Bezel
- 3 Plastic Latch Fingers

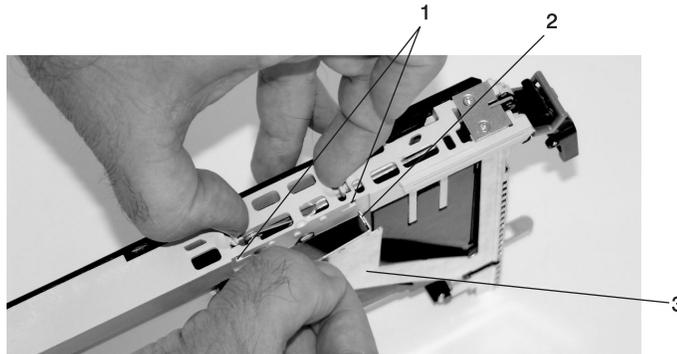
b. Using one hand, pinch the plastic latch fingers, and with your other hand, carefully lift the top part of the bezel extension out until the tabs clear the slots in the PCI adapter cassette assembly.

- 1 Slots
- 2 Tab
- 3 Bezel Extension

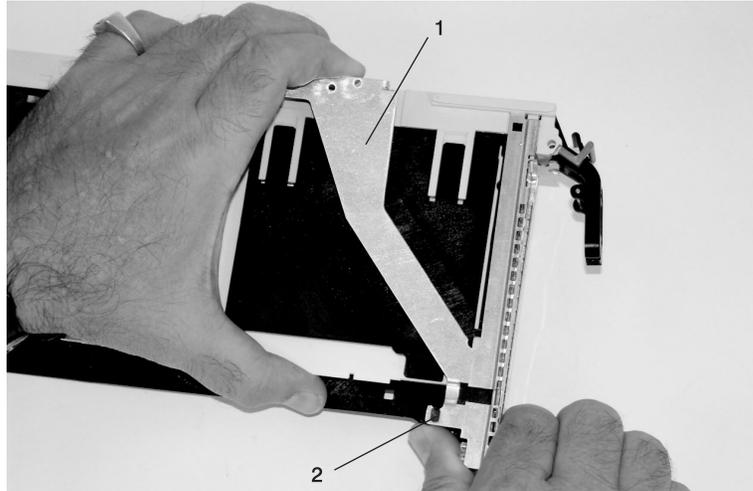
- c. While holding the bezel extension out, push the plastic cover latch out of the bezel hook, as shown in the following illustration. This action allows the bezel to be removed.

- 1 Bezel Extension
- 2 Plastic Cover Latch in Bezel Hook

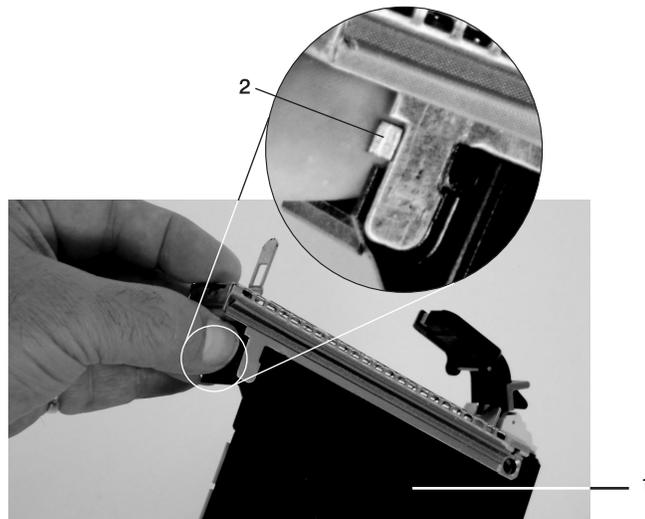
- d. On the opposite side of the cassette (cover side), push the cover latch to release the bezel.

- 1 Cover Side
- 2 Cover Latch

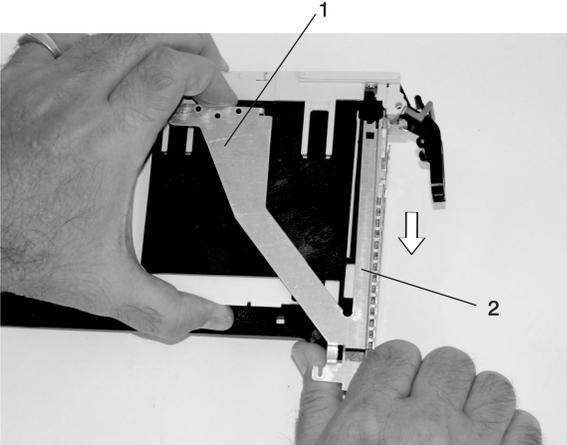
e. While holding the bezel extension out, carefully slide the bezel off. You might have to work from both sides to loosen the bezel assembly from the cassette assembly. When the bezel is free, slide it completely off the cassette assembly, and set it aside.

1 Bezel Extension
2 Bezel

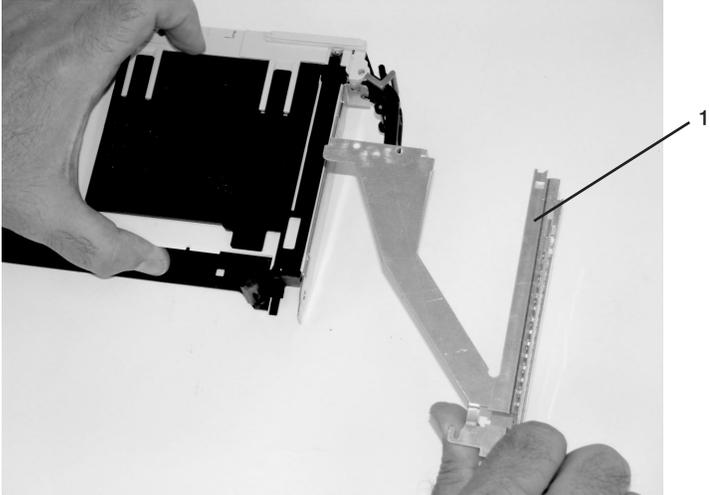
1 Bezel

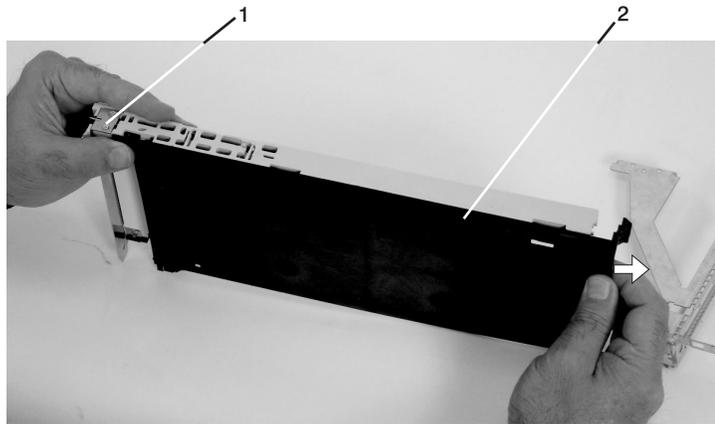
6. Turn over the cassette so that the cover is facing up, as shown in the following illustration. Remove the cover from the cassette as follows:
 - a. Slide the cover until it releases from the cassette assembly.

Attention: The cover might be tight and difficult to slide. If you grasp the left end (handle end) of the cassette and the right end of the cover, you can use enough force to pull the cover off the PCI adapter cassette assembly.

- 1 Left End of the Cassette
- 2 Cassette Cover

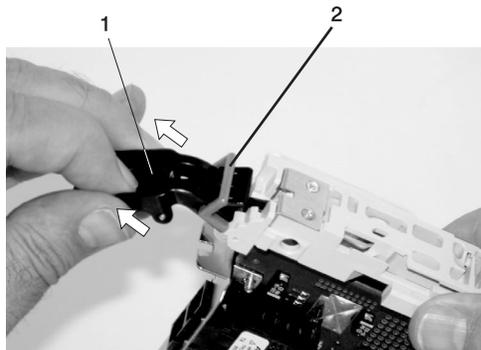
- b. Lift the cover off the assembly, and set it aside.
 - c. Depress the handle release lever to unlock the locking bar. The locking bar is located on the handle, ensure that the handle is pulled into the unlocked position. Raise the handle on the cassette linkage assembly until it locks into the up position (the blank filler or adapter moves downward).

- 1 Handle Release Lever
- 2 Locking Bar

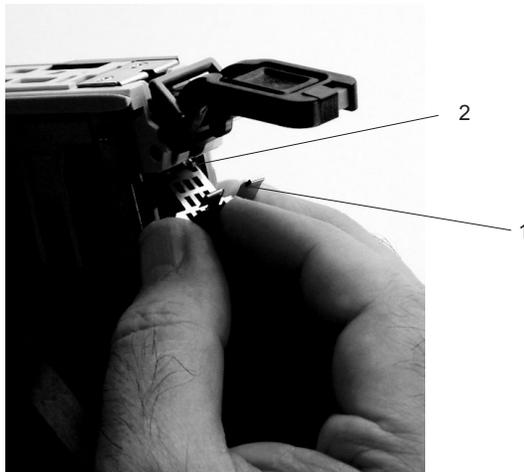
7. Remove the metal EMC shield from the top of the tailstock.

1 Metal EMC Shield

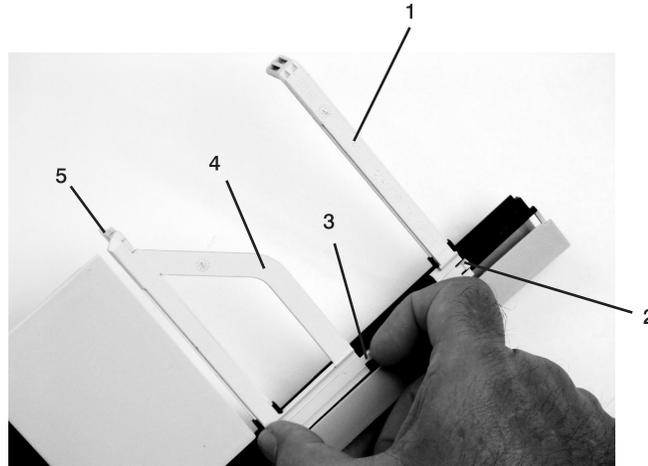
- b. Slide the long and short adapter arms away from the blank filler or adapter.

- 1 Long Adapter Arm
- 2 Release Tab
- 3 Release Tab
- 4 Short Adapter Arm
- 5 Slotted Tab
