Bull ESCALA PL 3200R

Service Guide

Hardware

March 2004

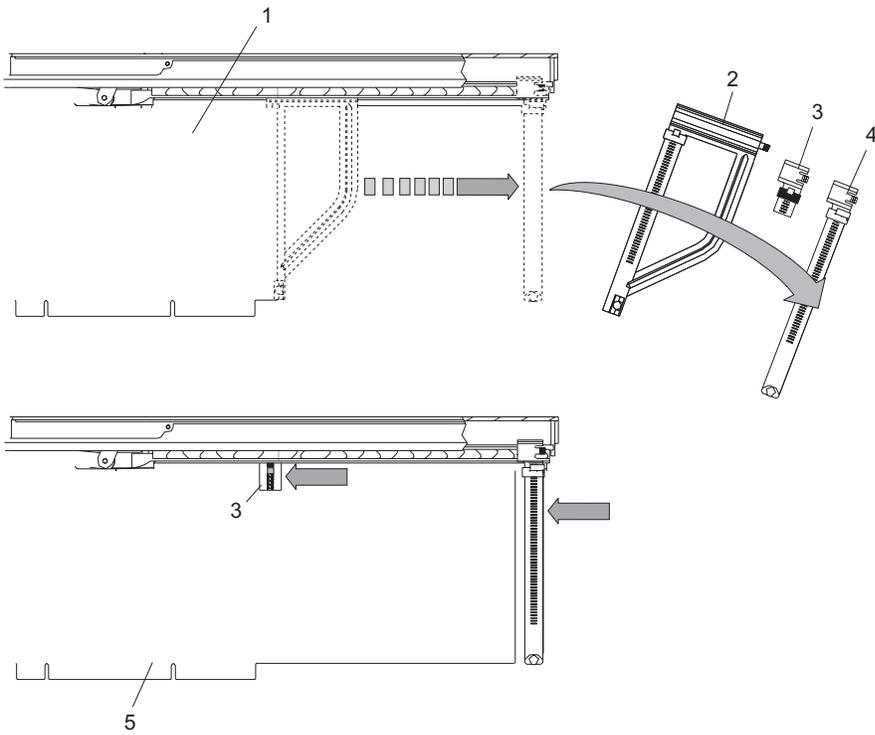
Note: Some dual linkage PCI adapter cassettes might contain a middle-spacer arm to be used with long adapter cards only. The middle-spacer arm and its installation can be seen in the following

- 1 Short PCI Adapter Card
- 2 Short Adapter Arm
- 3 Middle-Spacer Arm
- 4 Long Adapter Arm
- 5 Long PCI Adapter Card

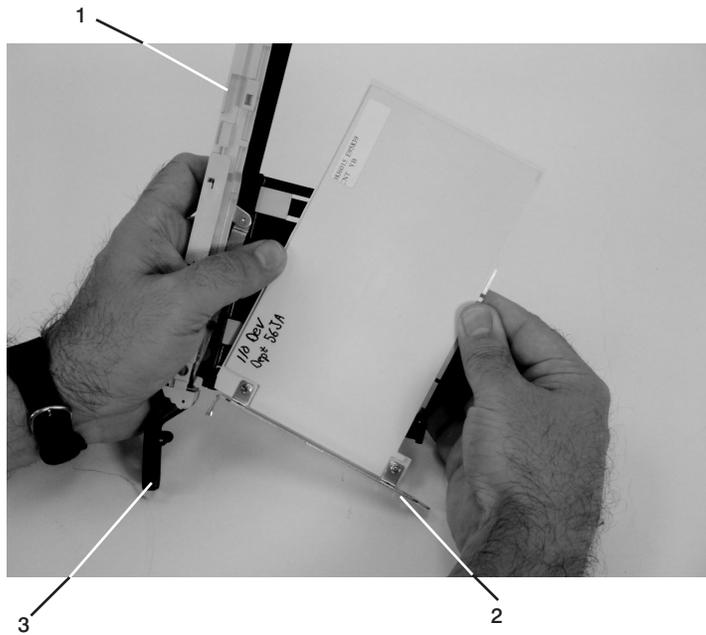
2. Remove the adapter or blank filler from the cassette linkage assembly by rotating the bottom of the tailstock out, as shown in the following illustration. Store the adapter or blank filler in a safe place.

- 1 Cassette Linkage Assembly
- 2 Bottom of Tailstock
- 3 Handle

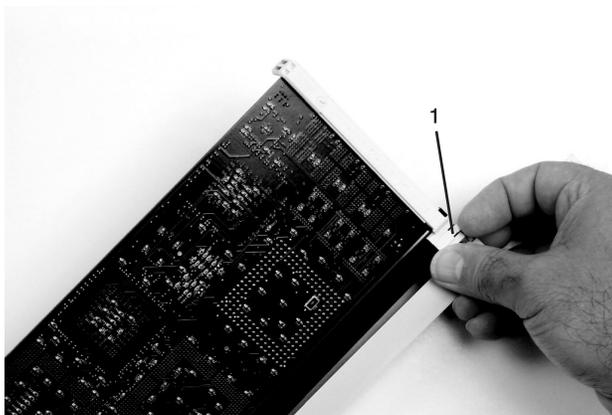
1. Each adapter arm has a release tab that allows the arm to be moved away from the adapter in the cassette assembly. Use your fingernail to lift the tab, to allow the arm to be moved away from the adapter. Lift the release tab on the long adapter arm, and slide it off the cassette linkage assembly.

1 Release Tab

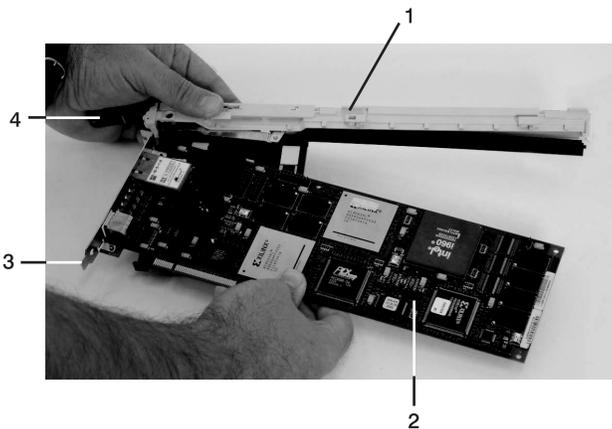
2. Remove the adapter from the cassette linkage assembly by rotating the bottom of the tailstock out, as shown in the following illustration. Store the adapter in a safe place.

1 Cassette Linkage
Assembly

2 Adapter

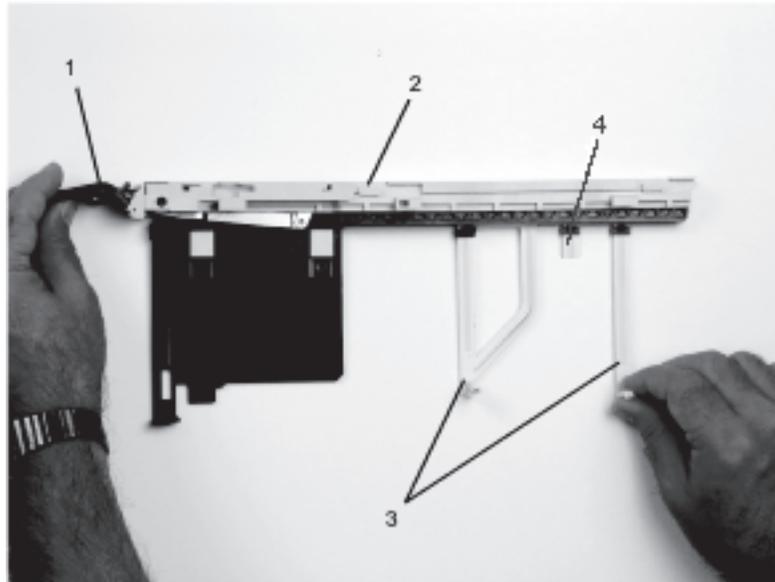
Note: Your PCI Adapter Cassette Assembly linkage might not have the short or long adapter retaining arms or the middle-spacer arm installed if you removed them during the removal procedure. In the following illustration, both arms are shown.

- 1 Handle
- 2 Cassette Linkage Assembly
- 3 Retaining Arms
- 4 Middle-Spacer Arm

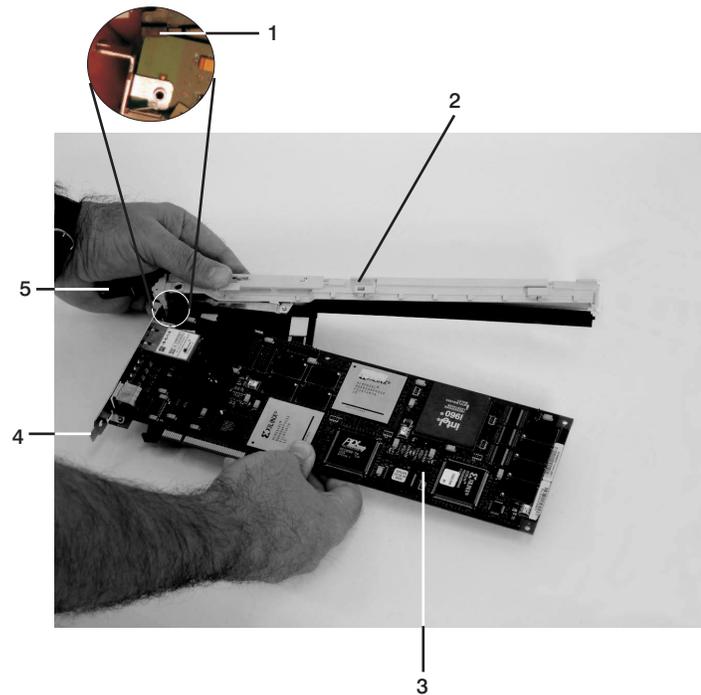
2. To determine if you are installing a long adapter or a short adapter, use the following steps. If you know the length of your adapter, skip the following steps and proceed to step 3 on page 951.
 - a. Remove the adapter from its protective packaging and, if present, remove the plastic extension handle from the end of the adapter.
 - b. Place the adapter or a blank filler over the cassette, with the upper-left corner aligned into the top adapter-retaining clip.

| 1 Top Adapter-Retaining Clip | 3 Adapter |
| | 5 Handle |

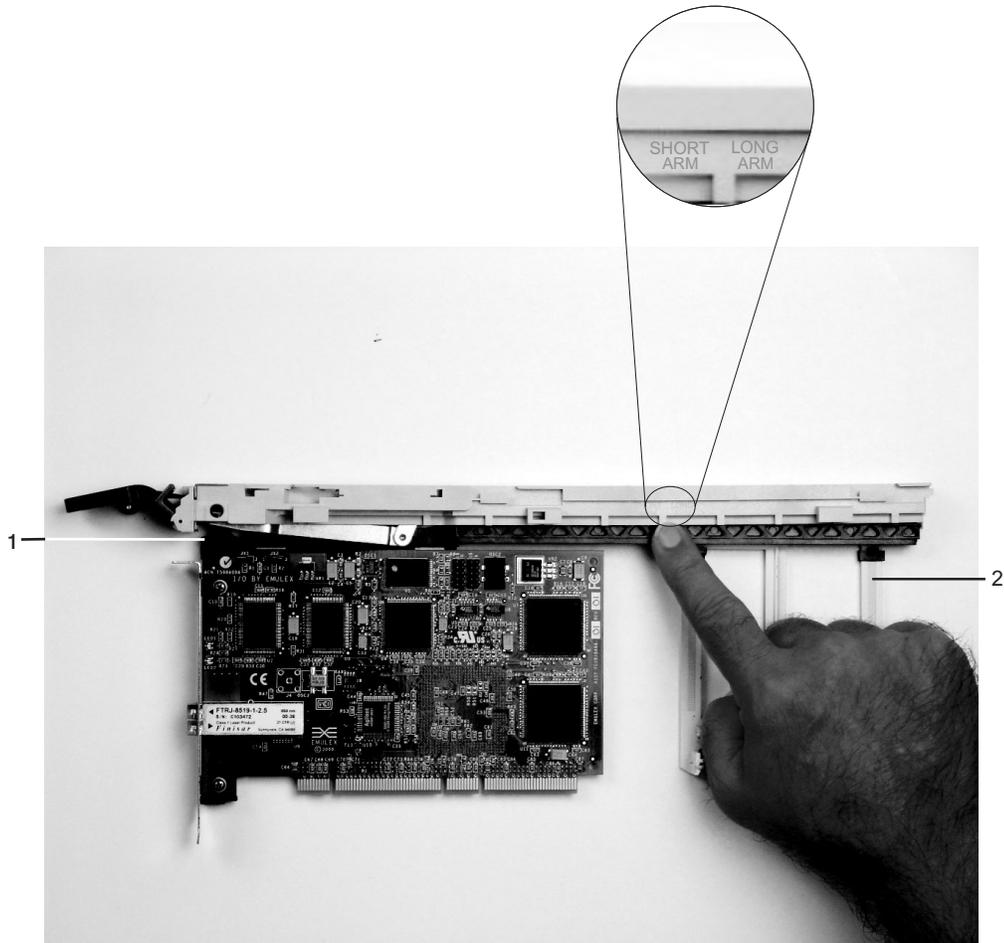
- c. The cassette linkage assembly is marked to show long or short adapters similar to the adapter shown in the following illustration. Check the right end of the adapter to determine if it is long enough to fall into the long area of the cassette linkage assembly. Ensure that the corner on the left end of the adapter is still aligned into the top adapter-retaining clip, and determine the length of the adapter.

- 1 Top Adapter-Retaining Clip
- 2 Long Adapter-Retaining Arm and Clip

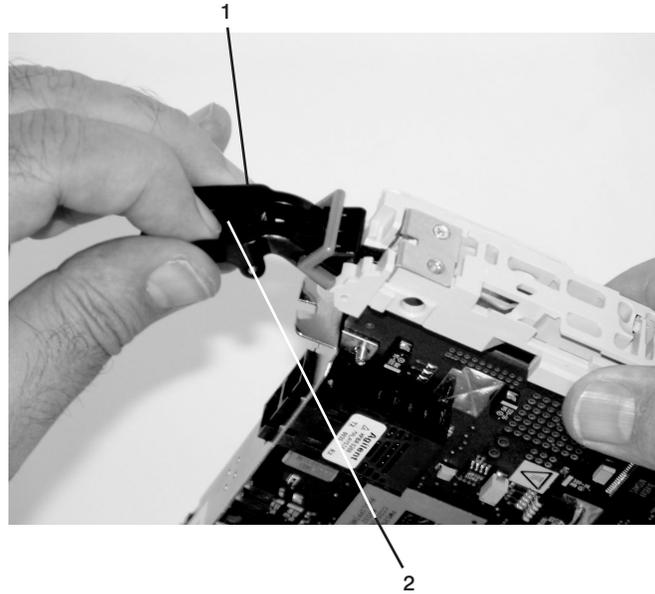
3. Remove the adapter or blank filler and ensure that the handle is in the up position. If you need to move the handle, ensure that the locking bar is pulled into the unlocked position, and then rotate the adapter handle until the handle is in the up position (the cassette linkage assembly will extend down beyond the cassette top).

- 1 Handle Release Lever
- 2 Lock

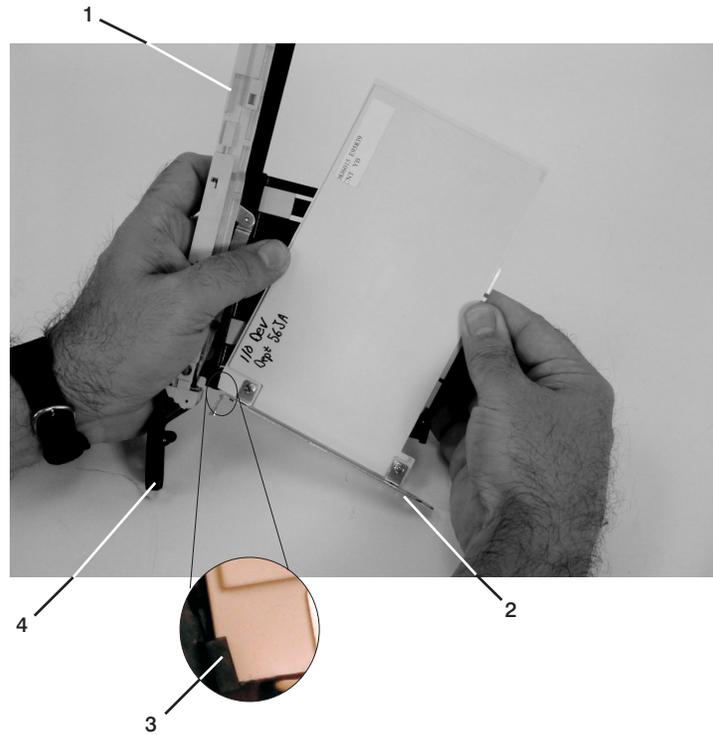
1. Place the adapter or blank filler into the cassette so that the upper-left corner of the adapter engages the adjustable top adapter-retaining clip as shown in the following illustration.

- 1 Cassette Linkage Assembly
- 2 Bottom of Tailstock
- 3 Retaining Clip
- 4 Handle

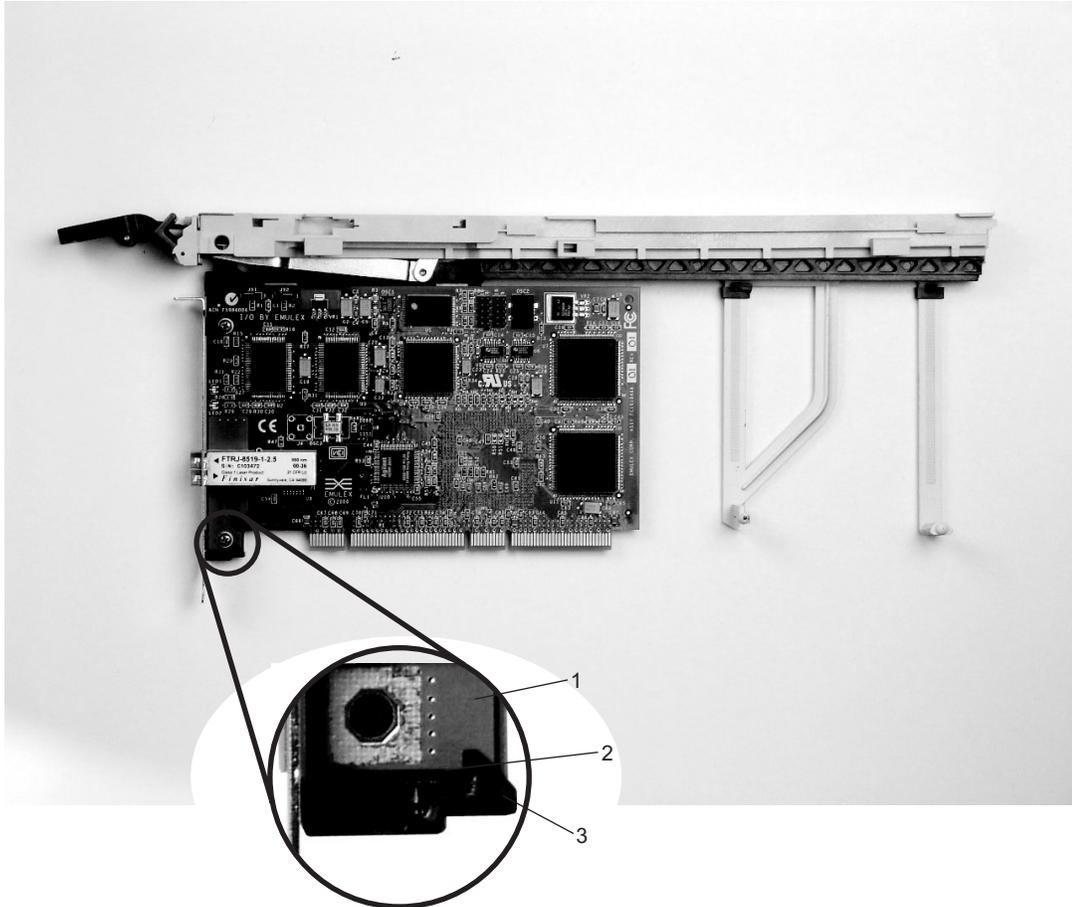
2. Rotate the adapter so that the adapter engages the slot in the bottom adapter-retaining clip and the top corner of the adapter is seated into the adjustable top adapter-retaining clip.

Note: If the adapter is not a full-height adapter, you must slide the adjustable top adapter-retaining clip downward until the lower edge of the adapter is seated into the slot on the bottom adapter-retaining clip.

- 1 Adapter
- 2 Slot
- 3 Bottom Retaining Clip

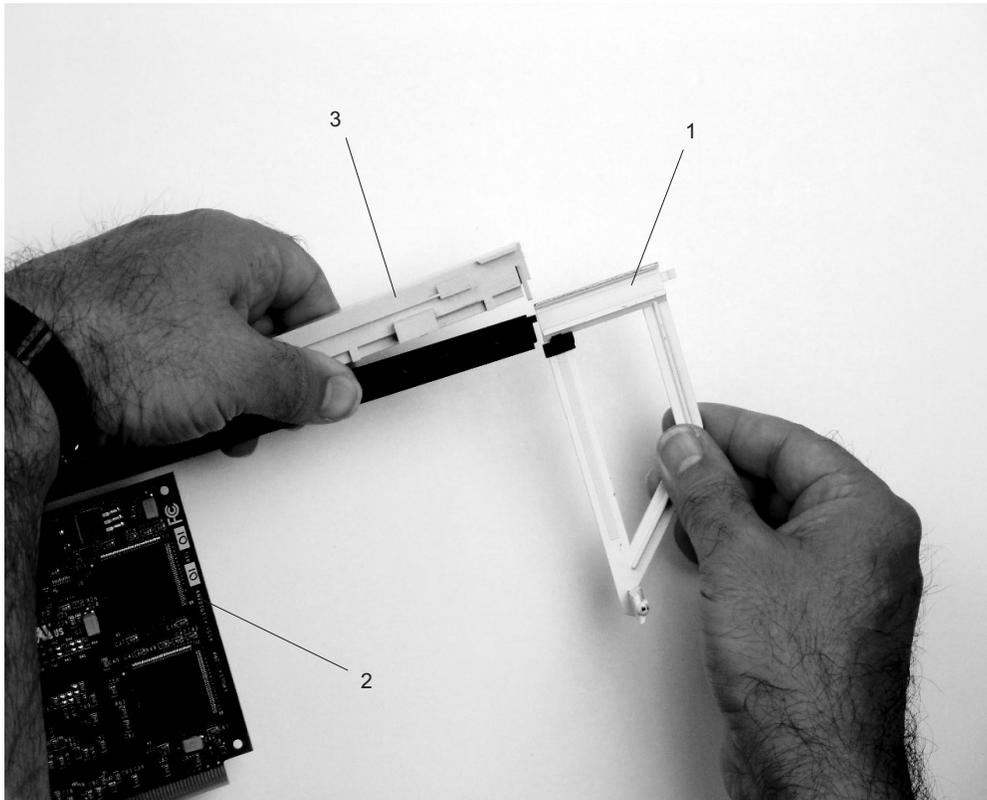
- Slide the short adapter-retaining arm toward the adapter or blank filler on the cassette linkage rail. If the short-adapter retaining arm has been removed from the cassette linkage rail, install the short-adapter retaining arm and then slide the arm until it contacts the adapter or blank filler as shown in the following illustration.

- Short-adapter Retaining Arm
- Adapter or Blank Filler
- Cassette Linkage Rail

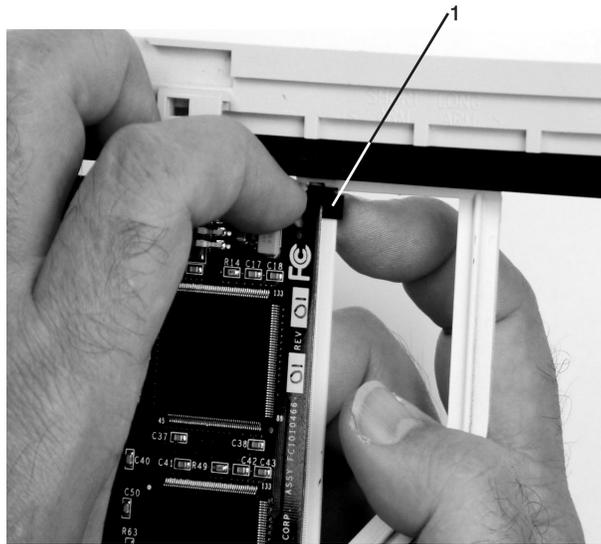
6. To hold the top of the adapter, slide down the adjustable top adapter-retaining clip on the retaining arm. Ensure that the bottom edge of the adapter is held by the lower part of the adapter retaining arm.

1 Adjustable Top Adapter-Retaining Clip

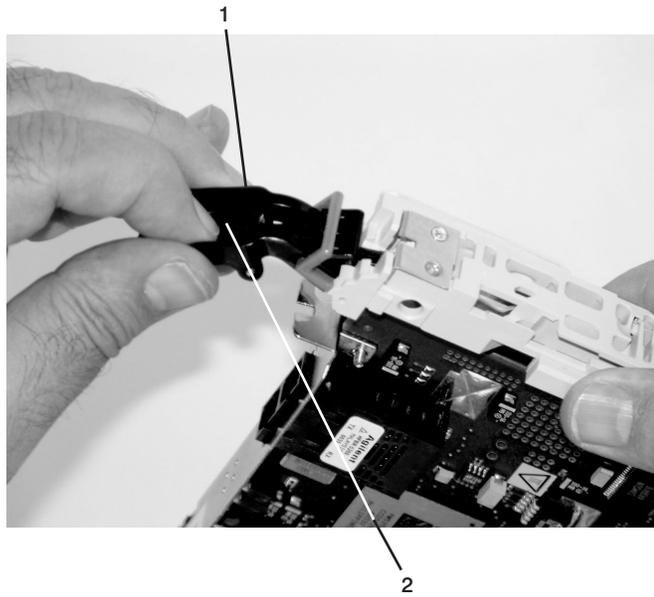
7. Press the lock on the handle, and rotate the adapter handle until it is in the down position (adapter or blank filler moves up into the cassette assembly).

- 1 Handle Release Lever
- 2 Lock

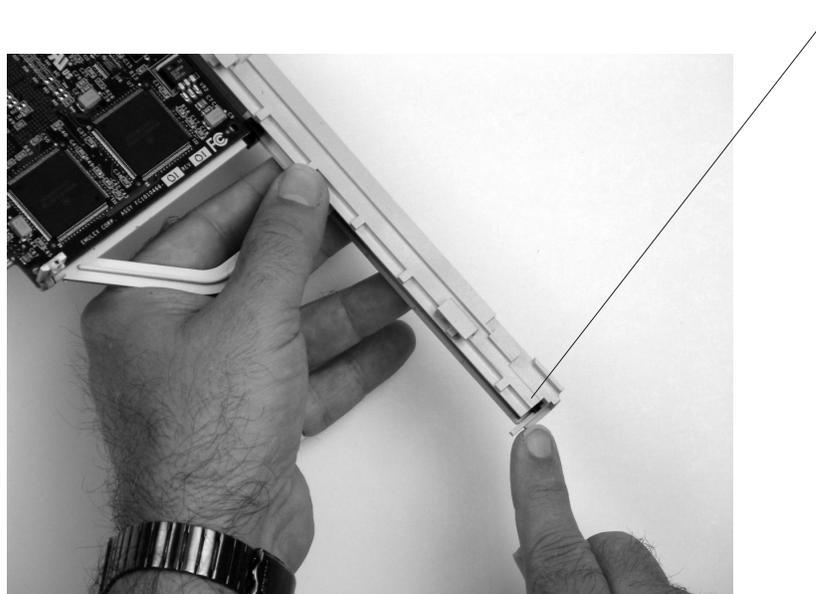
Ensure that the right end of the cassette linkage rail moves up into the cassette linkage assembly as shown in the following illustration:

- 1 Right End of Cassette Linkage

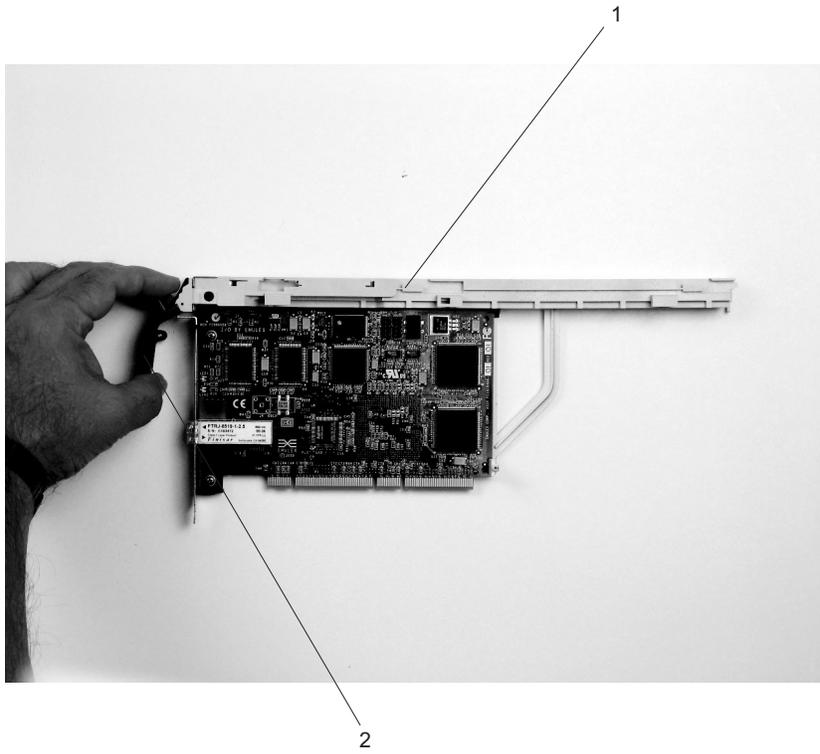
8. Position the adapter and cassette assembly with the handle on the left (in the down position) and the top facing away from you.

- 1 Top of Cassette
- 2 Handle

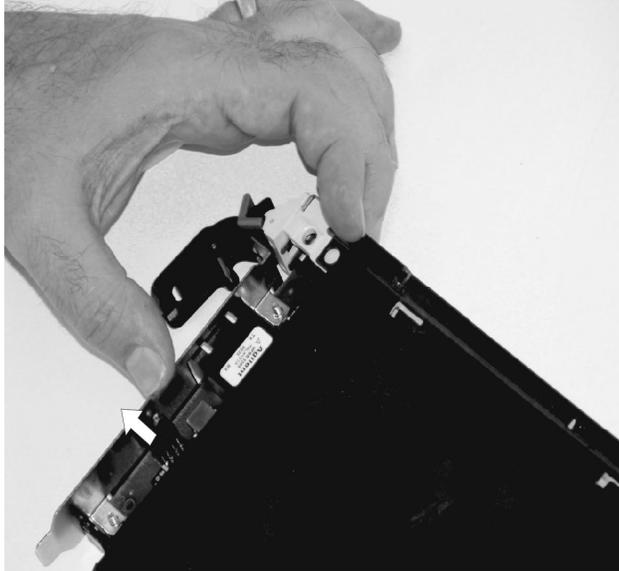
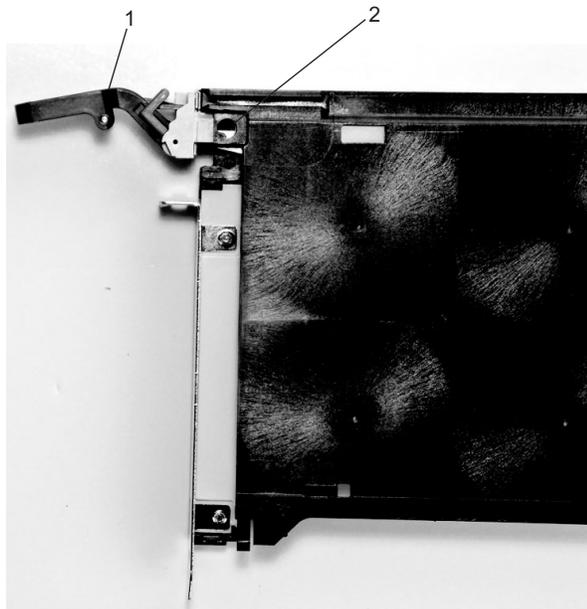
- a. Place the cassette cover on the cassette assembly as shown in the following illustration. Slide the cover toward the handle until the hole in the cover aligns with the hole in the cassette assembly.

- 1 Handle
- 2 Holes Aligned

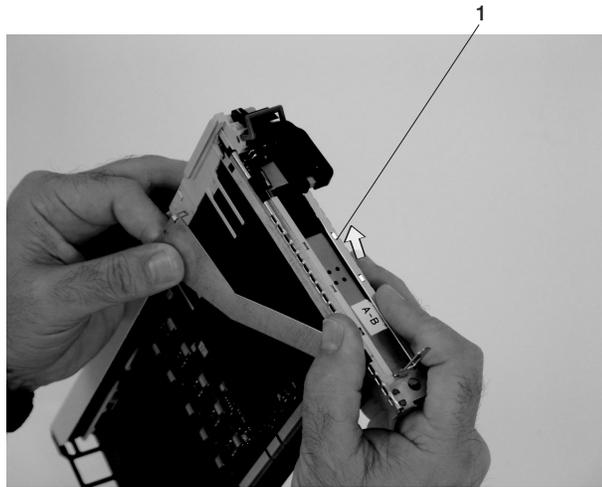
10. Install the bezel assembly using the following procedure:
- a. Carefully slide the bezel onto the cassette assembly.

1 Bezel

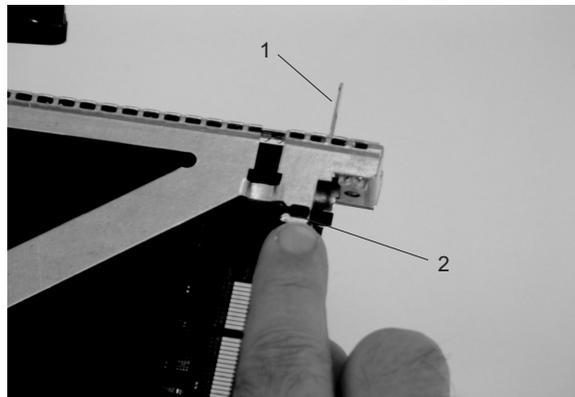
- b. Align and insert the cover arm latch in the hooked notch in the bezel.

1 PCI Adapter Pull Tab
2 Hooked Notch in the Bezel for the Cover Arm Latch

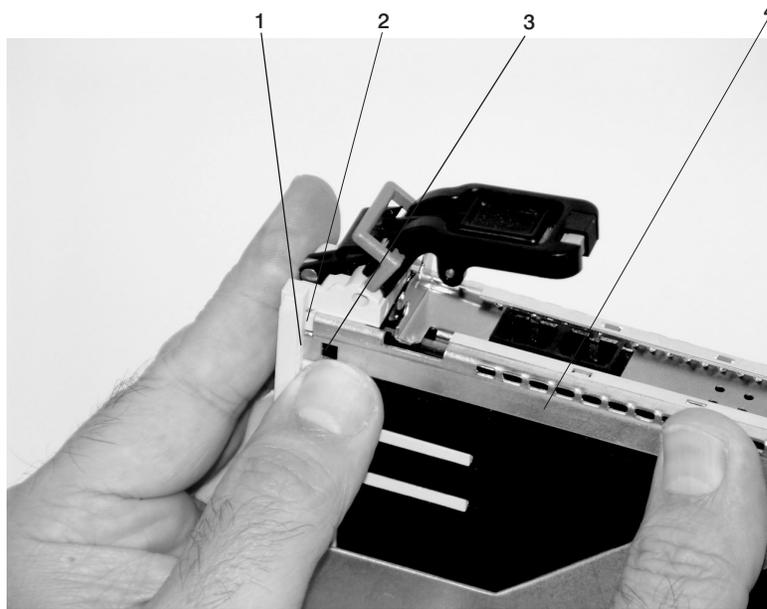
- c. Align the top of the bezel assembly into the grooves on the top of the cassette assembly. Push the bezel onto the cassette linkage assembly until the tab on the top of the bezel is seated in the recess of the cassette assembly.

| 1 Recess | 3 Tab |
| 2 Groove | 4 Bezel Assembly |

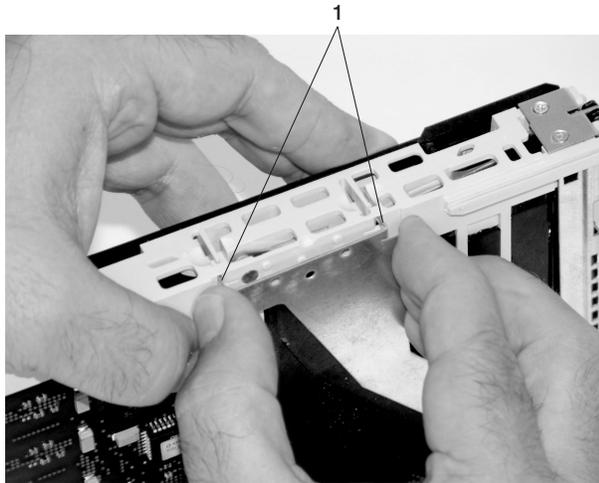
- d. Insert the two tabs on the bezel extension into the two slots on the cassette linkage assembly.

- 1 Tabs

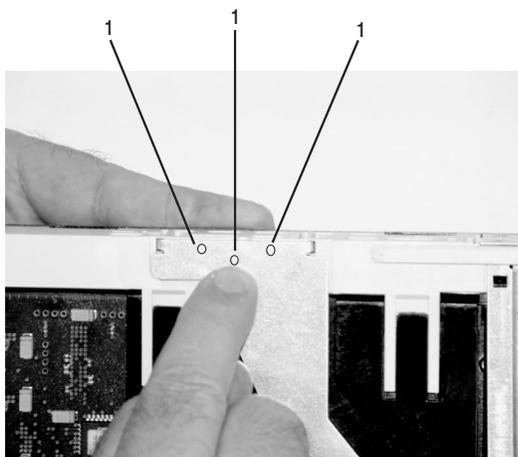
- a. Ensure that the extension arm engages the pins on the cassette. You should be able to see the three pins in the holes in the arm. The bezel tab should be seated as shown in the following illustration.

1 Pin

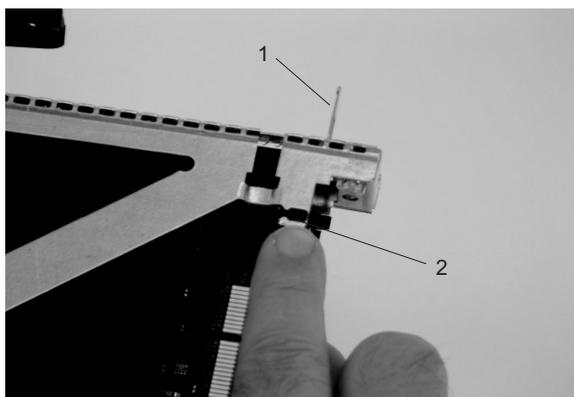
- b. Ensure that the cover arm latch is completely pressed into the hooked notch on the bezel as shown.

1 PCI Adapter Pull Tab
2 Hooked Notch in the Bezel

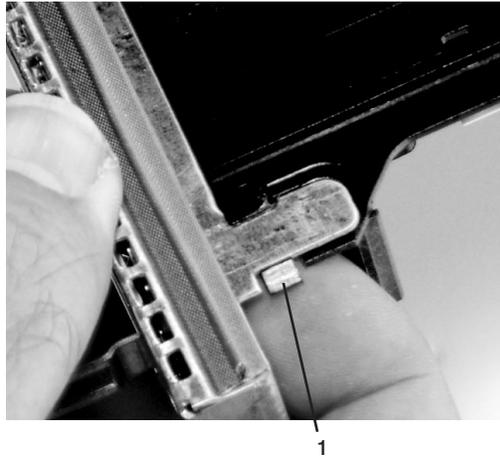
- c. Turn the cassette assembly over so the cover is facing up. Check the cover latch to ensure that it is holding the bezel to the cover as shown.

1 Cover Latch

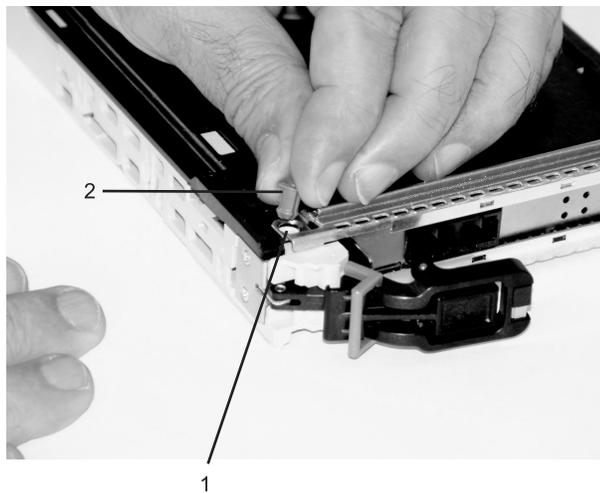
12. Ensure the holes are aligned, and insert the bushing-lock pin into the bushing as shown.

1 Bushing
2 Bushing-Lock Pin

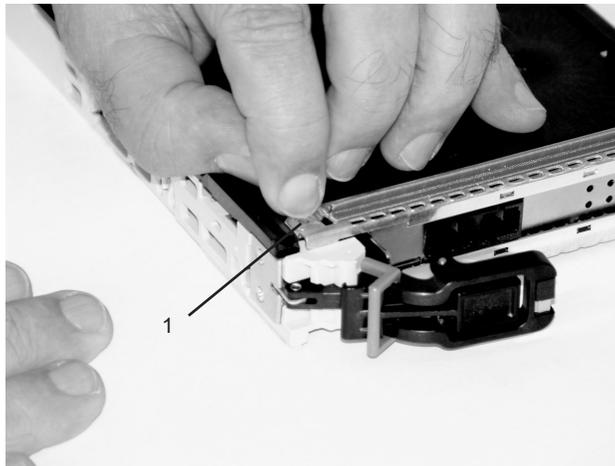
The following illustration shows the location of the bushing in the cassette.

1 Location of the Installed Bushing and Bushing-Lock Pin

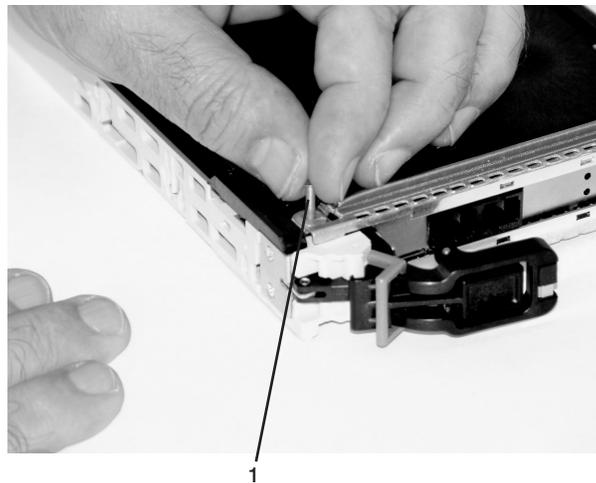
13. Insert the bushing-lock pin into the hole in the bushing, and push it in until it seats as shown in the following illustration.

1 Bushing-Lock Pin

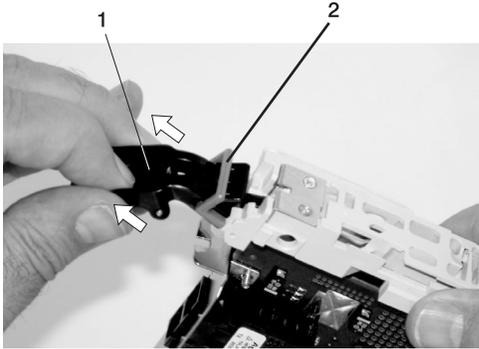
14. Depress the handle release lever to ensure the locking bar on the handle is pulled into the unlocked position. Raise the handle on the cassette linkage assembly until it locks into the up position (the blank filler or adapter moves downward).

- 1 Handle Release Lever
- 2 Locking Bar

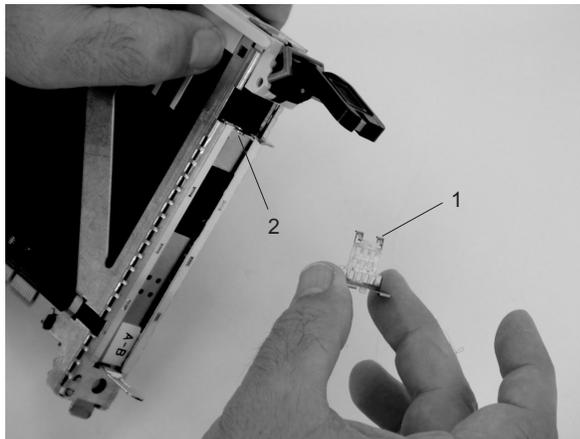
15. To install the metal EMC shield on the adapter bracket, grasp the EMC shield as shown in the following illustration, and do the following:

- 1 Metal EMC Shield
- 2 Installation Location for the Metal EMC Shield

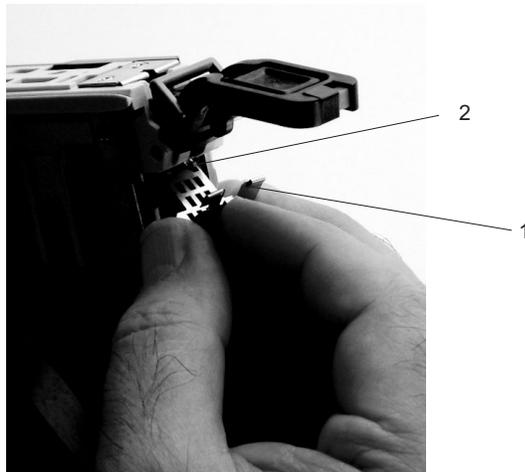
- a. Ensure that the metal EMC shield slides up inside the top of the cassette.

1 Metal EMC Shield

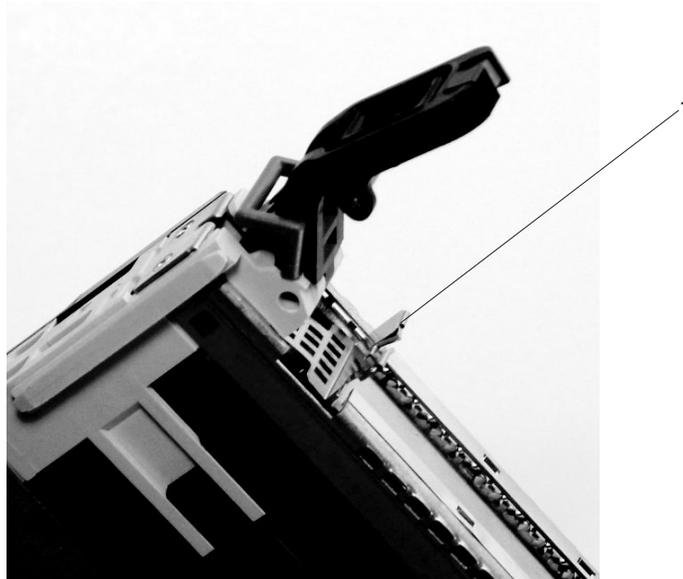
- b. The metal EMC shield has clips that slide over the top of the tailstock. Ensure that these clips are holding the metal EMC shield to the tailstock.

1 Top of Tailstock

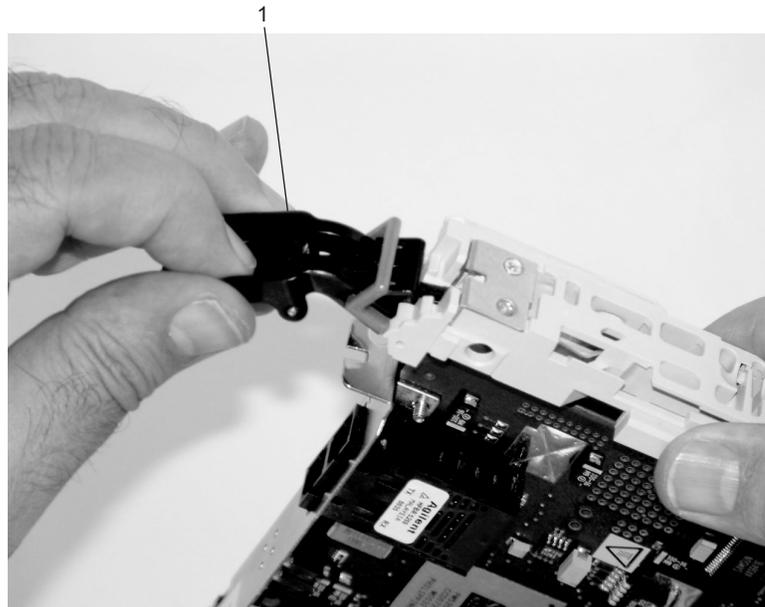
16. Depress the handle release lever on the handle, and rotate the adapter handle until the handle is in the down position (adapter or blank filler moves up into the cassette assembly).

1 Handle

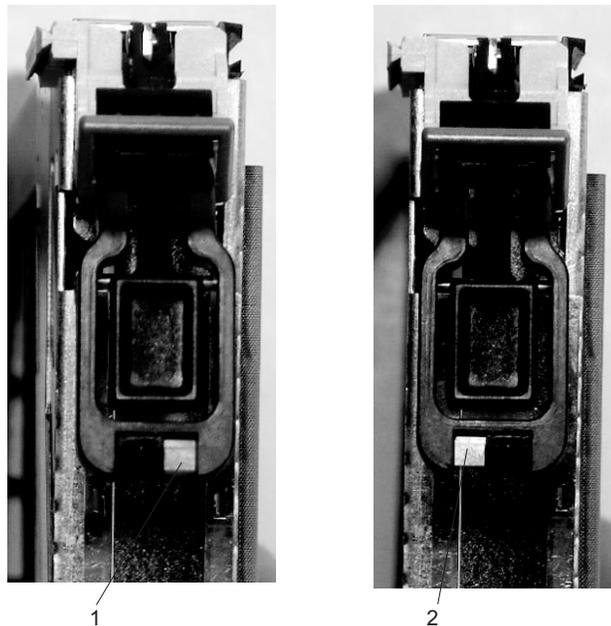
17. Using the system documentation, determine if the adapter you are installing is hot-swappable. If the adapter is hot-swappable, move the slider on the color indicator to allow the orange color to be visible. If the adapter is not hot-swappable, the blue color is visible.

- 1 Orange indicates Hot-Swappable
- 2 Blue indicates Not Hot-Swappable

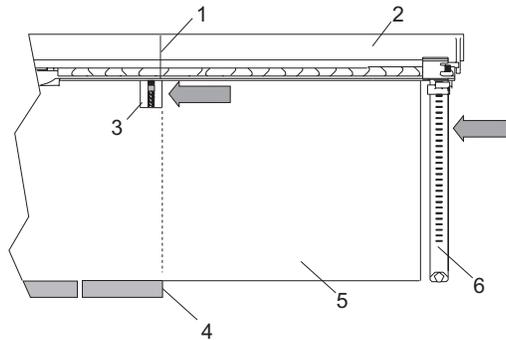
Note: Some long adapters are shipped with a middle-spacer arm. If your adapter uses the middle-spacer arm, slide it onto the cassette linkage as shown in the following illustration. If there is an embossed line on the face of the top rail, align the middle-spacer arm as shown in the following illustration. If there is no line embossed on the face of the top rail, align the middle-spacer arm with the leading edge of the adapter's connector, as shown in the following illustration.

- 1 Embossed Middle-Spacer Alignment Lines
- 2 Top Cassette Rail
- 3 Middle-Spacer Arm

- 4 Adapter Connector (Leading Edge)
- 5 Long Adapter Card
- 6 Long Adapter Arm

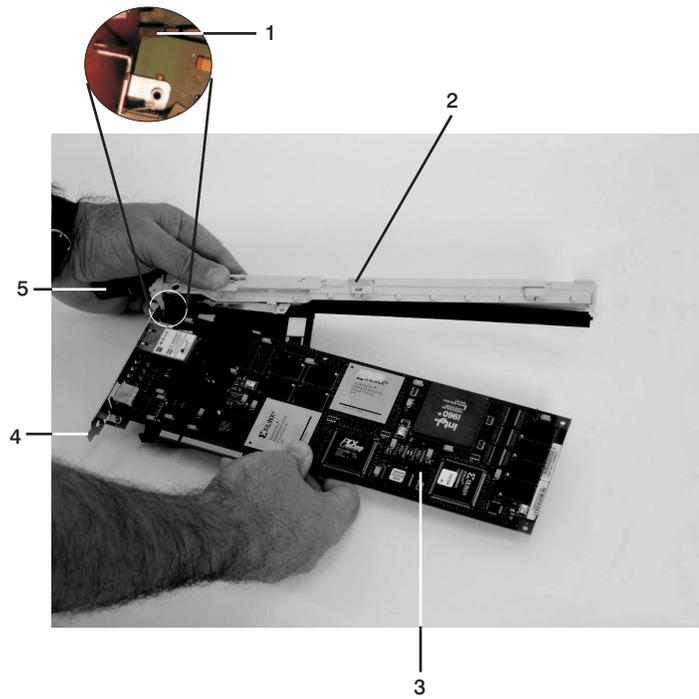
3. Place the adapter into the cassette so that the upper-left corner of the adapter engages the top adjustable adapter-retaining clip as shown in the following illustration:

- 1 Top Adapter-Retaining Clip
2 Cassette Linkage Assembly

- 3 Adapter
4 Bottom of Tailstock
5 Handle

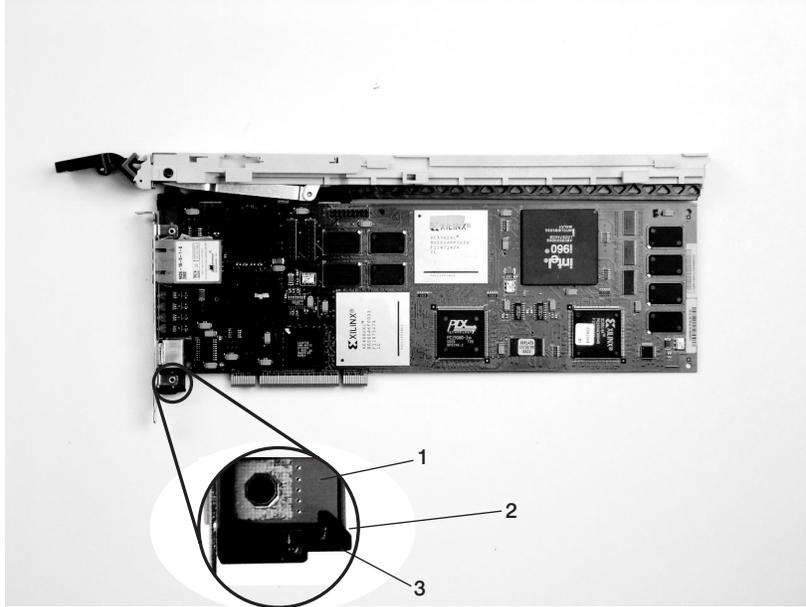
4. Rotate the adapter so that the adapter engages the slot in the bottom retaining clip and the top corner of the adapter is seated into the top adjustable adapter-retaining clip.

Note: If the adapter is not a full-height adapter, slide the top adjustable adapter-retaining clip downward until the lower edge of the adapter is seated into the slot on the bottom retaining clip.

1 Adapter
2 Slot

3 Bottom Retaining Clip

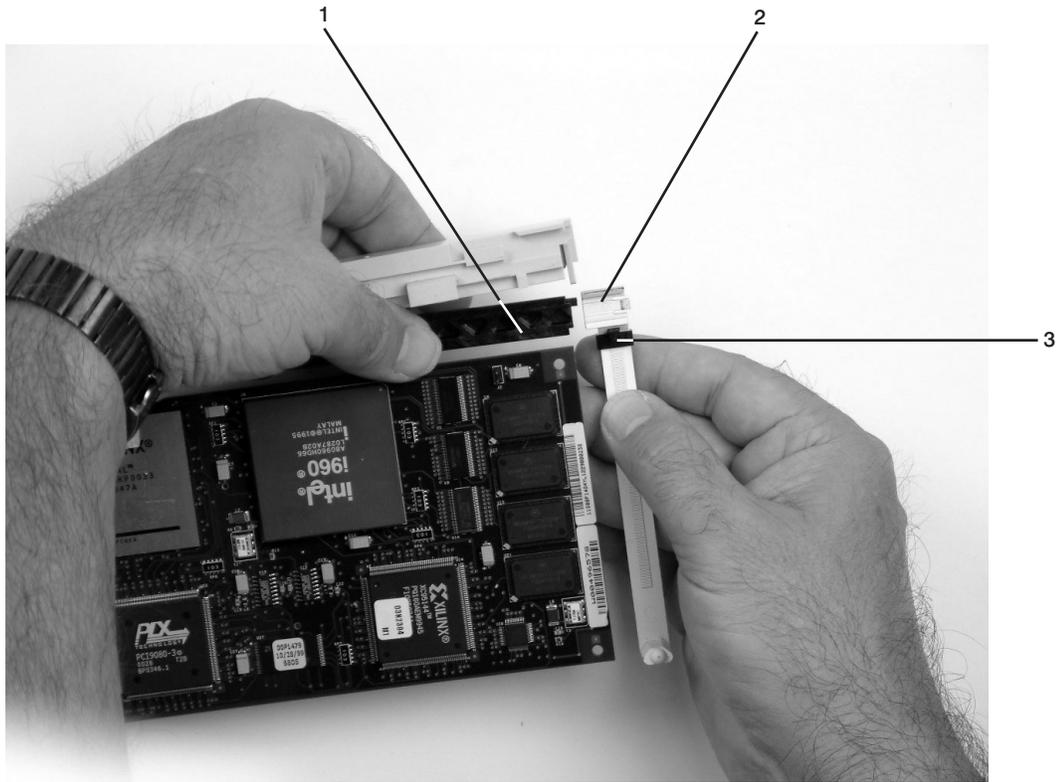
5. Install the long adapter-retaining arm onto the cassette linkage rail, as shown in the following illustration, and slide the arm toward the adapter.

1 Cassette Linkage Assembly
2 Adapter Retaining Arm

3 Top Adapter Retaining Clip

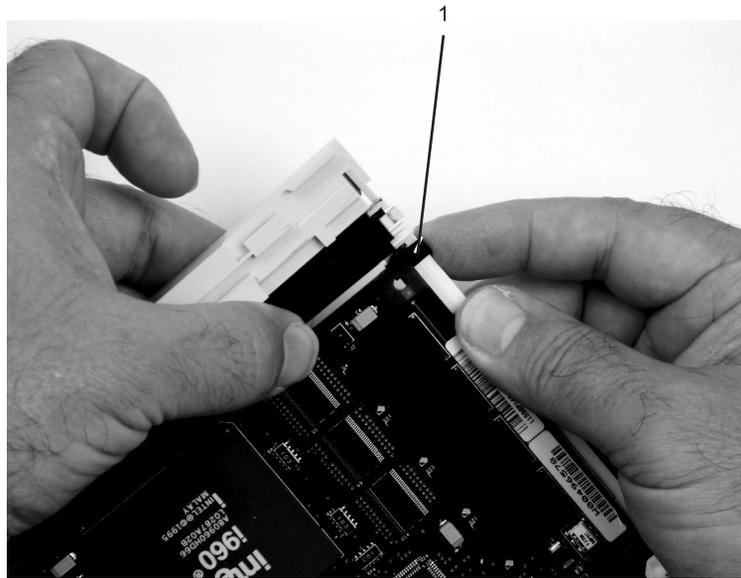
6. Ensure that the top adjustable adapter-retaining clip catches the corner of the adapter as shown in the following illustration.

1 Top Adjustable-Retaining Clip

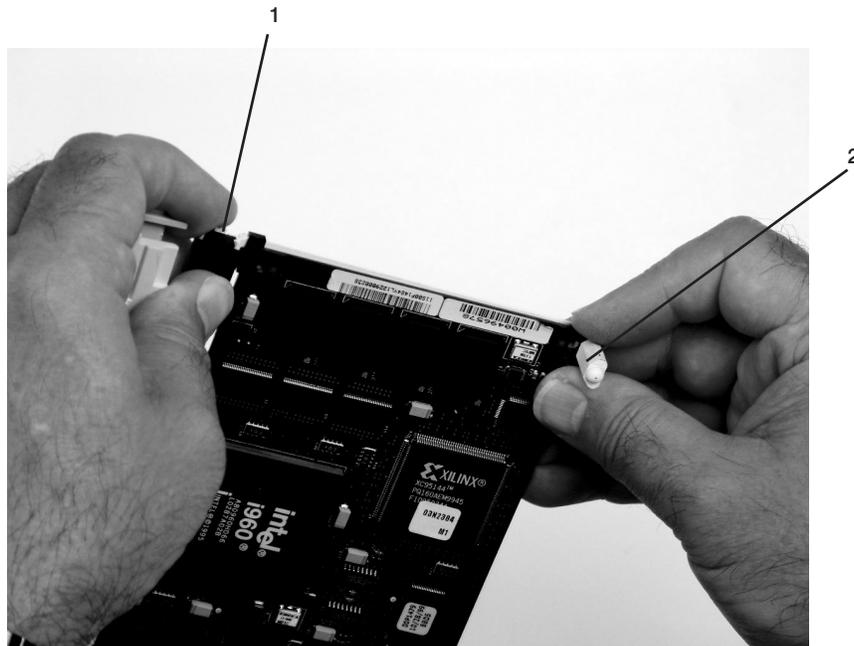
7. Ensure that the bottom edge of the adapter is held by the groove in the lower part of the adapter-retaining arm.

1 Top Adjustable-Retaining Clip

2 Long Adapter Retaining Arm Slot

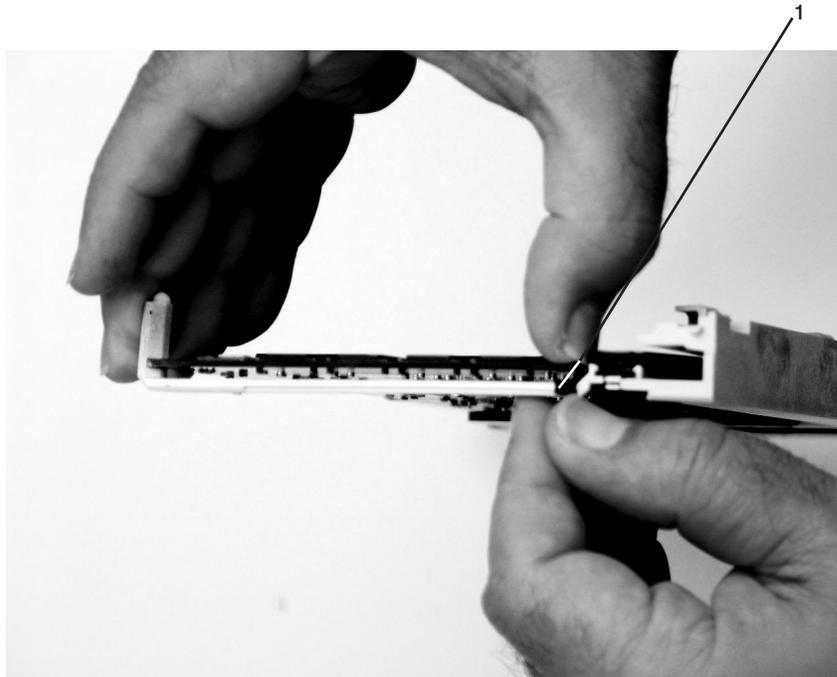
8. To hold the top of the adapter, slide down the top adjustable adapter-retaining clip on the retaining arm.

1 Long Adapter Retaining Arm

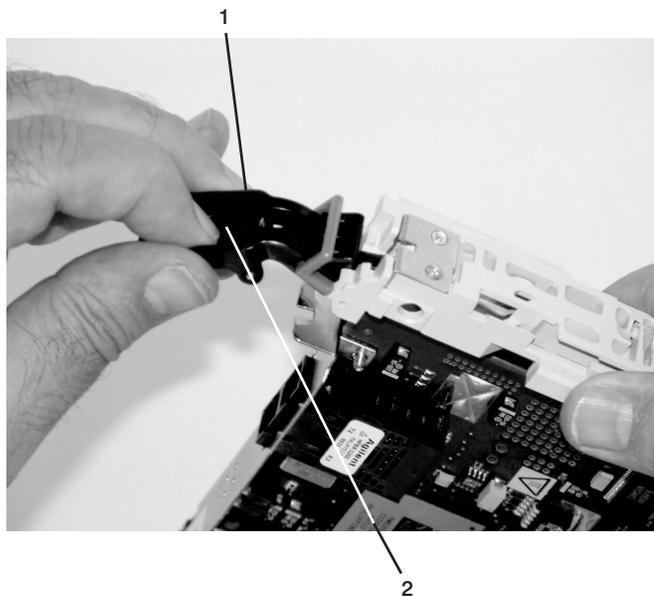
9. If you installed a middle-spacer arm, ensure that the adapter-retaining clip is seated around the top edge of the adapter.
10. Depress the handle release lever on the handle. Rotate the adapter handle until it is in the down position (adapter or blank filler moves up into the cassette assembly).

1 Handle
2 Handle Release Lever

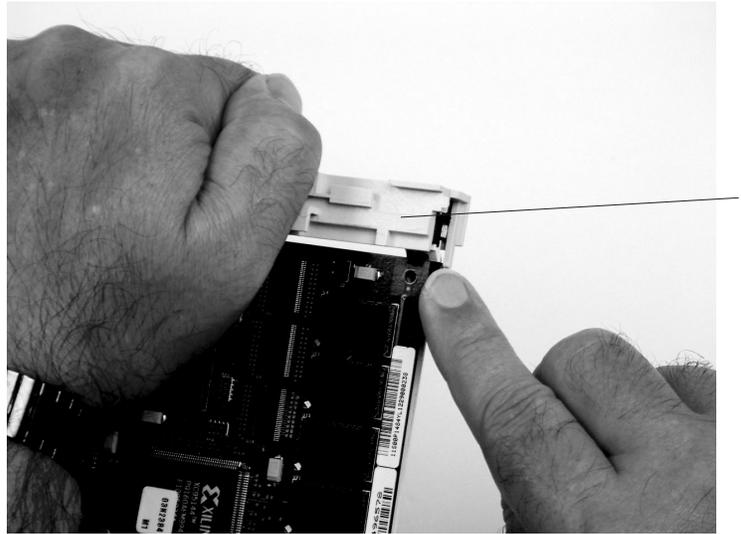
Ensure the right end of the cassette linkage rail moves up into the cassette linkage assembly as shown:

1 Right End of Cassette Linkage

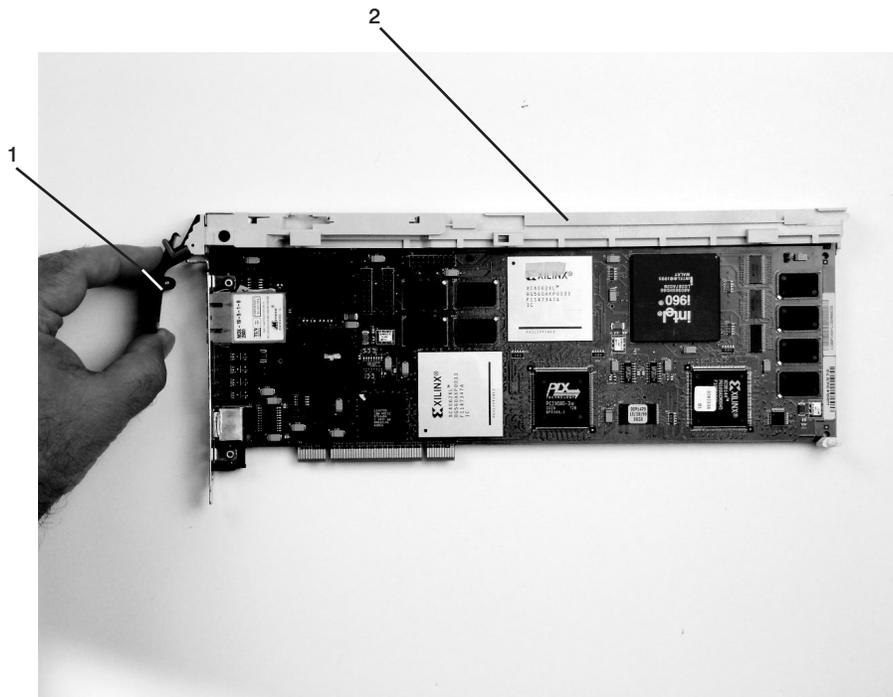
11. Position the adapter and cassette assembly with the handle on the left (in the down position) and the top facing away from you.

1 Handle
2 Top of Cassette

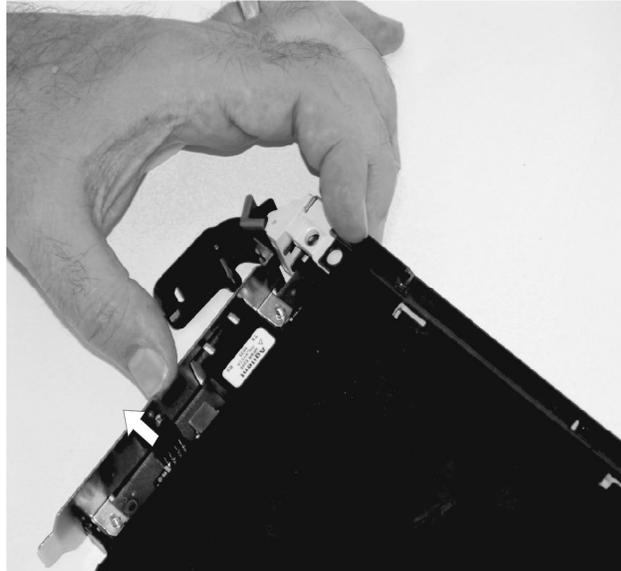
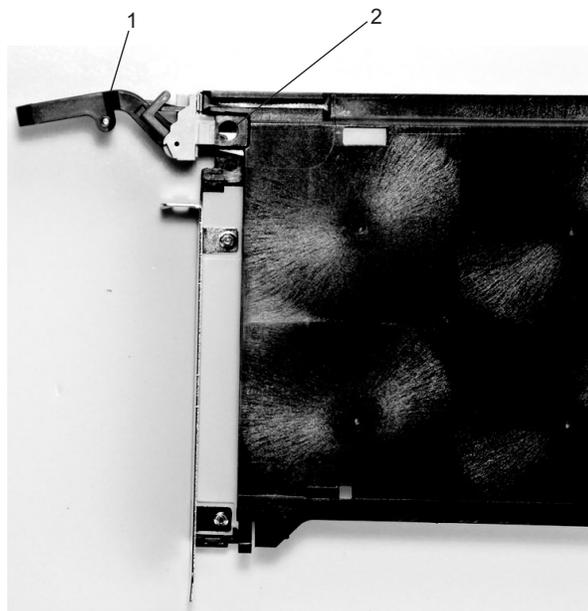
12. Install the cover on the cassette assembly by placing the cassette cover on the cassette assembly as shown. Slide the cover toward the handle until the hole in the cover aligns with the hole in the cassette assembly.

- 1 Handle
- 2 Hole Aligned in the Cover

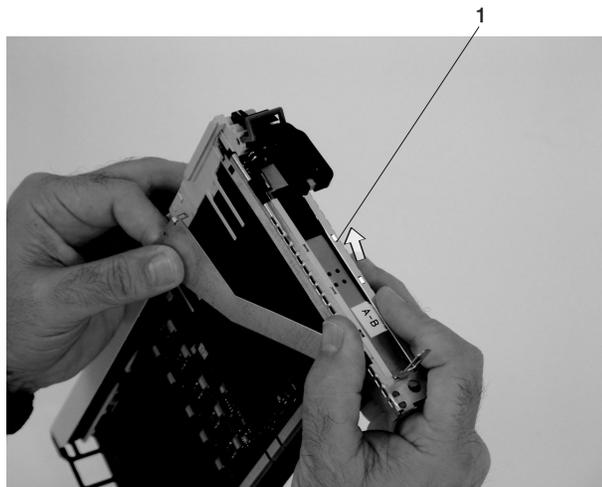
13. Install the bezel assembly using the following procedure:
- Carefully slide the bezel onto the cassette assembly.

1 Bezel

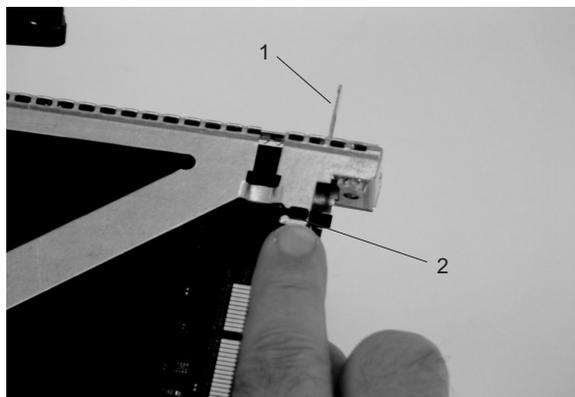
- Align and insert the cover arm latch in the hooked notch in the bezel.

1 PCI Adapter Pull Tab
2 Hooked Notch in the Bezel

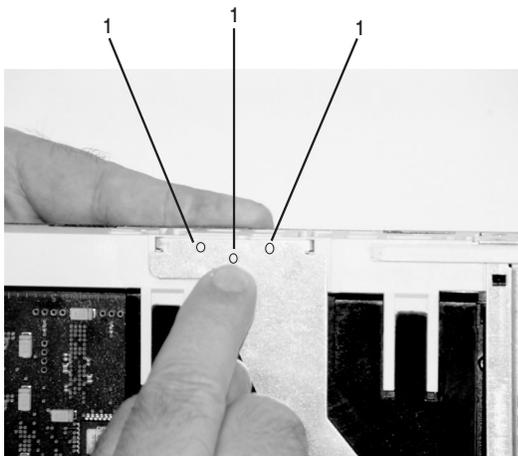
- a. Ensure that the extension arm engages the three pins on the cassette. You can see the pins in the holes in the arm. The bezel tab is seated as shown in the following illustration.

1 Pins
