Bull ESCALA PL 3200R

Service Guide

Hardware

March 2004

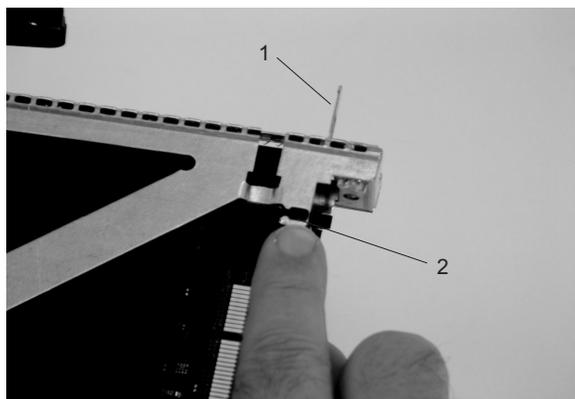
- b. Ensure that the cover arm latch is completely pressed into the hooked notch on the bezel as shown.

1 PCI Adapter Pull Tab
2 Hooked Notch in the Bezel

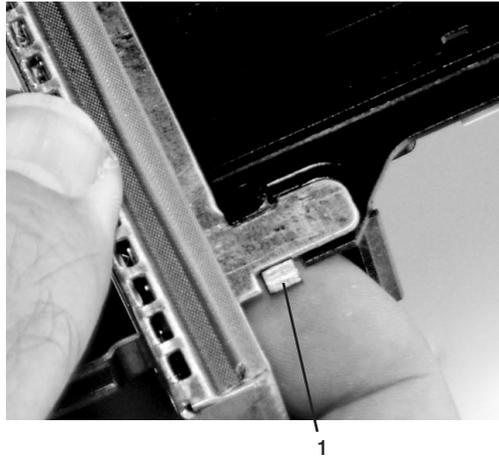
- c. Turn the cassette assembly over so that the cover is facing up. Check the cover latch to ensure that it is holding the bezel to the cover as shown.

1 Cover Latch

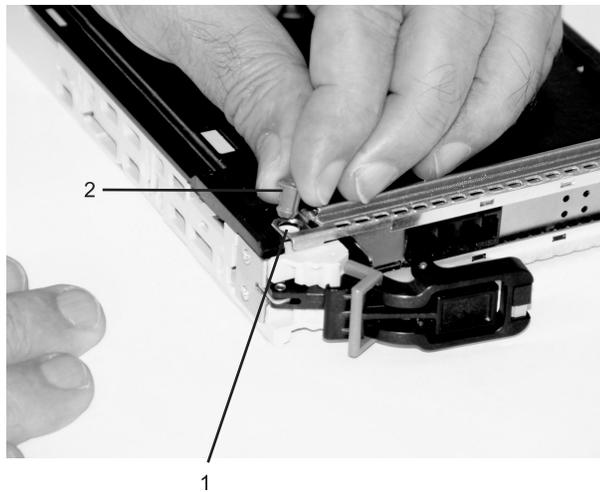
15. Position the adapter with the cover side facing up. Ensure that the holes are aligned, and insert the bushing as shown.

1 Bushing
2 Bushing-Lock Pin

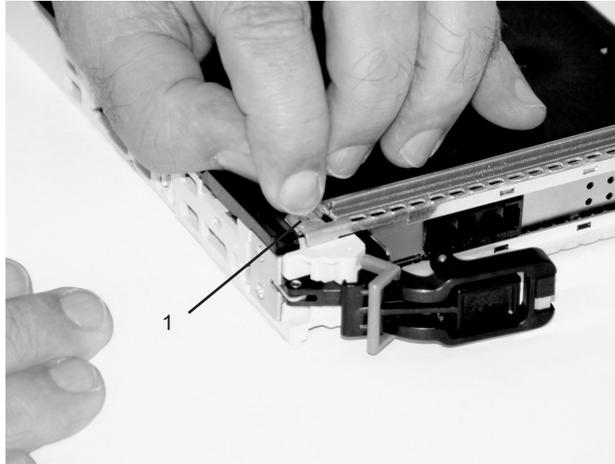
- 1 Bushing
- 2 Bushing-Lock Pin

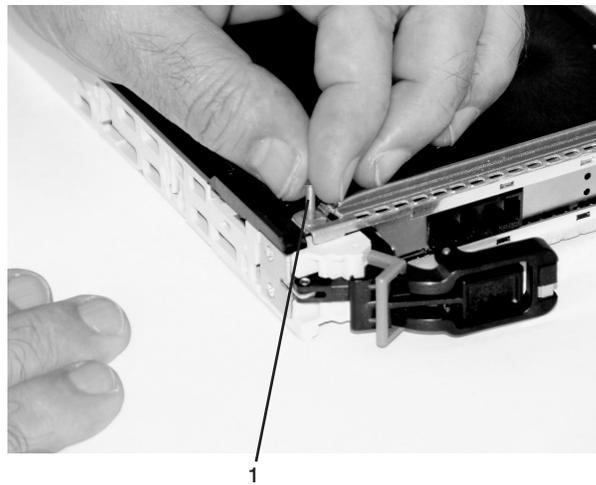
16. Insert the bushing-lock pin into the hole in the bushing. Push on the pin until it seats.

- 1 Location of the Installed Bushing and Bushing-Lock Pin

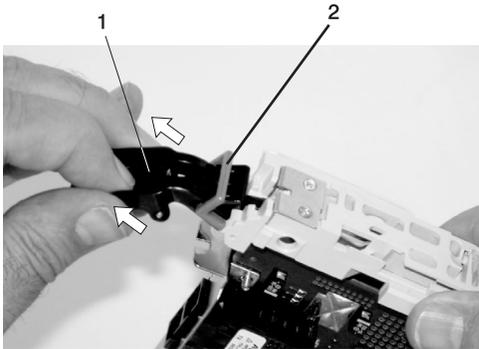
17. Depress the handle release lever to ensure the locking bar on the handle is pulled into the unlocked position. Raise the handle on the cassette linkage until it locks into the up position (the blank filler or adapter moves downward).

- 1 Handle
2 Locking Bar

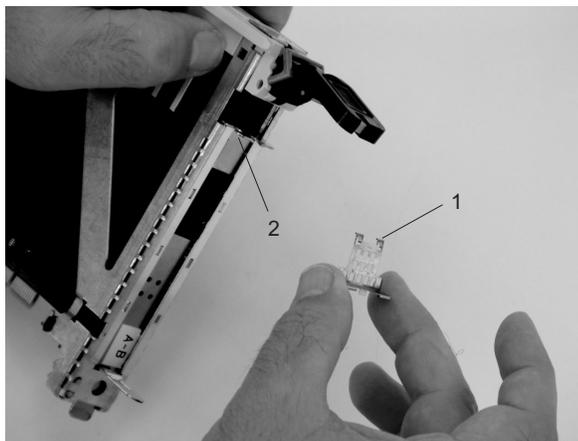
18. To install the metal EMC shield on the adapter bracket, grasp the metal EMC shield as shown in the following illustration, and do the following:

- 1 Metal EMC Shield
2 Adapter Bracket

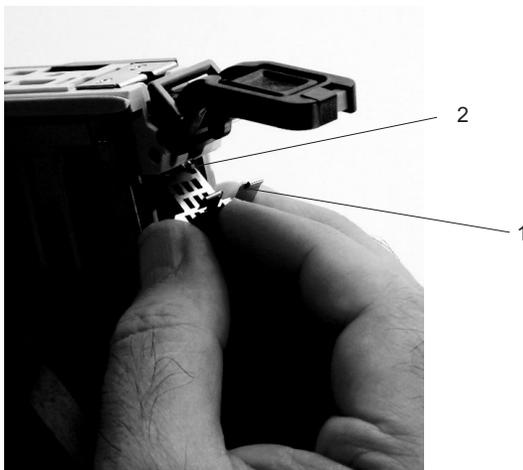
a. Ensure that the shield slides up inside the top of the cassette.

- 1 Metal EMC Shield
- 2 Adapter Bracket

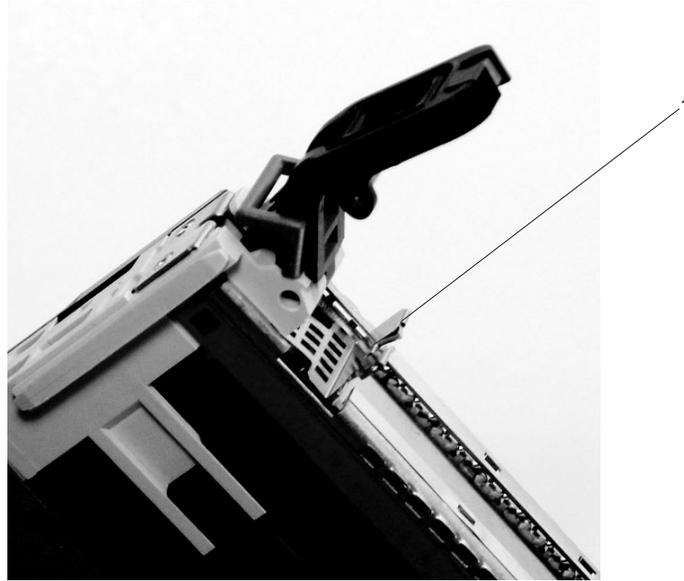
- b. The metal EMC shield has clips that slide over the top of the tailstock. Ensure that these clips are holding the EMC shield to the tailstock.

1 Top of Tailstock

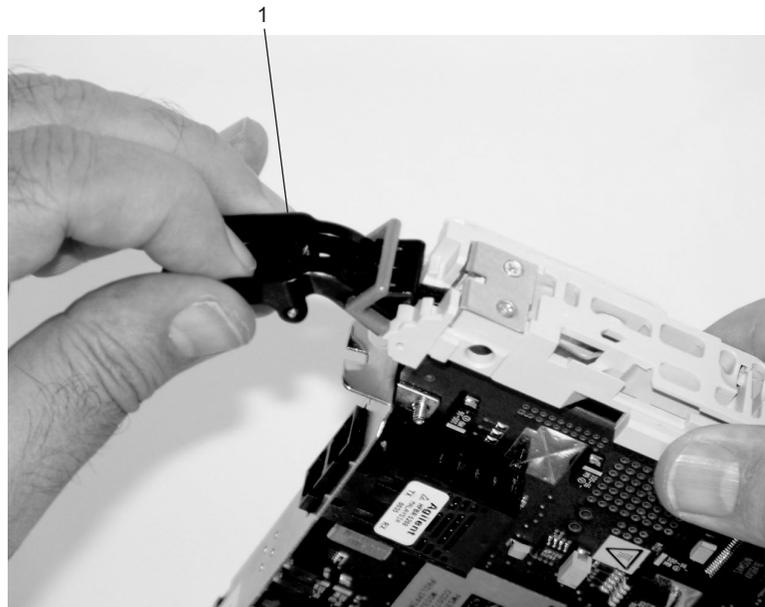
19. Press the lock on the handle and rotate the adapter handle until the handle is in the down position (adapter or blank filler moves up into the cassette assembly).

1 Handle

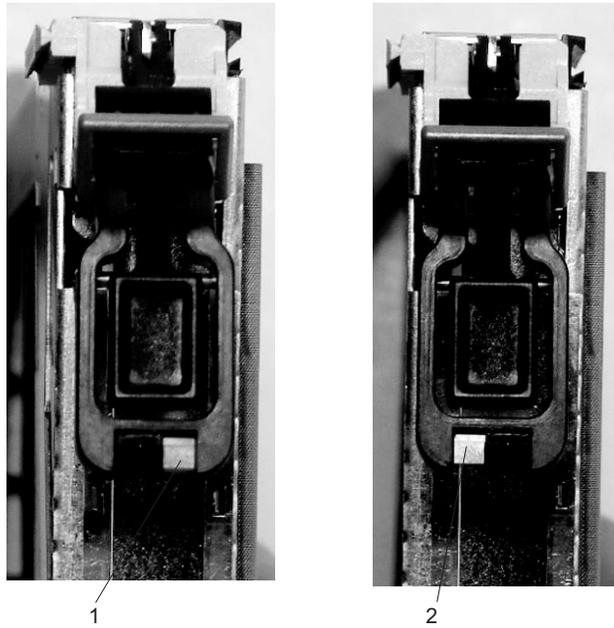
20. Using your system documentation, determine if the adapter you are installing is hot-swappable. If the adapter is hot-swappable, move the slider on the color indicator to allow the orange color to be

visible. If the adapter is not hot-swappable, the blue color is visible.

- 1 Orange indicates Hot-Swappable
- 2 Blue indicates Not Hot-Swappable

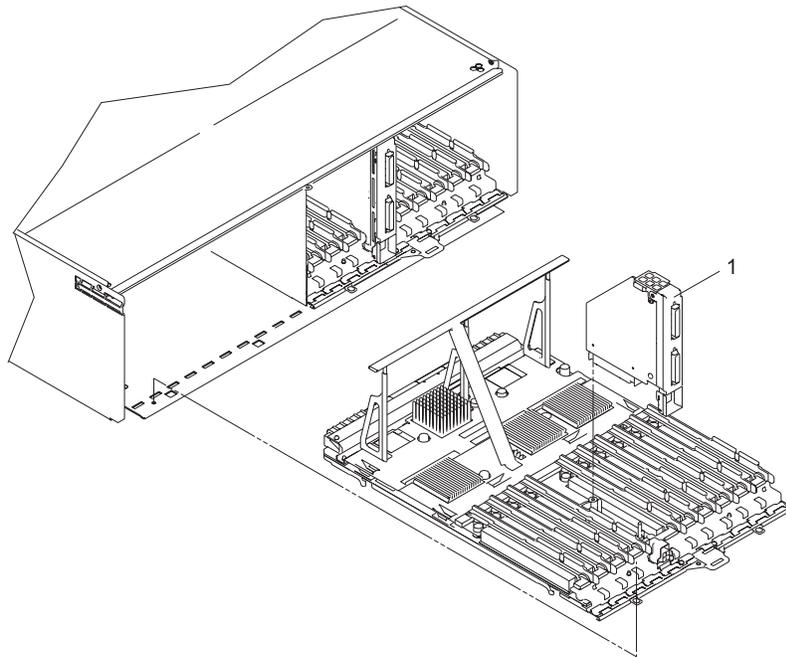
1. Turn off power as described in “Powering Off and Powering On the System” on page 838.
2. Disconnect all cables from the RIO riser card.
3. Remove the I/O subsystem backplane, as described in “I/O Subsystem I/O Backplane Assembly” on page 989.
4. Remove the two screws that attach the RIO riser card to the I/O subsystem backplane.
5. Carefully pull the card out of the slot as shown in the following illustration.

1 RIO Riser Card

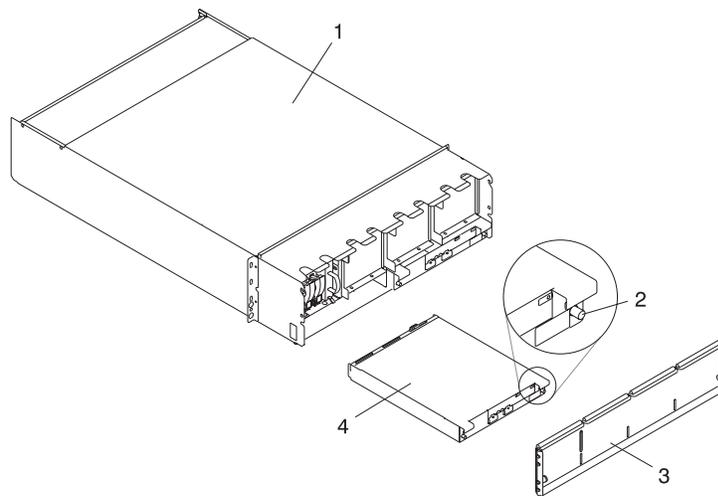
- Grasp both sides of the front DCA, and pull it out of the drawer.

| 1 I/O Subsystem | 3 I/O Subsystem Front Cover |

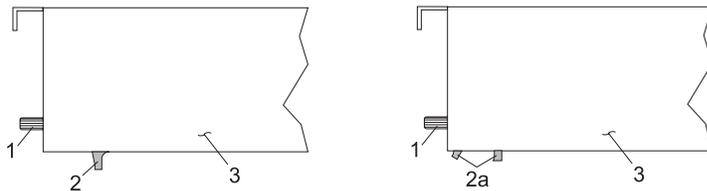
Attention: Rotating the thumbscrews counter clockwise engages the stop mechanism located on the bottom of the DCA. Failure to do so could result in the system powering off during a concurrent replacement operation. The following illustrations shows a DCA stop mechanism completely engaged.

| 1 DCA Captive Thumbscrew (quantity 2) | 2a Stop Mechanism (disengaged) |

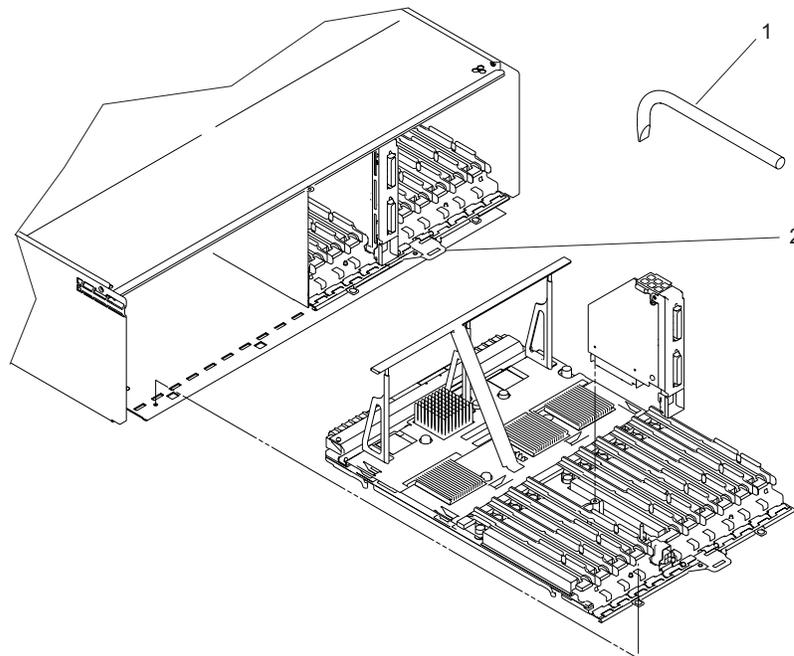
Note: Be sure to hold the board level to ensure that the board can clear the step in the cover and then again to clear the EMC gasket.

- 1 Backplane removal tool (part number 11P4789)
- 2 Backplane removal and insertion tab

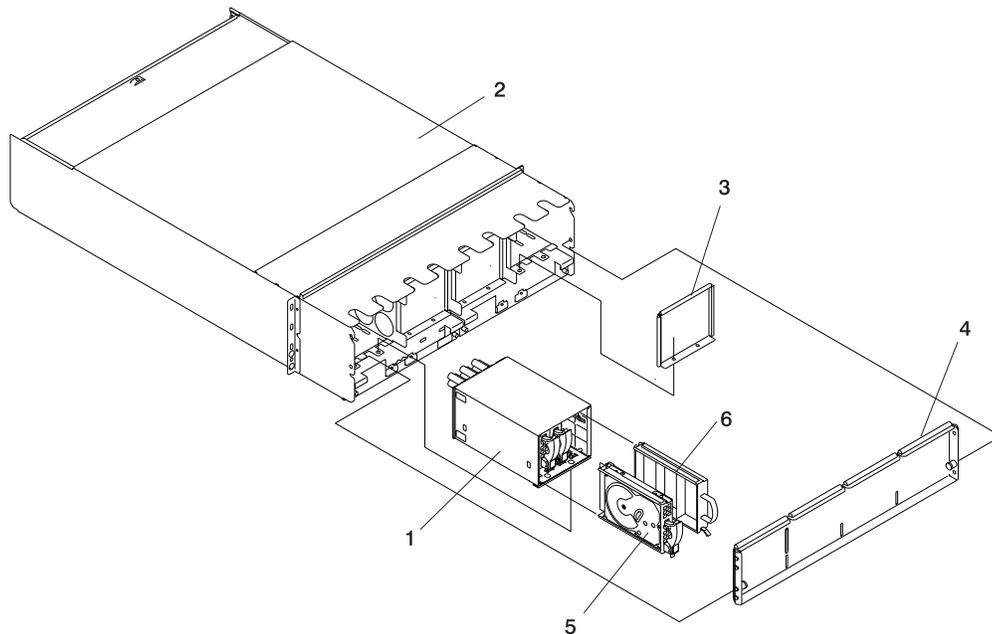
1. This procedure is a hot-swap procedure. Refer to the “SCSI Hot-Swap Manager” in the “Introduction to Tasks and Service Aids” chapter in the *Diagnostic Information for Multiple Bus Systems*, order number SA23-2769. Use the SCSI Hot-Swap Manager Task to prepare to remove and replace a SCSI disk drive. Then continue with the following steps.
2. Press on the blue latch to release it from hooking the body.
3. Move the black handle all the way down and pull out the assembly. A slight initial resistance is normal.
4. Ensure that the 4-pack has not been damaged. If the DASD assembly was installed incorrectly, the removal could force the metal tab in the 4-pack to bend over the camming slot.

- 1 DASD 4-Pack Assembly
- 2 I/O Subsystem Chassis
- 3 EMC Filler Shield

- 4 Cover
- 5 Disk Drive Assembly
- 6 DASD Filler

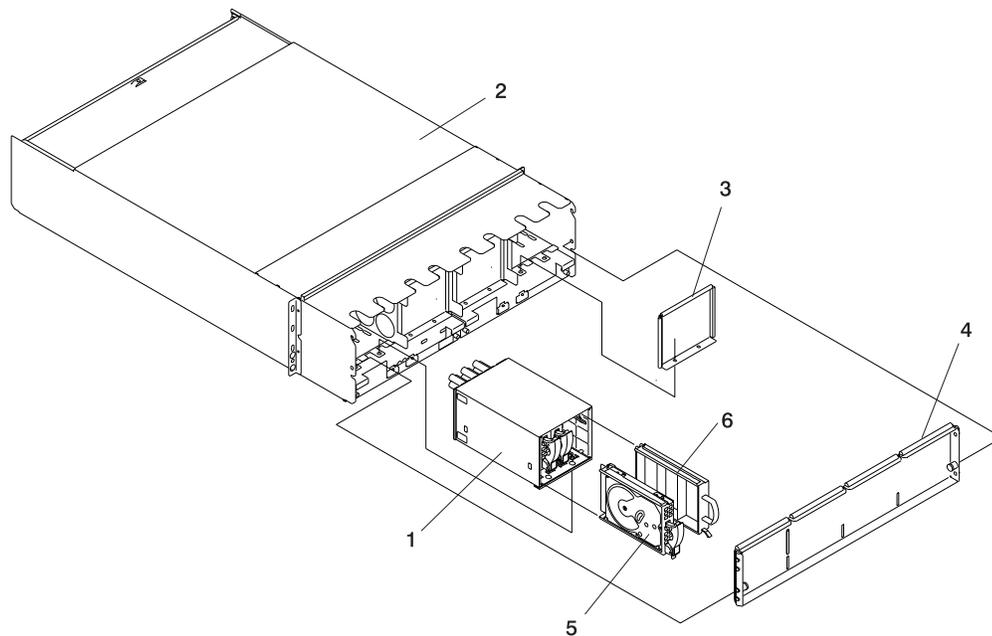
1. Press the green **Start Service** button on the UEPO switch.
2. Locate the DASD backplane to be replaced.
3. Turn off the power as described in “Powering Off and Powering On the System” on page 838.
4. Remove the front cover from the I/O subsystem by grasping the pins at either side of the cover, pulling them towards the center of the drawer, and simultaneously lifting the cover up and to the front to release it from the I/O subsystem chassis.
5. Remove the DASD disk drive assemblies or DASD filler(s) from the affected 4-pack as shown in the following illustration.

- 1 DASD 4-Pack Assembly
- 2 I/O Subsystem Chassis
- 3 EMC Filler Shield

- 4 Cover
- 5 Disk Drive Assembly
- 6 DASD Filler

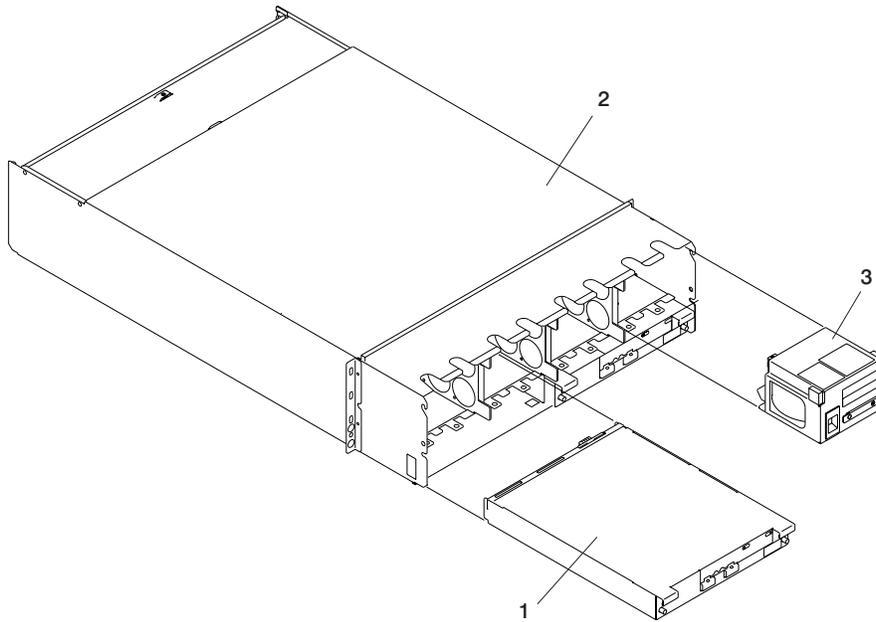
1. Press the green **Start Service** button on the UEPO switch.
2. Locate the fan to be replaced.
3. Turn off the power as described in “Powering Off and Powering On the System” on page 838.
4. Remove the DASD cage from the front of the fan to be removed (see “I/O Subsystem DASD 4-Pack” on page 993).
5. Slide the black retention latch on the fan assembly upward and, with the handle located on the fan, pull the fan from the front of the I/O subsystem. A door automatically closes when the fan is removed, preventing loss of airflow while the fan is out of the enclosure.

- 1 DCA (DCA 1 shown)
- 2 I/O Subsystem Chassis
- 3 Fan (Fan 4 shown)

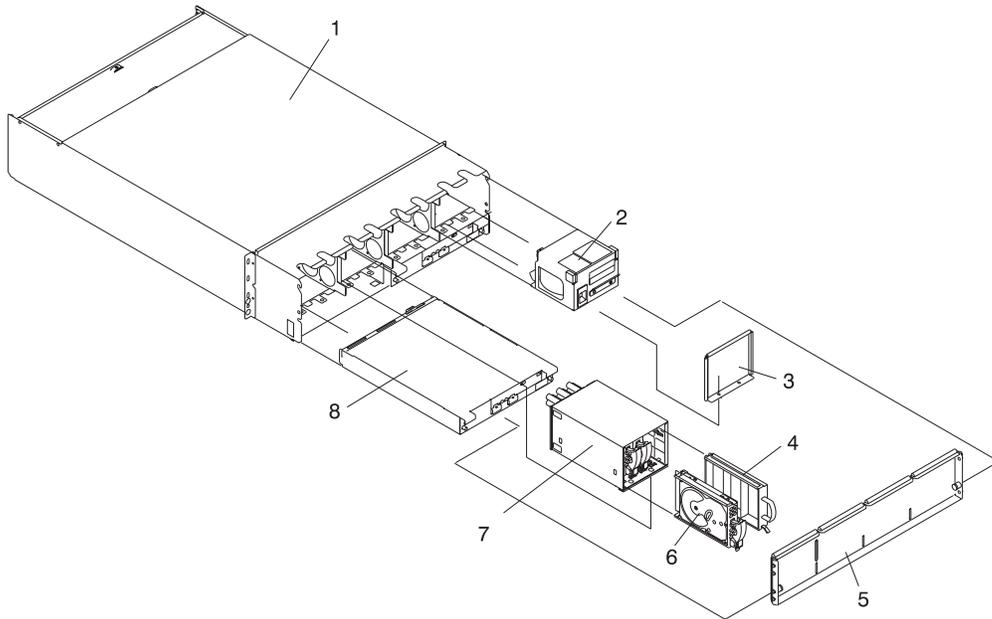
Front:

| 1 I/O Subsystem Chassis | 6 SCSI DASD Disk Drives |
| 5 Front Cover | |

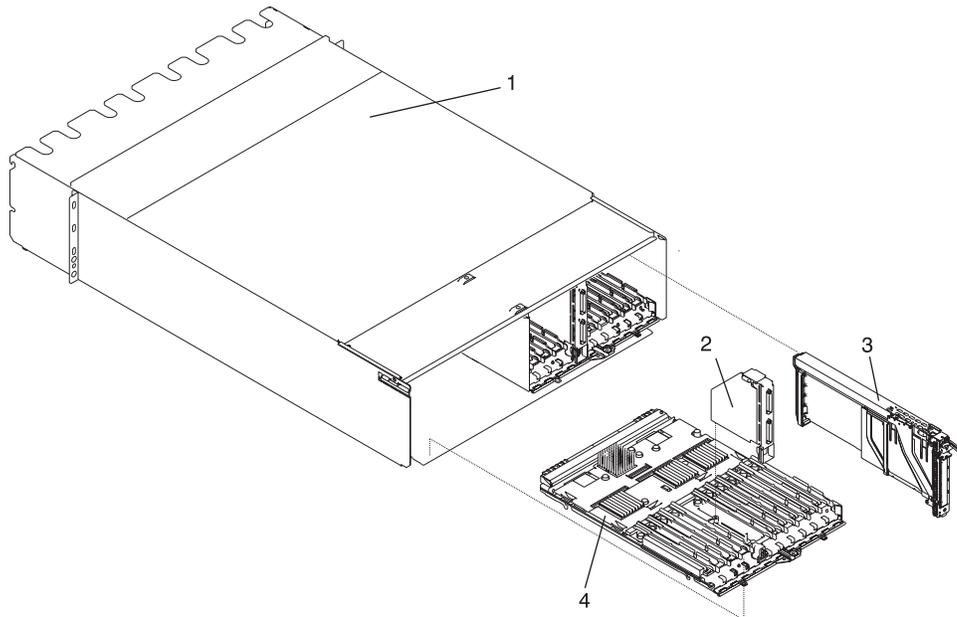
Rear:

| 1 PCI I/O Subsystem Chassis | 3 Blind-swap cassette or PCI filler with no adapter |

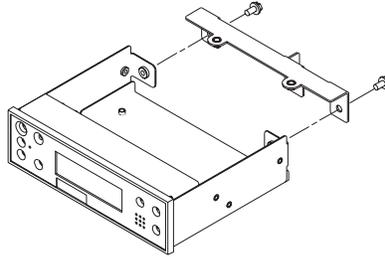
1. Turn off power as described in “Powering Off and Powering On the System” on page 838.
2. Remove the upper-left and lower-right screws that hold the media subsystem in the rack, and pull the subsystem out no more than two inches.
3. Pry the spring clip on the left side just enough to release the panel while grasping the operator panel by the top and bottom front (do not pull on the bezel). Pull the operator panel out of the chassis.
4. Note the locations and disconnect the cables from the operator panel, and then remove the operator panel as shown in the following illustration.

1. Remove the VPD module from the old operator panel and insert it in the new operator panel. Make sure you insert the module in the same position as it was in the old panel.
2. Reconnect the cables to the operator panel.
3. Push the operator panel into the chassis until the spring clip engages.
4. Push the chassis into the rack, and replace the two mounting screws.
5. Turn on the power as described in “Powering the System On” on page 841.

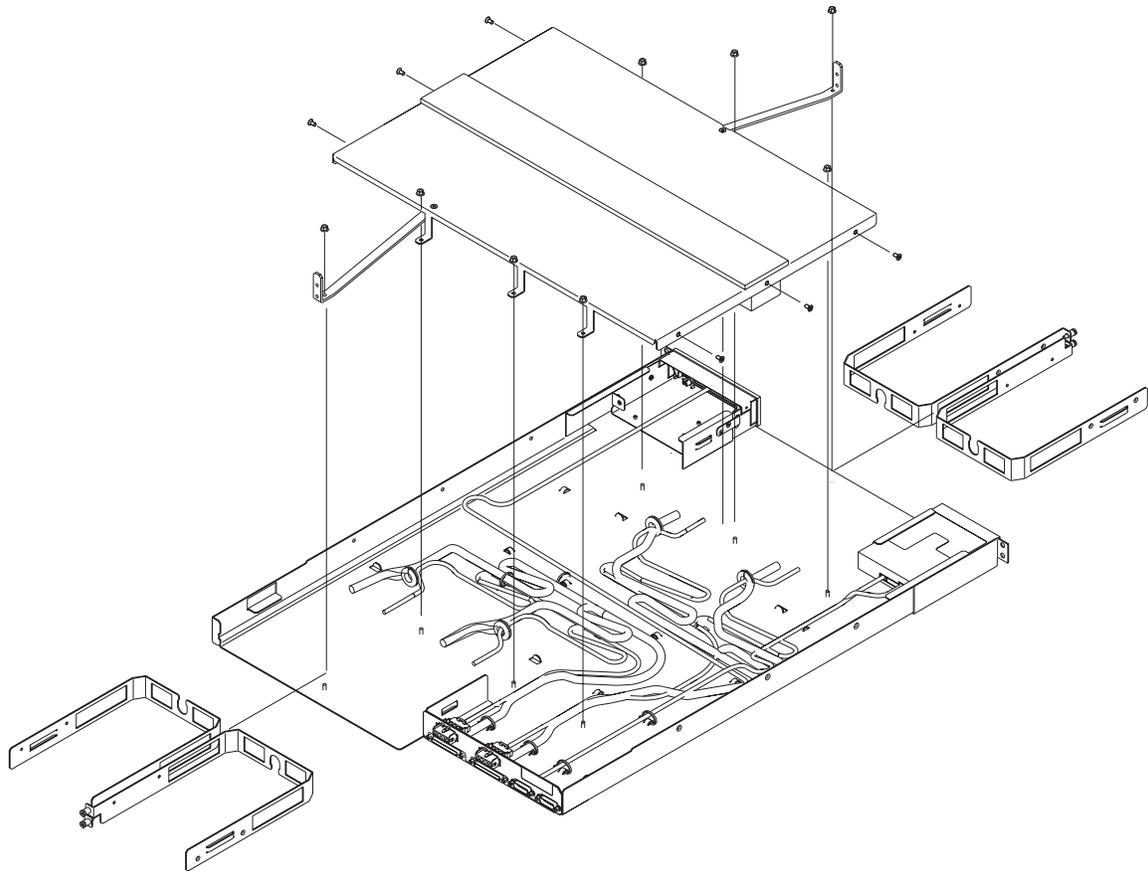
1. Turn off power as described in “Powering Off and Powering On the System” on page 838.
2. If you have not already done so, open the front door of the rack unit.
3. Remove the media subsystem from the rack as described in “Media Subsystem Chassis” on page 1001, and place it on a work surface.
4. Remove the six screws and the eight 7-mm nuts that hold the cover to the subsystem, as shown in the following illustration.

5. Loosen the four captive screws (one for each SCSI drive bay) to free the two truss brackets.
6. Remove the cover.
7. Release the ties that hold the affected cable. If ties must be cut, cut them from the underside of the chassis.
8. Disconnect the cable connector from the chassis.
9. Note the cable routing, and remove the cable from the subsystem chassis.

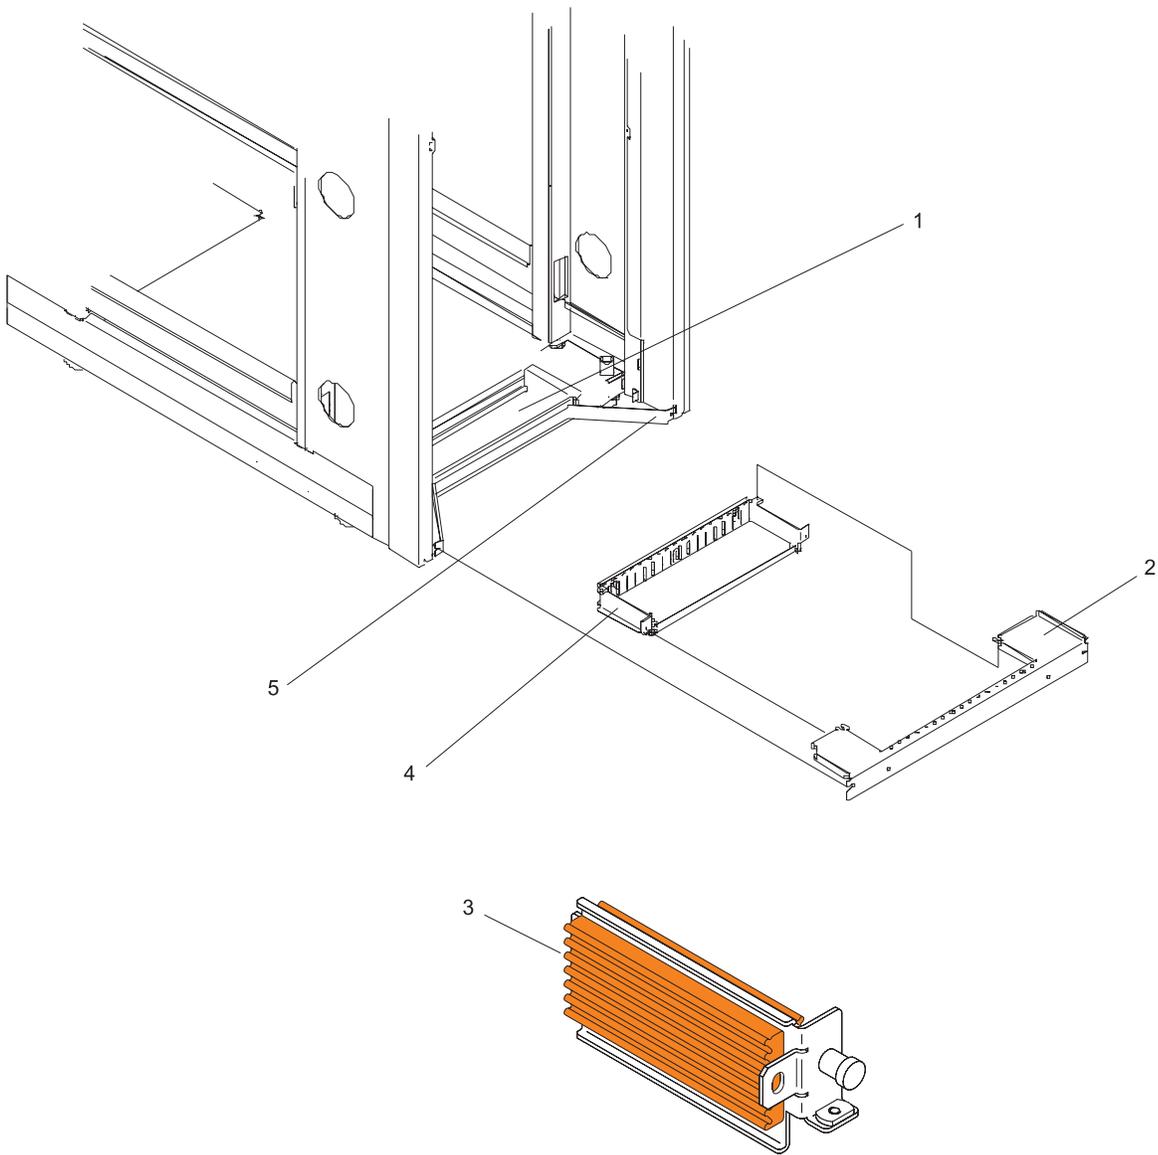
The following illustration shows the tailgate assembly and standard frame extenders of a properly cabled frame. Refer to the service guide for more parts information.

| <ul style="list-style-type: none"> 1 Rear Cutout 2 Extender 3 Tailgate Insert | <ul style="list-style-type: none"> 4 Cable Management Basket 5 Stiffener |

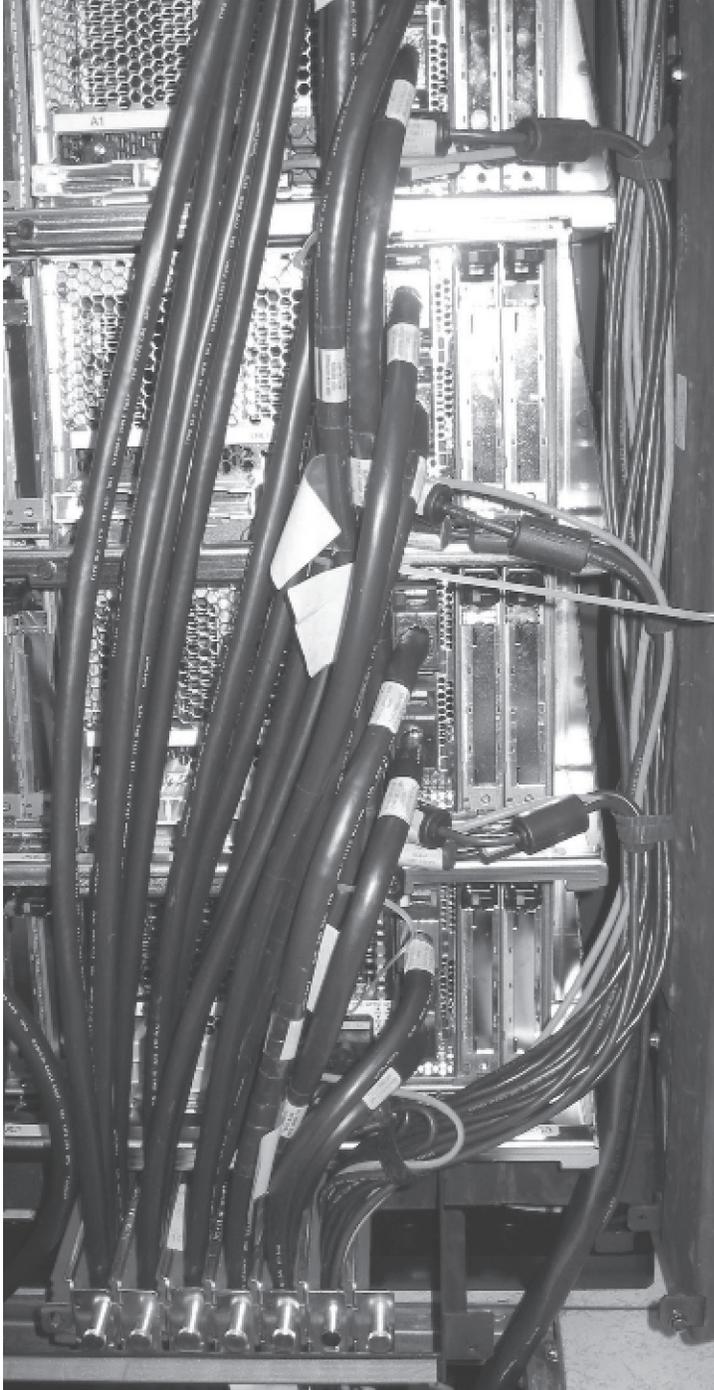
The following illustration shows a properly cabled frame.

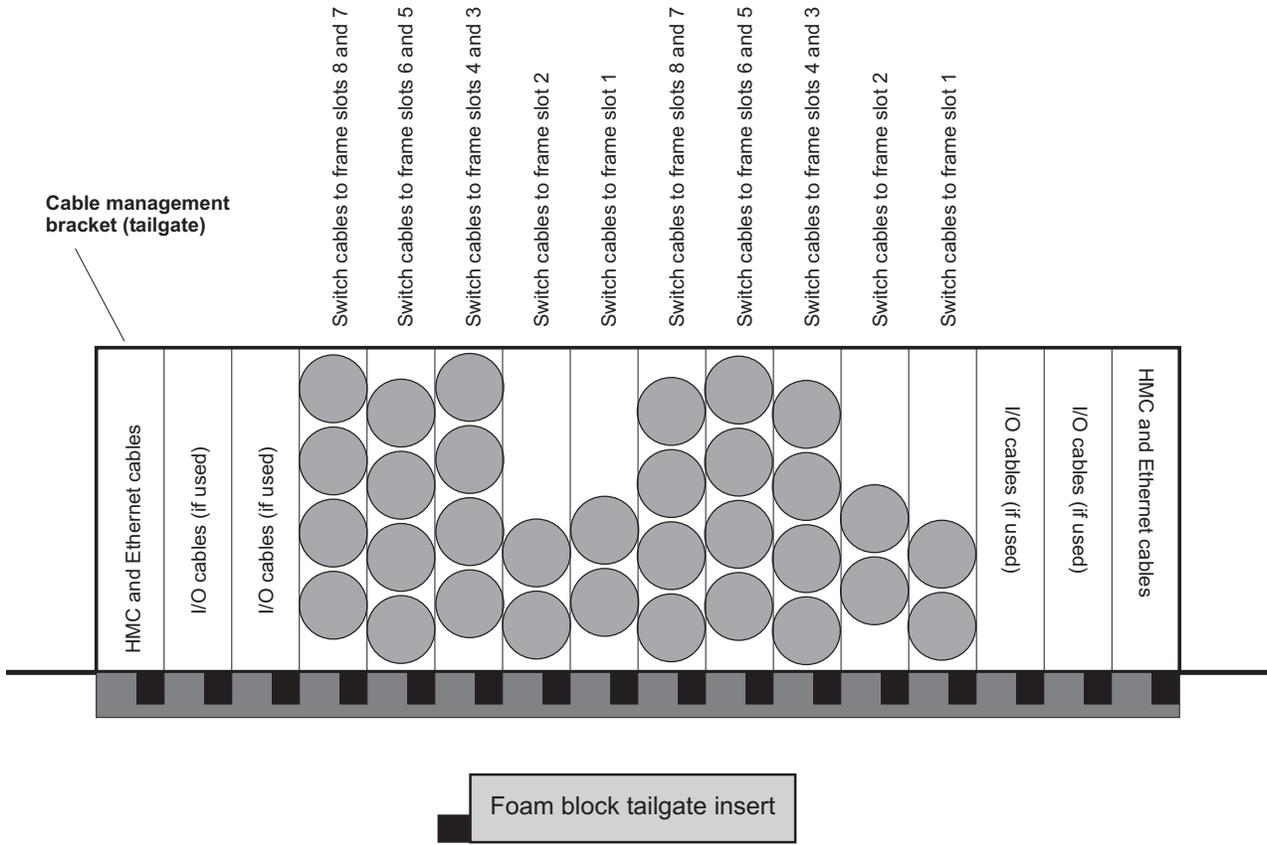
If you have properly cabled the frame, the cable layout should look like the following illustration.

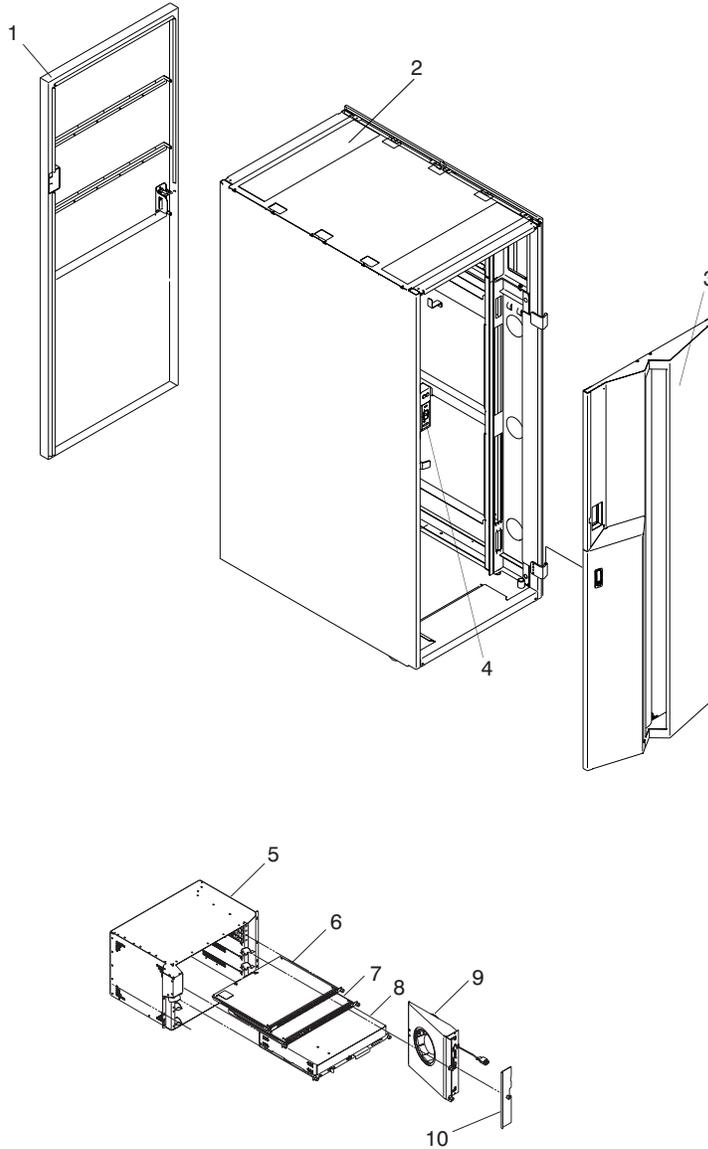
406/1R Rack Subsystem

The rack subsystem consists of the rack, power subsystem, and the integrated battery feature.

11 - Integrated Battery Feature (not pictured)

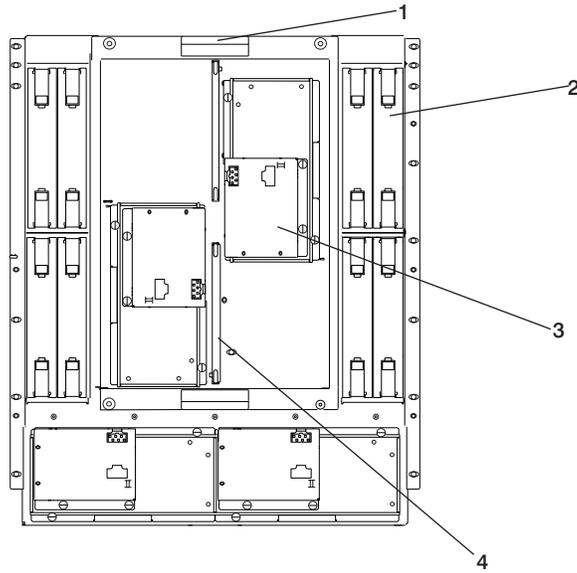
406/81 Processor Subsystem (Front)

This processor subsystem front view consists of the processor chassis, memory books, fans, and filters.

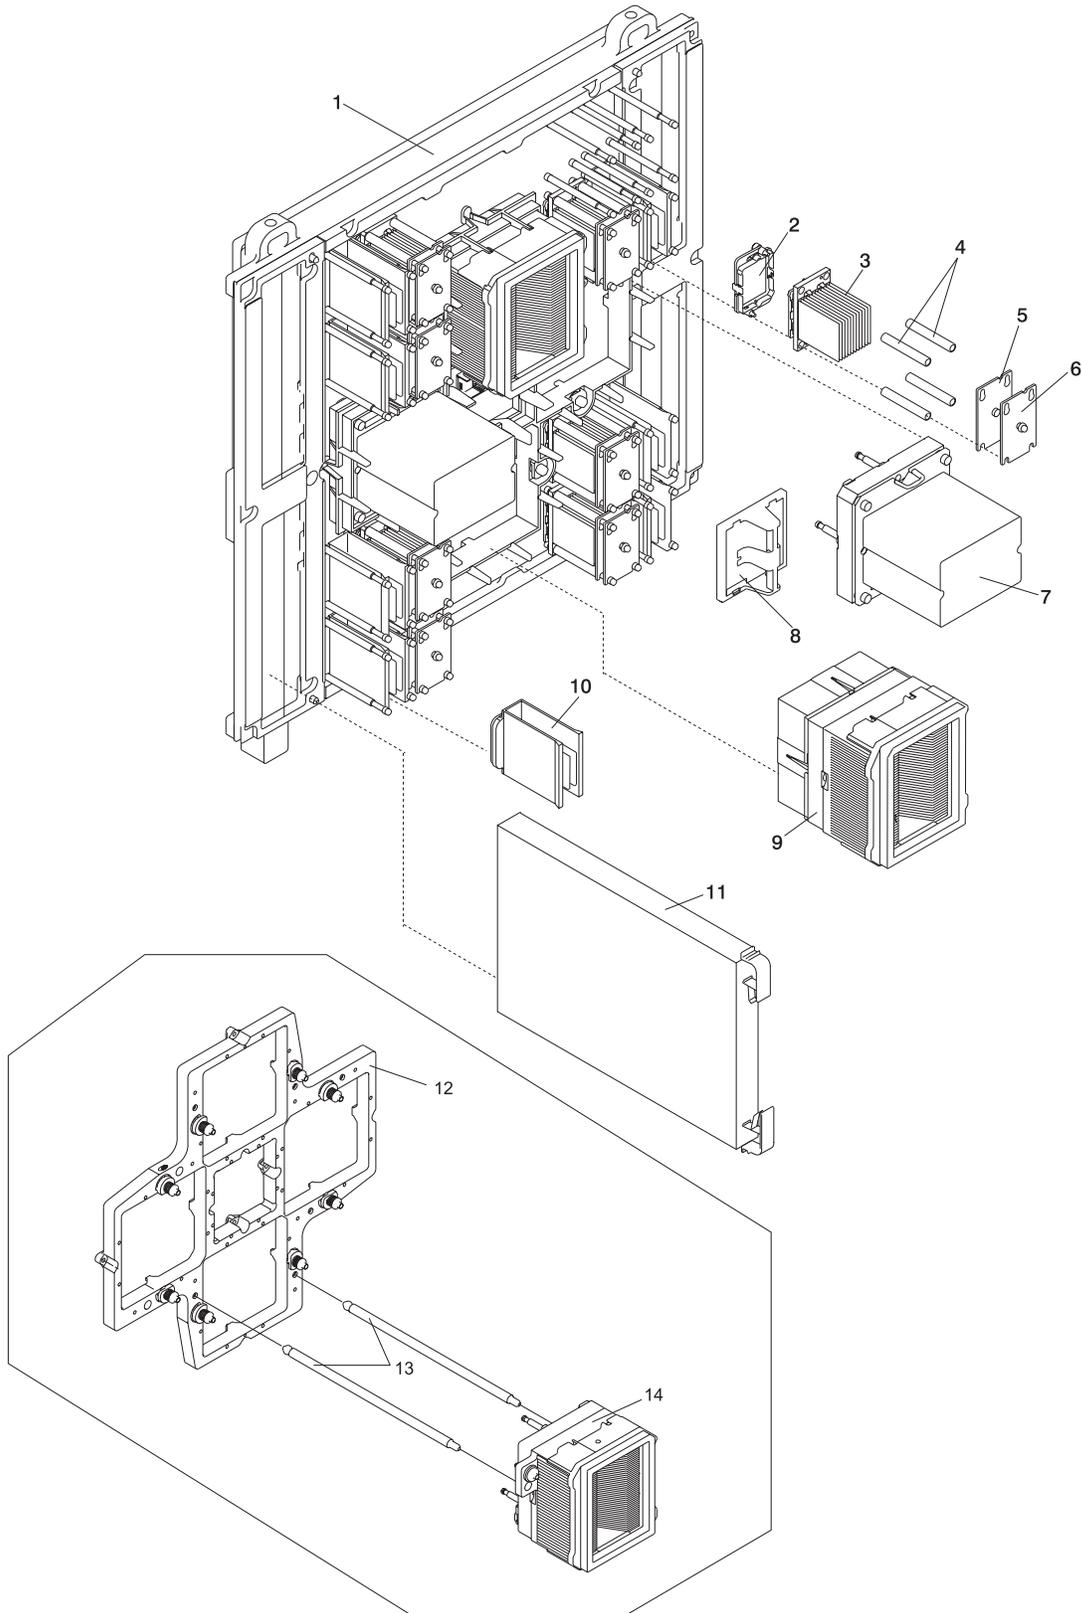
406/81 Processor Subsystem (Front)

This processor subsystem front view consists of the memory books, MCM and L3 modules.

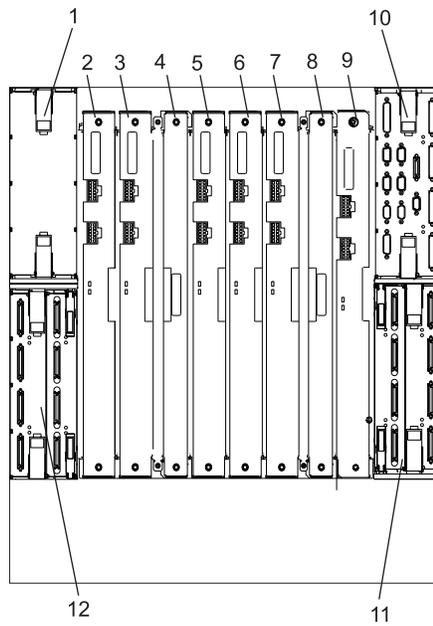
406/81 Processor Subsystem (Rear)

This processor subsystem rear view consists of the RIO books, DCAs, and capacitor books, MCM and L3 modules, as well as the media subsystem.

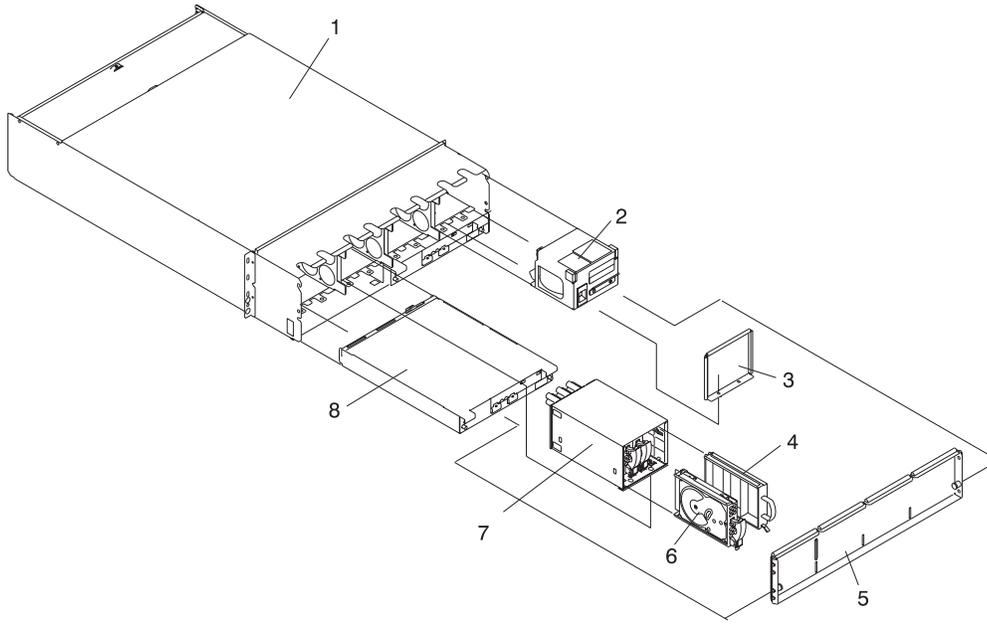
Front

The system can contain up to eight I/O subsystems. This section lists detail for one I/O subsystem. Depending on your configuration, the quantities of parts listed may increase by the actual number of I/O subsystems in your system.

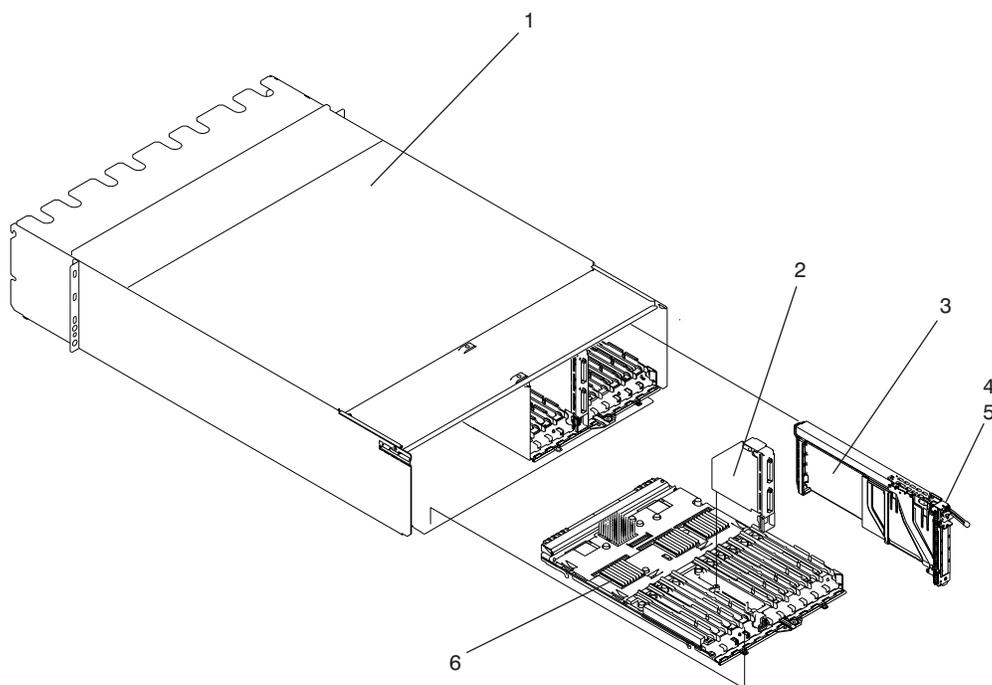
Rear

Index	Part Number	Units Per Assembly	Description
1	44P0705	1	PCI I/O Subsystem Chassis
1	44P2285	1	PCI-X I/O Subsystem Chassis
2	NA	2	RIO Riser Card, part of the I/O subsystem backplane assembly
3	11P4861	1 to 20	PCI Adapter Cassette Assembly
	44P0239		PCI Adapter Cassette Assembly
	11P4089	1 to 20	PCI Cassette Filler
4	44P1055	1 to 20	Blind-swap cassette, for standard PCI adapter
	44P1390	As needed	Blind-swap cassette, for two-adapter-wide PCI adapter
	44P3320	As needed	Blind-swap cassette, for Gigabit Ethernet PCI adapter
5	44P0323	As needed	Adapter clip, used with blind-swap cassette:
	44P0324		for Gigabit Ethernet FC 2969 type 9U
	44P0321		for Ultra3 SCSI FC 6203 Type 4Y
	44P0406		for 10/100 BaseT Ethernet FC 4962 Type AF
			for Gigabit Fibre Channel PCI FC 6228 Type 4W
	11P4861	1 to 20	PCI filler, for slots with no adapter
6	44P1414	1 to 2	PCI I/O Backplane
	44P1970	1 to 2	PCI-X I/O Backplane
(Not Shown)	21P5454		RIO-2 Remote I/O-2 Cable, 1.2 M

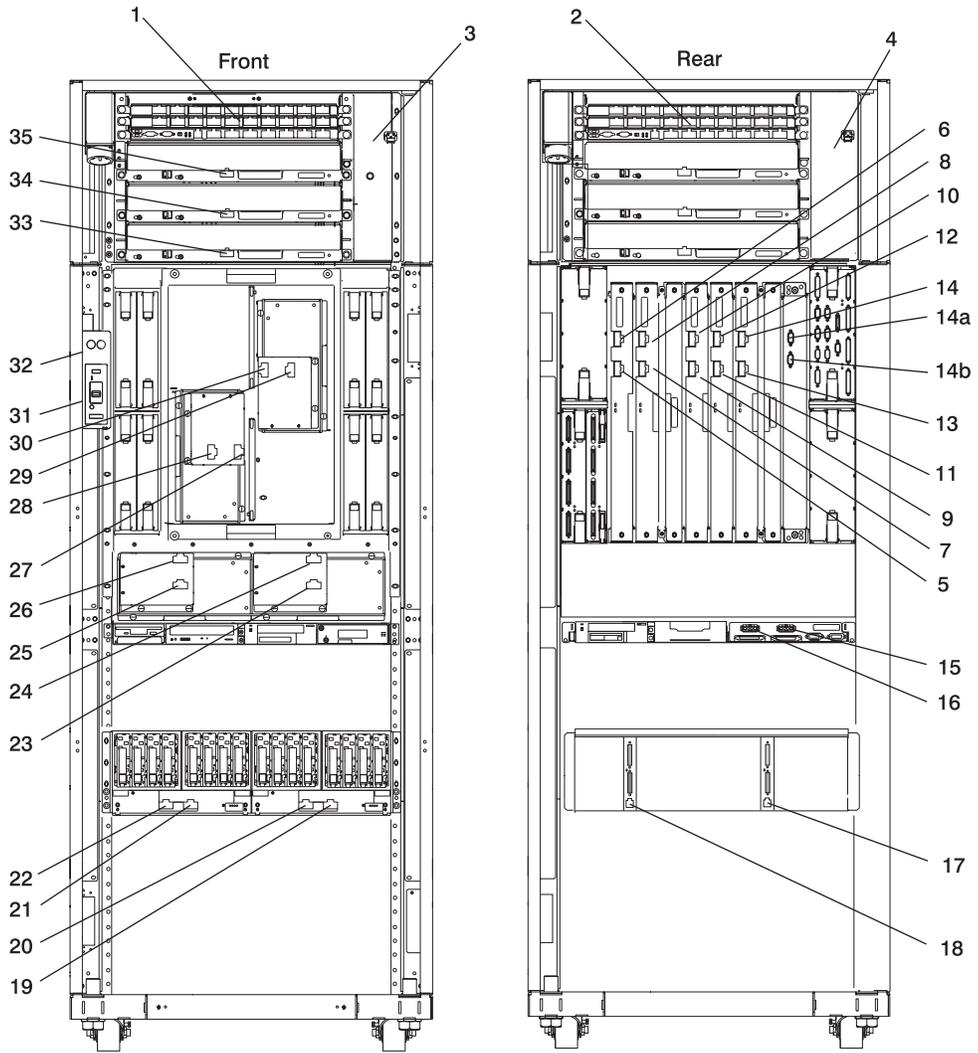
Power Cabling

Index	Part Number	Units Per Assembly	Description
1	NA 11P1598		Bulk Power Distribution on the A side of the system (BPD A Side) Cable A35-BPC-P00 to B35-BPC-P00
2	NA 11P1598		Bulk Power Distribution on the B side of the system (BPD B Side) Cable B35-BPC-P00 to A35-BPC-P00
3	NA	1	A35-BPC-P03 to Bulk Power Fan P1-F1, Cable attached to FAN (BPF-A)
4	NA	1	B35-BPC-P03 to Bulk Power Fan P2-F1, Cable attached to FAN (BPF-B)
5	11P4449	1	B35-BPC-P08 to DCA-1-P01, Red
6	11P4448	1	A35-BPC-P08 to DCA-1-P00, Red with white stripe
7	11P4451	1	B35-BPC-P09 to DCA-2-P01, Red
8	11P4450	1	A35-BPC-P09 to DCA-2-P00, Red with white stripe
9	11P4453	1	B35-BPC-P10 to DCA-3-P01, Red
10	11P4452	1	A35-BPC-P10 to DCA-3-P00, Red with white stripe
11	11P4455	1	B35-BPD1-P08 to DCA-4-P01, Red
12	11P4454	1	A35-BPD1-P08 to DCA-4-P00, Red with white stripe
13	11P4457	1	B35-BPD1-P09 to DCA-5-P01, Red
14	11P4456	1	A35-BPD1-P09 to DCA-5-P00, Red with white stripe

14a		1	A35-BPD1-P06 to DCA-6-P01, Red with white stripe
14b		1	A35-BPD1-P06 to DCA-6-P00, Red
15 to 17	11P4734	1	I/OB9-P00 to Media P02
16 to 18	11P4735	1	I/OB9-P01 to Media P00
19, 20, 21, 22	NA		B35-BPDx-P0x to I/O Subsystem #x "RIO Cables and I/O Power Cables" on page 1029
23	11P4462	1	B35-BPC-P05 to (AMD2-P01) MDA2-J02, Red
24	11P4461	1	A35-BPC-P05 to (AMD2-P00) MDA2-J01, Red with white stripe
25	11P4460	1	B35-BPC-P04 to (AMD1-P01) MDA1-J02, Red
26	11P4459	1	A35-BPC-P04 to (AMD1-P00) MDA1-J01, Red with white stripe
27	11P4463	1	A35-BPC-P06 to (AMD3-P00) MDA3-J01, Red with white stripe
28	11P4464	1	B35-BPC-P06 to (AMD3-P01) MDA3-J02, Red
29	11P4466	1	A35-BPC-P07 to (AMD4-P01) MDA4-J02, Red
30	11P4465	1	B35-BPC-P07 to (AMD4-P00) MDA4-J01, Red with white stripe
31	11P1596	1	B35-BPC-P02 to UEPO J01, Red
32	11P1595	1	A35-BPC-P02 to UEPO J00, Red with white stripe
33	05N6740	1	A35-BPR-P00 to A13-IBF1-P00 B35-BPR-P00 to B13-IBF2-P00

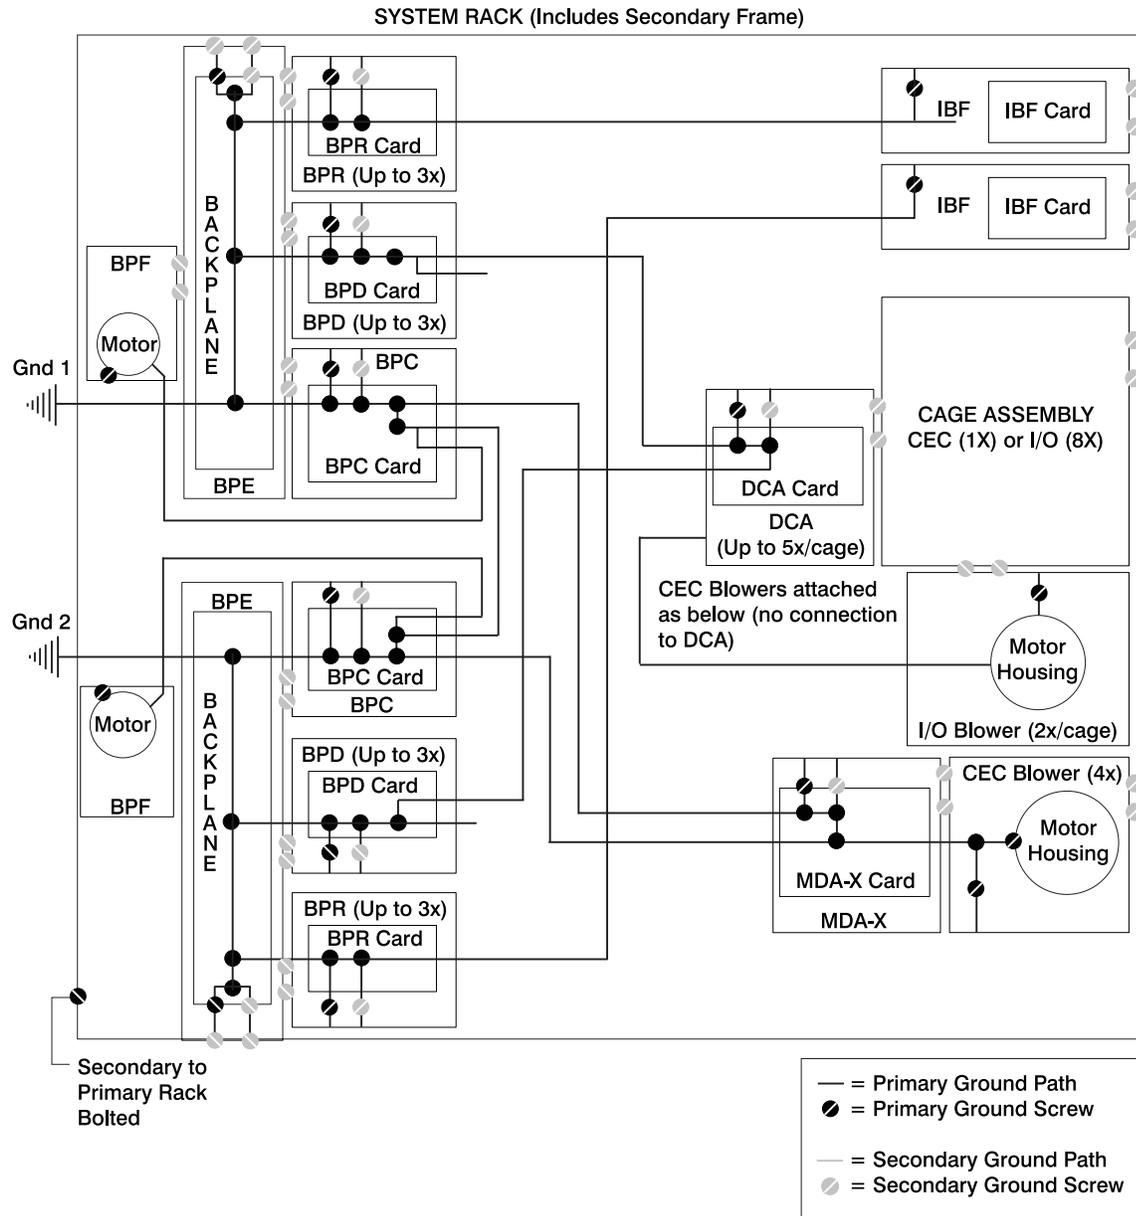
Appendix E. Ground Path

The ground path for the 406/90 is shown in the following figure.
