bullion S

Release Note

TS 24.05

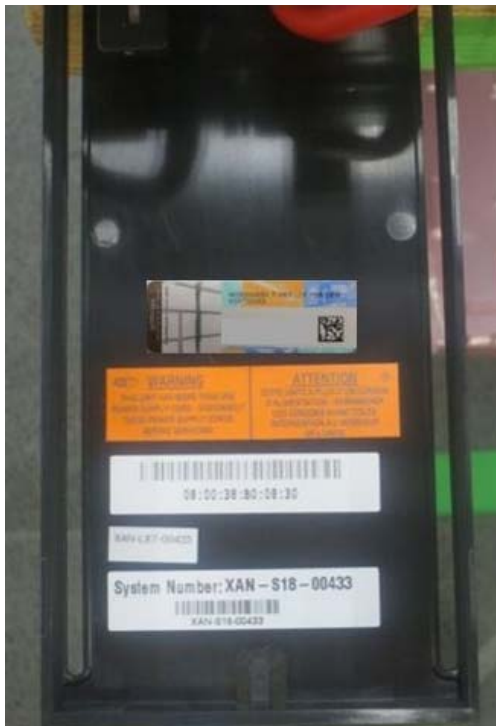
Press on the small drawer to open it and check the labels.
