Customer Release Note - TS007.03

■ Number DEL000906

■ Version G.1

This document is the customer release note for **Technical Status 007.03**.

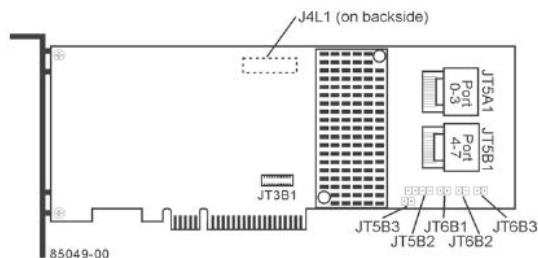
5.6.3. LSI MegaRAID® SAS 9261-8i and 9361-4i

Eight-Port 6Gb/s PCI Express SATA+SAS RAID Controller

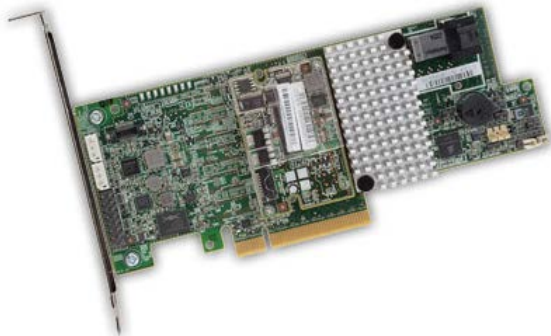
Four Port MegaRAID SAS 9361-4i 12Gb/s SAS and SATA RAID Controller

No external connector.

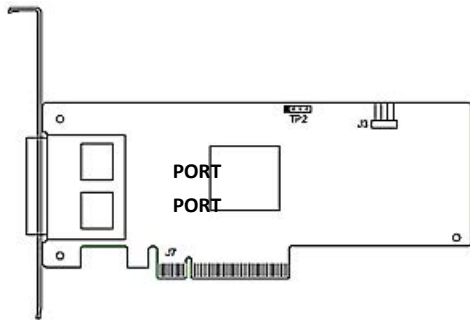
LSI SAS 9200-8e
8-Port, 6Gb/s SAS+SATA to PCI Exp HBA

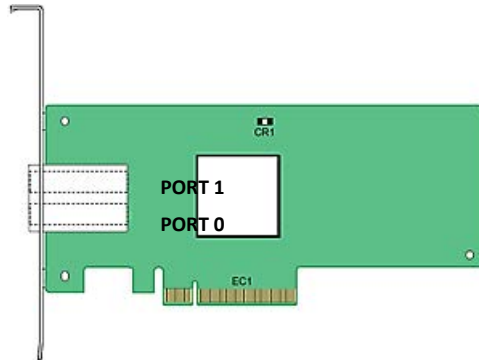
LSI SAS 9300-8e
8-Port 12Gb/s SAS+SATA to PCI Exp HBA

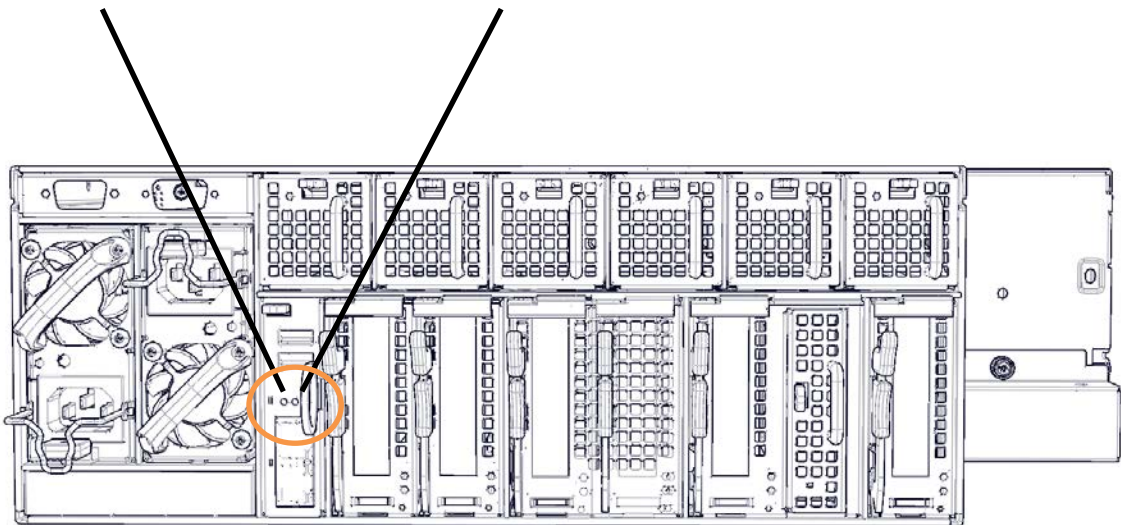
RESET button (left)

DEFAULT button (right)

The Reset and Default buttons are close together. Be careful to press the appropriate button indicated on the figure to reset the BMC / EMM.

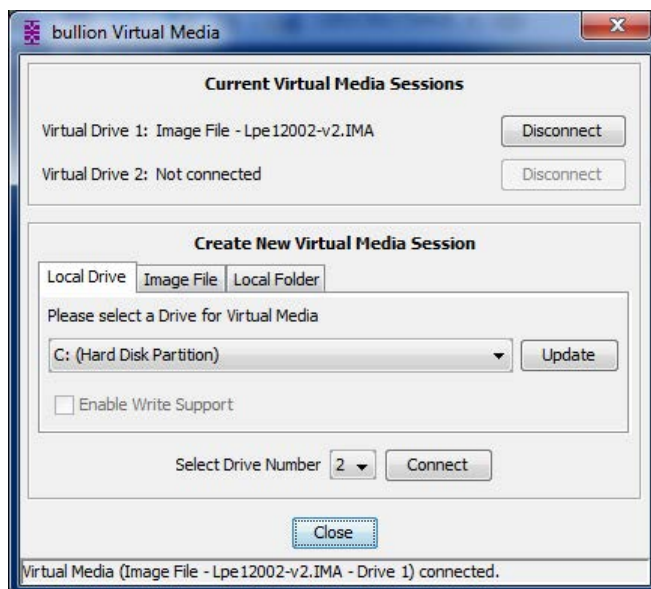
1. For virtual drive 1, select image file, browse to **Lpe12002-v2.ima**, and then click **Connect**.

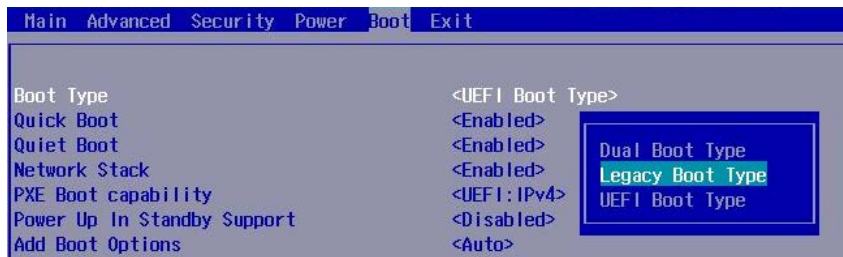
- In the **"Boot"** section, select for Boot type **"Legacy Boot Type"**. Save by pressing F10 and reboot the system in Legacy mode.
