Customer Release Note - TS008.03

■ Number DEL000906

■ Version I

1. Abstract and purpose of the release

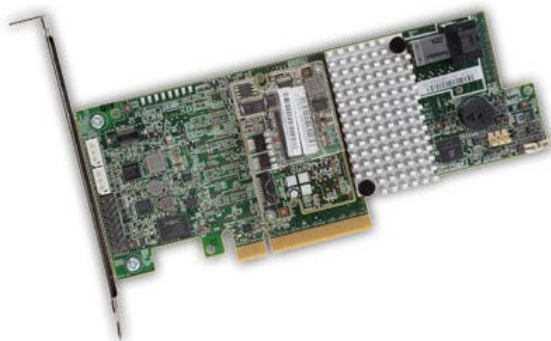
Four Port MegaRAID SAS 9361-4i 12Gb/s SAS and SATA RAID Controller

No external connector.

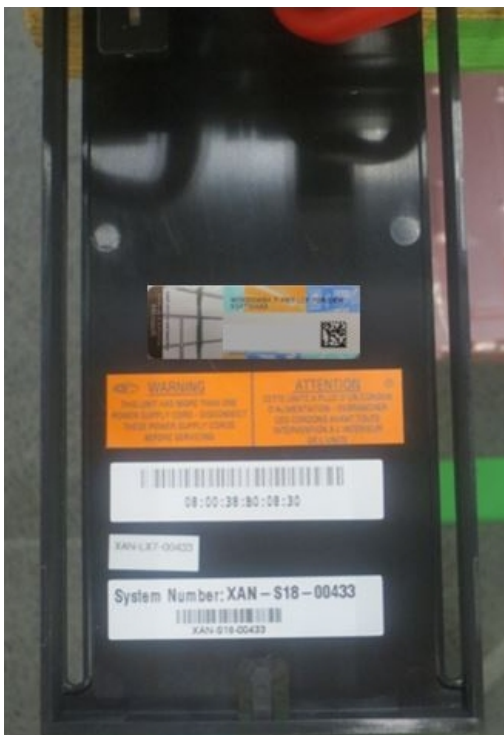
Press on the little drawer to open it and check the labels.
