bullion S

Release

Notes

TS 20.04

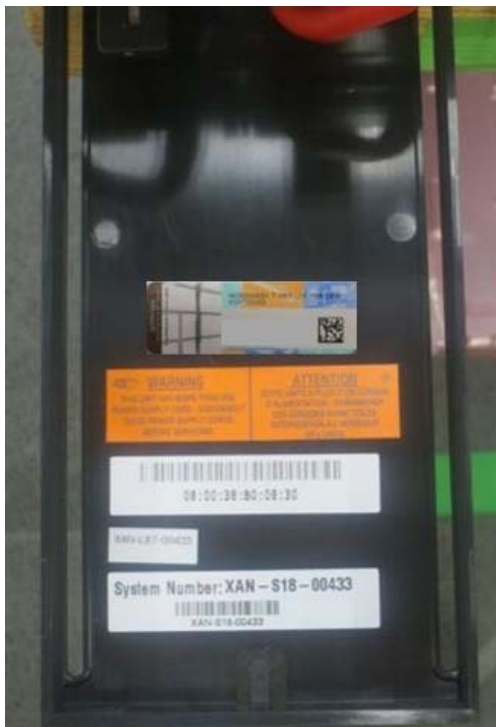
Press on the small drawer to open it and check the labels.
