bullion S
Release
Notes
TS 21.02

Hardware

This document gives some recommendations and information about known problems, restrictions and the associated workarounds.

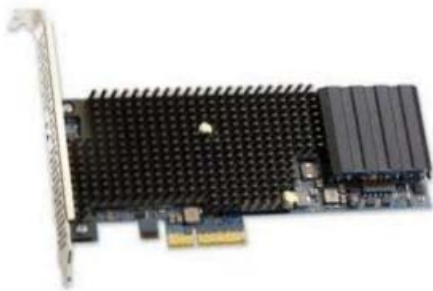
HGST Solid-State Drive - PCIe 1 TB S1122

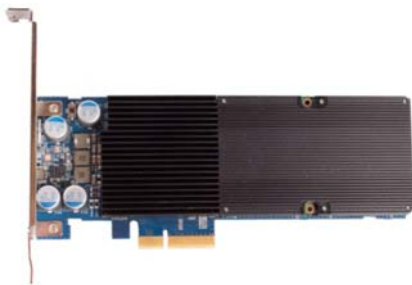
HGST PCIe Solid-State Accelerator - PCIe 1.6 TB SN150

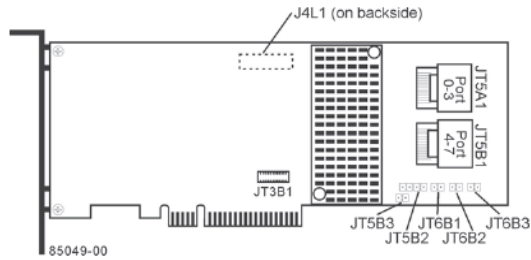
Eight Port MegaRAID SAS 9261-8i 6Gb/s PCI Express SATA+SAS RAID Controller

8 internal connectors.

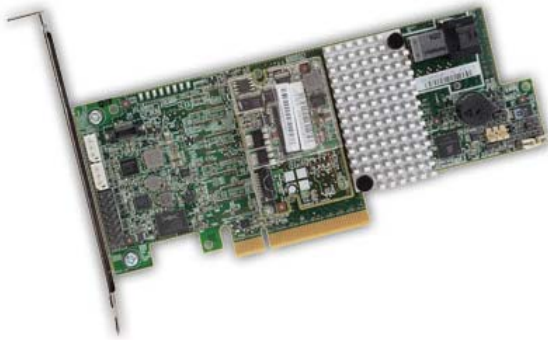
Four Port MegaRAID SAS 9361-4i 12Gb/s SAS and SATA RAID Controller

4 internal connectors.

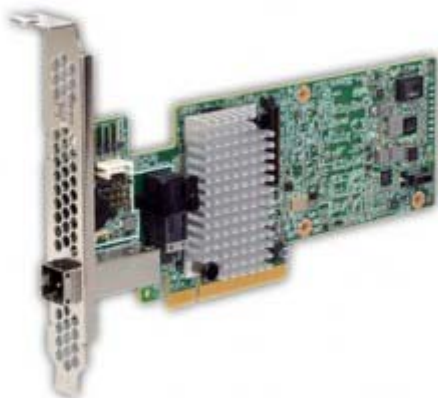
Eight Port MegaRAID SAS 9380-4i4e 12Gb/s SAS and SATA RAID Controller

4 internal connectors + 4 external connectors.

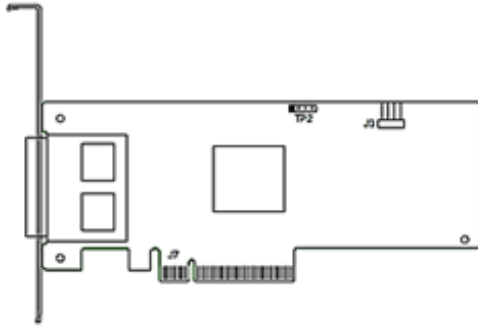
LSI SAS 9200-8e 8-Port, 6Gb/s SAS+SATA to PCI Exp HBA

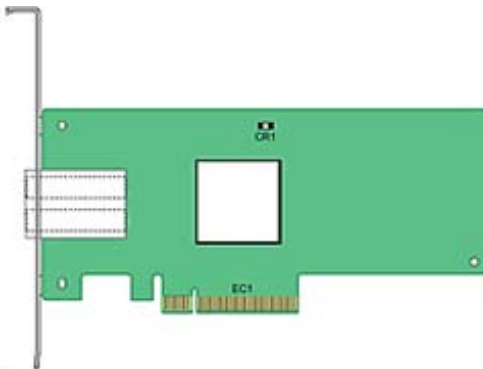
LSI SAS 9300-8e 8-Port 12Gb/s SAS+SATA to PCI Exp HBA

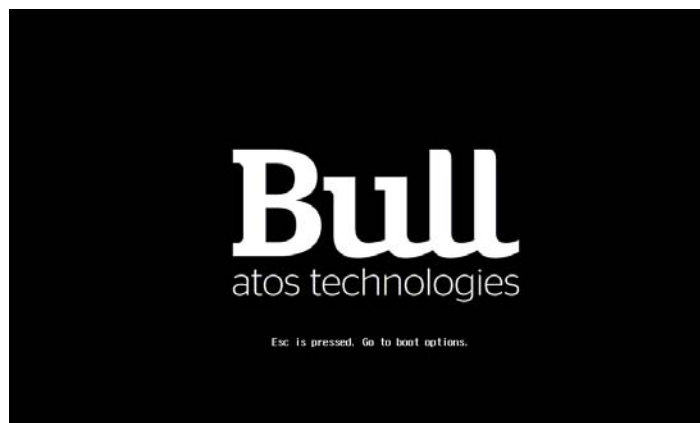
3. Launch the BIOS interface
 - a. Click **Power > Power Management** to open the **Power Management** page and click **Power On** to launch the boot sequence.
 - b. Switch to the Remote Console screen.
 - c. After a few minutes, the following screen is displayed.

Figure 4-1. Accessing the boot options
d. Press **[Esc]** to access the boot options.

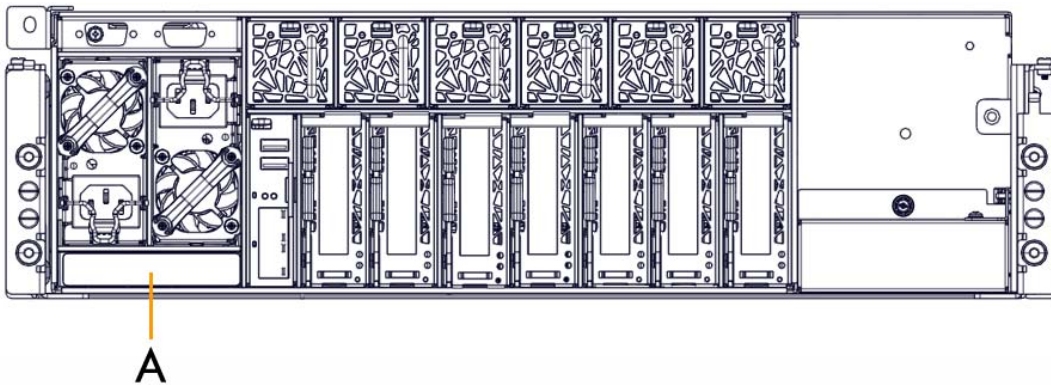
The identification labels are located at the rear of the server drawers in a small drawer (A).

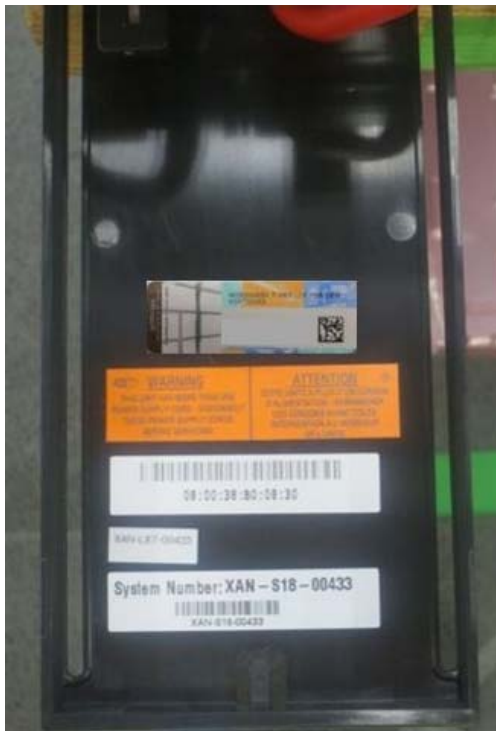
Press on the small drawer to open it and check the labels.

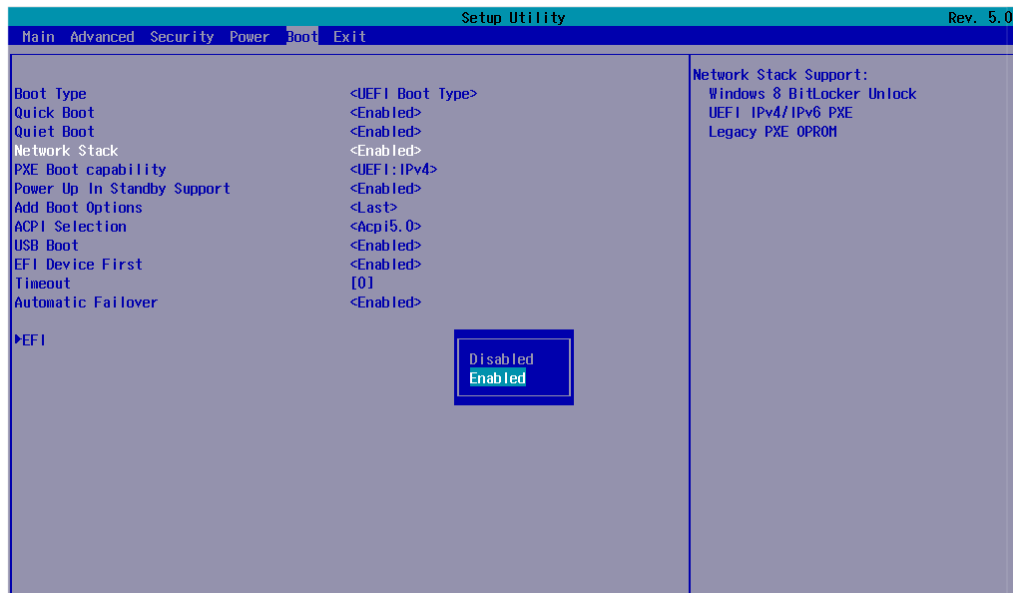
1. Open the BIOS interface as explained in this document
2. Configure PXE boot
 1. Click **Power > Power Management** to open the **Power Management** page and click **Power On** to launch the boot sequence.
 2. Switch to the Remote Console screen and follow the boot sequence.
 3. Press **[Esc]** when the **Hit [Esc] for Boot Menu** message is displayed.
 4. From the BIOS interface, select **Setup Utility > Boot > Network Stack** and press **[Enter]**.
 5. Use the Up and Down arrows to move to the **Enable** option.
 6. Press **[Enter]** to complete changes.

Figure 4-2. Boot configuration - Enabling Network Stack support

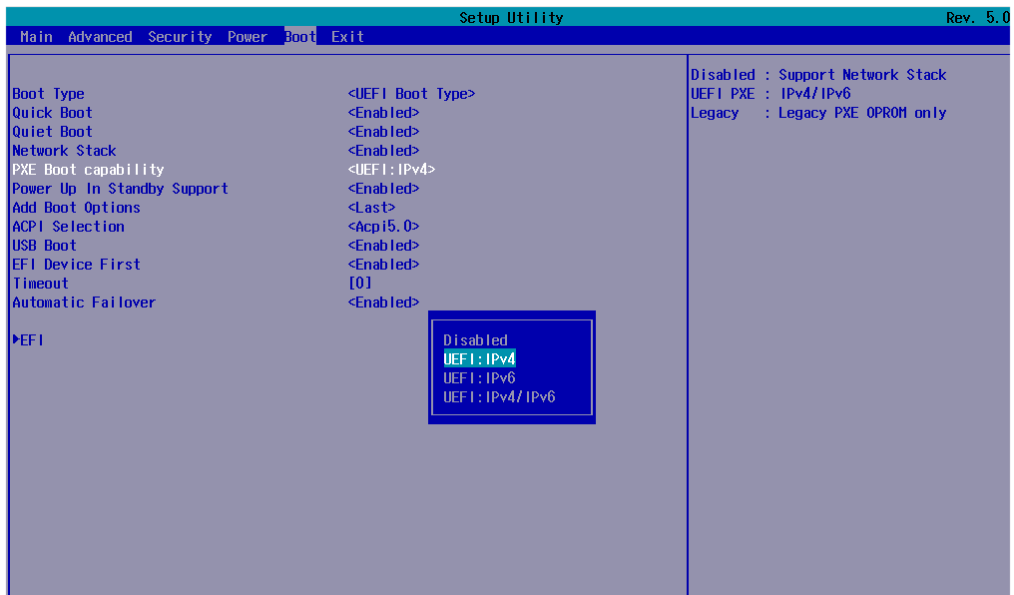
7. Select **PXE Boot capability** and press **[Enter]**.
8. Use the Up and Down arrows to move to an **UEFI** option.

Figure 4-3. Enabling PXE Boot capability - Example

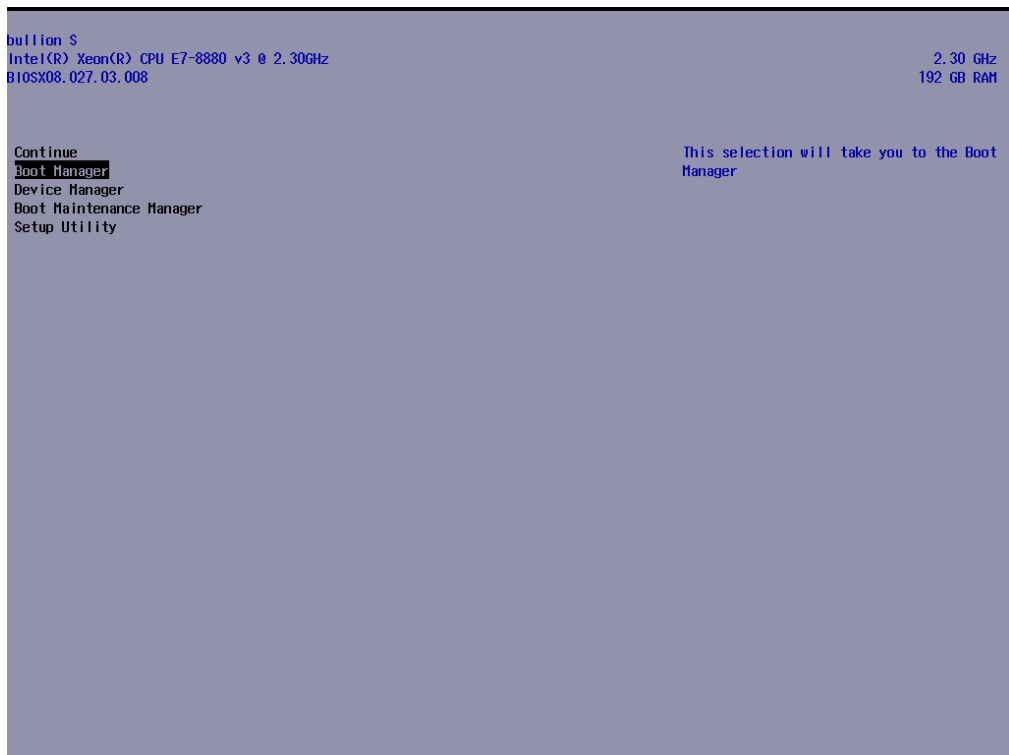
1. Using the navigation arrows, select **Boot Manager** from the main menu and press **[Enter]**.

Figure 4-4. Main Menu - Boot Manager
