bullion S
Release
Notes
TS 22.02

March 2017

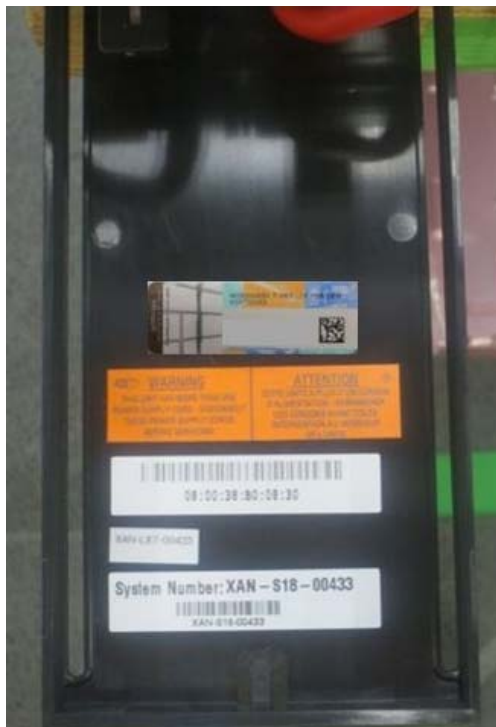
Press on the small drawer to open it and check the labels.
