**bullion S**  
Release  
Notes  
TS 23.03

This document gives some recommendations and information about known problems, restrictions and the associated workarounds.

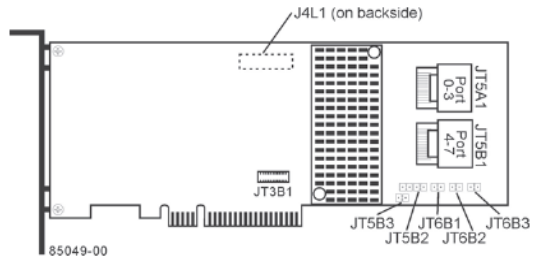
#### **Eight Port MegaRAID SAS 9261-8i 6Gb/s PCI Express SATA+SAS RAID Controller**

8 internal connectors.

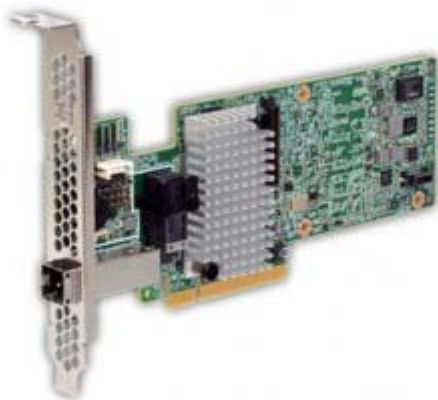
#### **Eight Port MegaRAID SAS 9380-4i4e 12Gb/s SAS and SATA RAID Controller**

4 internal connectors + 4 external connectors.

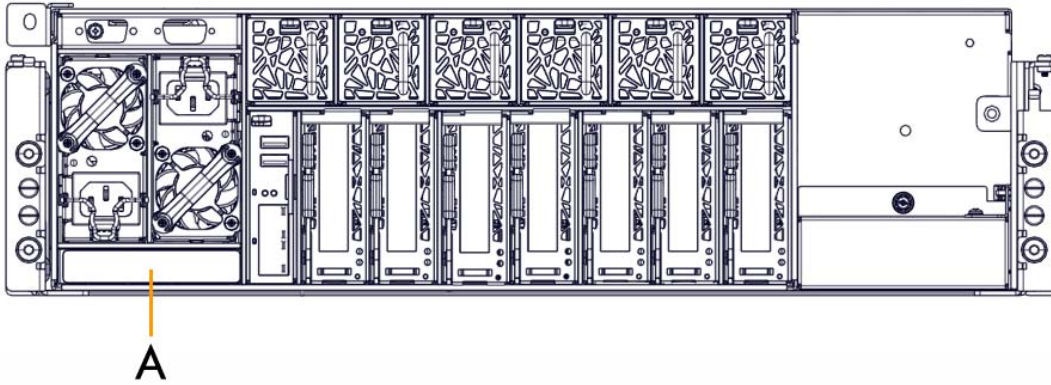
The identification labels are located at the rear of the server drawers in a small drawer (A).
