# bullion S

## Release Note

### TS 24.03

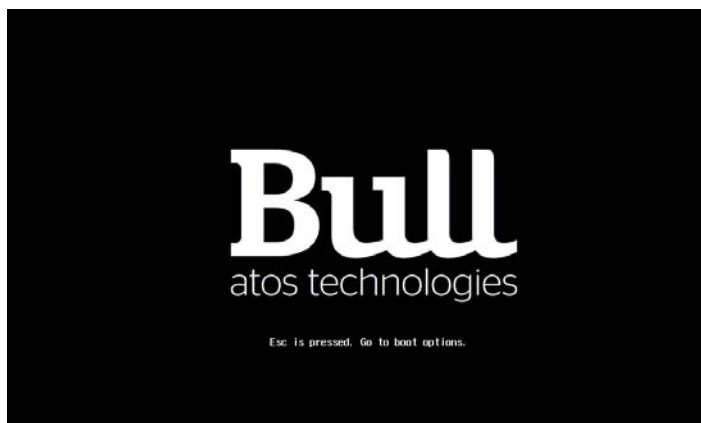
3. Launch the BIOS interface
  - a. Click **Power > Power Management** to open the **Power Management** page and click **Power On** to launch the boot sequence.
  - b. Switch to the Remote Console screen.
  - c. After a few minutes, the following screen is displayed.

Figure 4-1. Accessing the boot options  
d. Press **[Esc]** to access the boot options.
