# Release Note TS 25.01

This document gives some recommendations and information about known problems, restrictions and the associated workarounds.

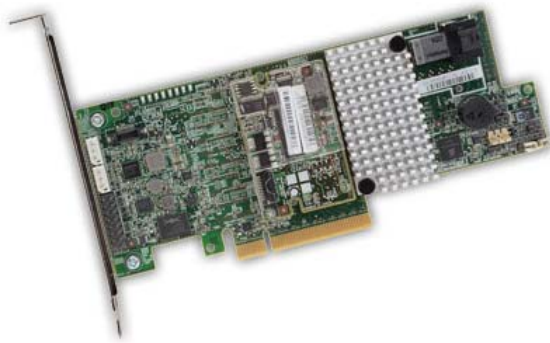
#### **Four Port MegaRAID SAS 9361-4i 12Gb/s SAS and SATA RAID Controller**

4 internal connectors.

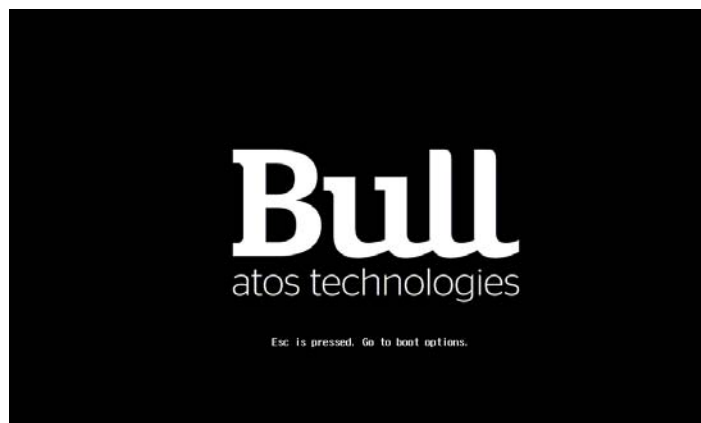
3. Launch the BIOS interface
  - a. Click **Power > Power Management** to open the **Power Management** page and click **Power On** to launch the boot sequence.
  - b. Switch to the Remote Console screen.
  - c. After a few minutes, the following screen is displayed.

Figure 4-1. Accessing the boot options  
d. Press **[Esc]** to access the boot options.
