Release Note TS 026.03

Hardware

This document gives some recommendations and information about known problems, restrictions and the associated workarounds.

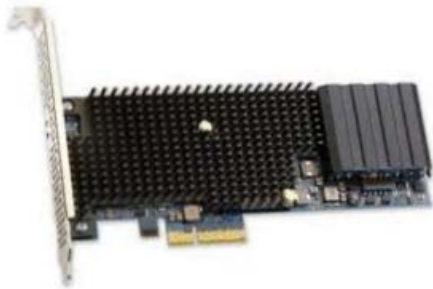
HGST Solid-State Drive - PCIe 1 TB S1122

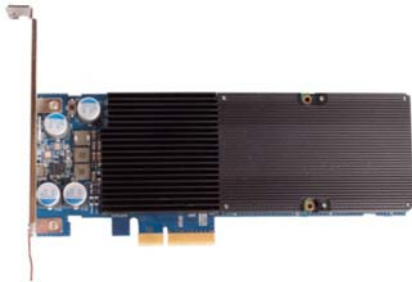
HGST PCIe Solid-State Accelerator - PCIe 1.6 TB SN150

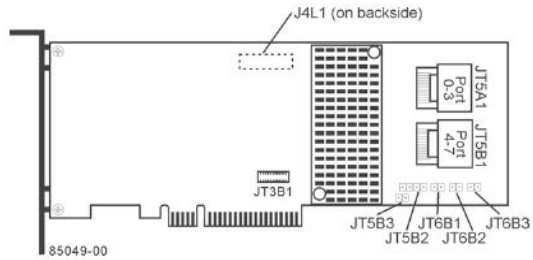
Eight Port MegaRAID SAS 9261-8i 6Gb/s PCI Express SATA+SAS RAID Controller

8 internal connectors.

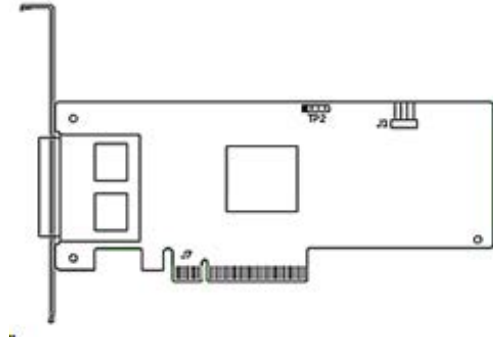
LSI SAS 9200-8e 8-Port, 6Gb/s SAS+SATA to PCI Exp HBA

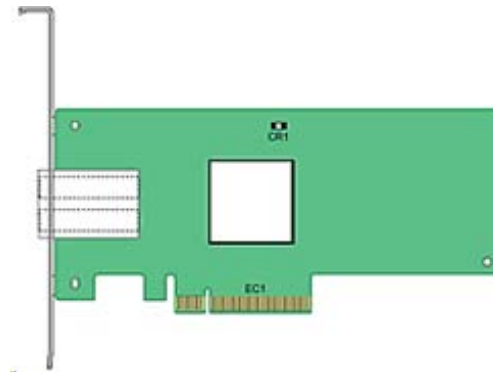
LSI SAS 9300-8e 8-Port 12Gb/s SAS+SATA to PCI Exp HBA

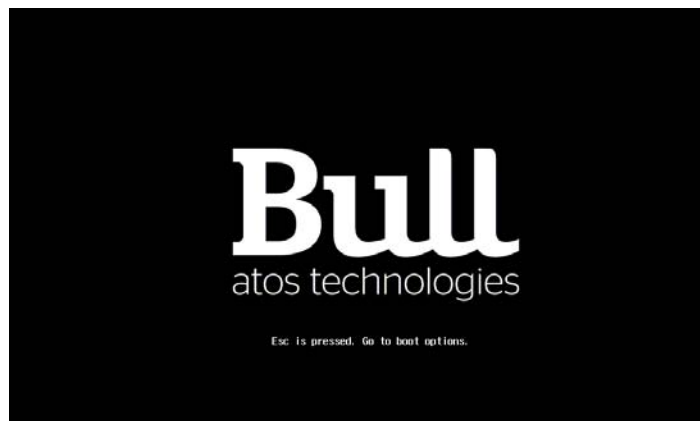
Figure 4-1. Accessing the boot options
d. Press **[Esc]** to access the boot options.

3. Launch the BIOS interface
 - a. Click **Power > Power Management** to open the **Power Management** page and click **Power On** to launch the boot sequence.
 - b. Switch to the Remote Console screen.
 - c. After a few minutes, the following screen is displayed.

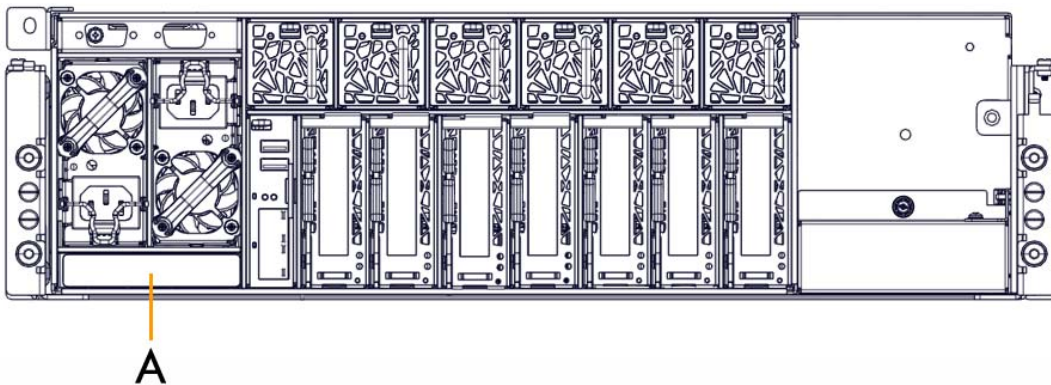
The identification labels are located at the rear of the server drawers in a small drawer (A).

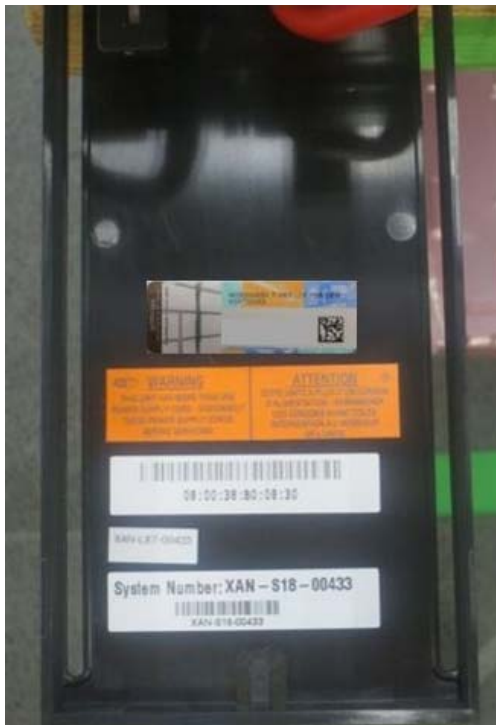
Press on the small drawer to open it and check the labels.
