# bullion S

Release Note

TS 23.05

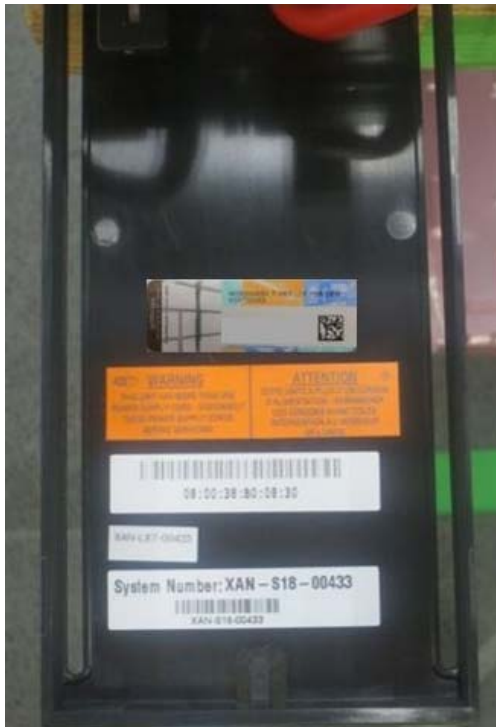
Press on the small drawer to open it and check the labels.
