<p>Doc. reference: NS-HT-003 Version 2.0</p>	<h1>bullion How To</h1>

<p>Product:</p>	<p>novascale bullion</p>	<p>Issued : December 2, 2013</p>
<p>Subject:</p>	<p>Procedure to update firmware of Emulex, LSI and Intel adapters</p>	
<p>Abstract:</p>	<p>This note explains how to update the firmware & boot code of PCIe adapters:</p> <p>Emulex Fiber Chanel & CNA:</p> <ul style="list-style-type: none"> - lpe1150 - lpe1250 - lpe11002 - lpe12002 - OCE11102 <p>LSI MegaRAID SAS 9261-8i,</p> <p>Intel Ethernet:</p> <ul style="list-style-type: none"> - I350 T2/T4 - X520 SR2/DA2

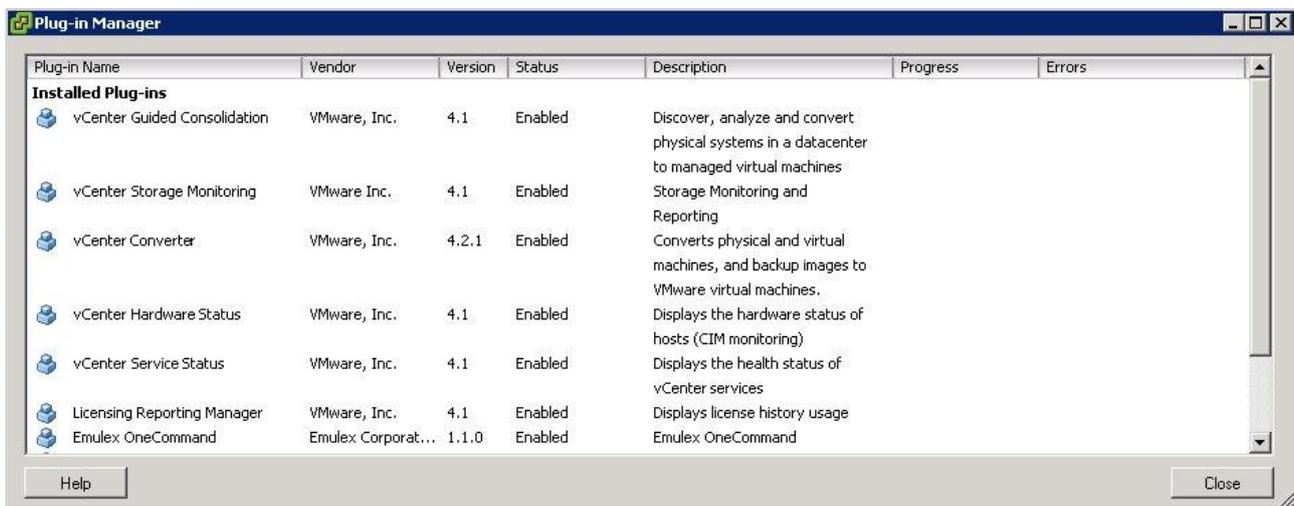
- In the vSphere console select **Plug-ins** from the menu bar and select **Manage Plug-ins**.

The Plug-in Manager window appears.

In the Plug-in Manager window check the status of OCM for VMware vCenter (Emulex OneCommand) is 'enabled'.

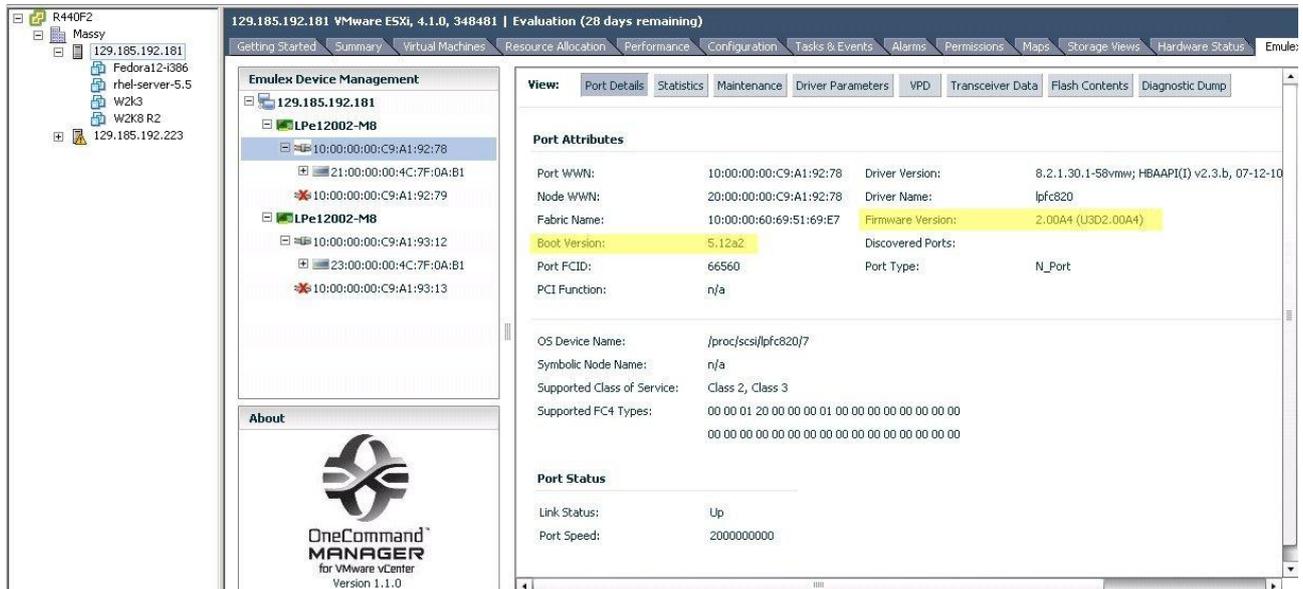
1.1.3 Getting the current Firmware and Boot Code versions

Expand the tree under “Emulex Device Management”, select a port, then click on the “Port Details” button in the 'View' area.

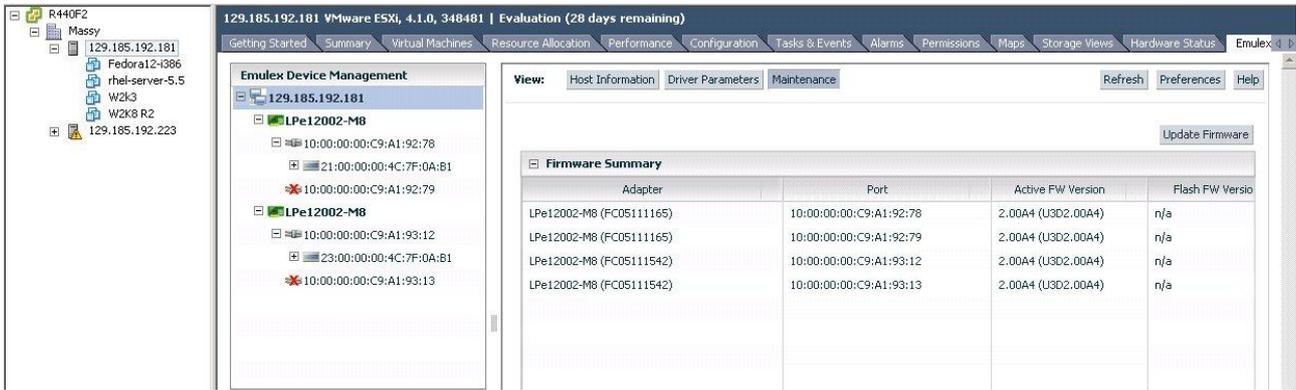
Select the Host in the tree under “Emulex Device Management”, and click on the “Maintenance” button

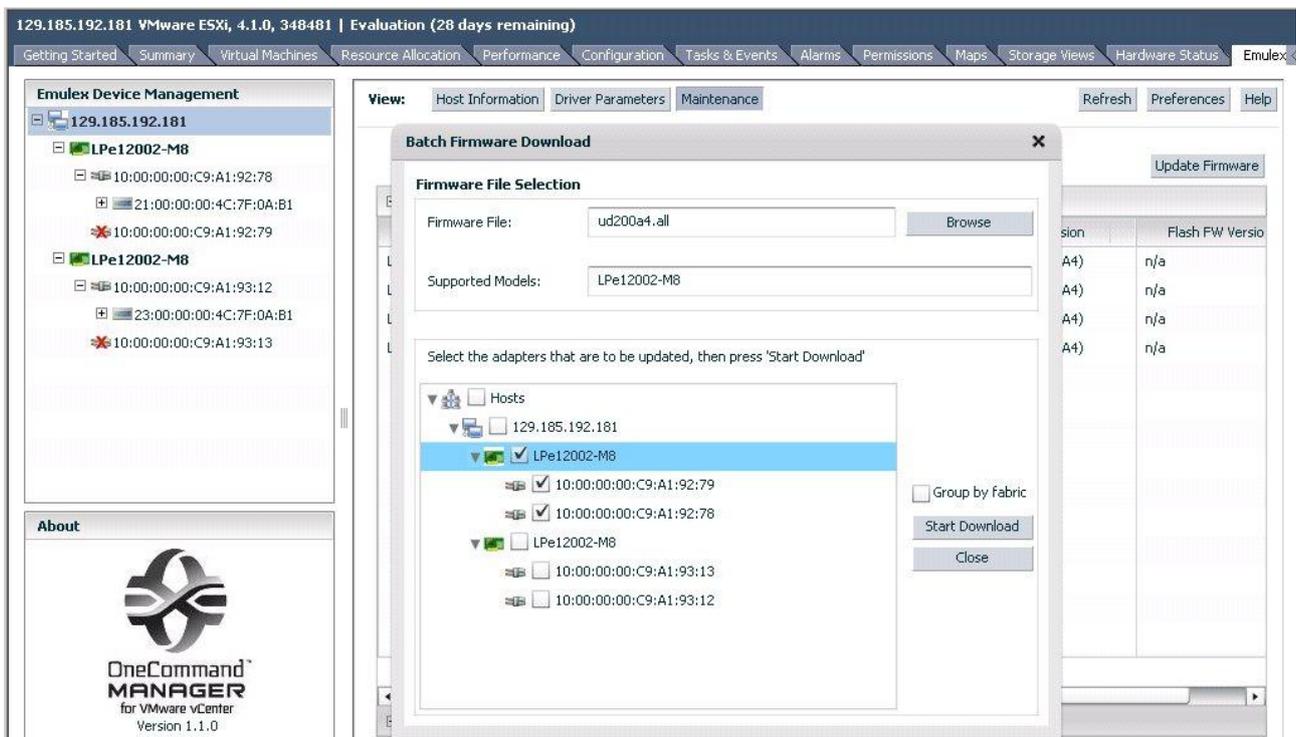
Then click on the “Update Firmware” button. The “Batch Firmware Download” window is displayed. Thru this interface, use the “Browse” button to select the ‘firmware’ or ‘Boot code’ file containing the new version. Select the adapters to be updated, at the level of Port, adapter, Host or Fabric. Then, click the “Start Download” button to initialize the firmware update

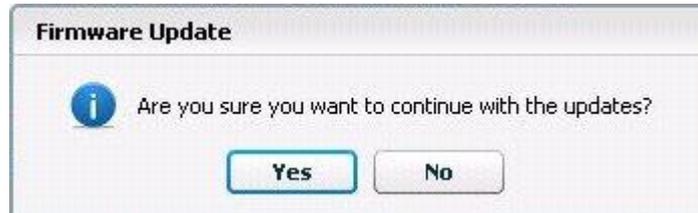
Click on the “Yes” button in the “Firmware Update” dialog box to continue with the update.

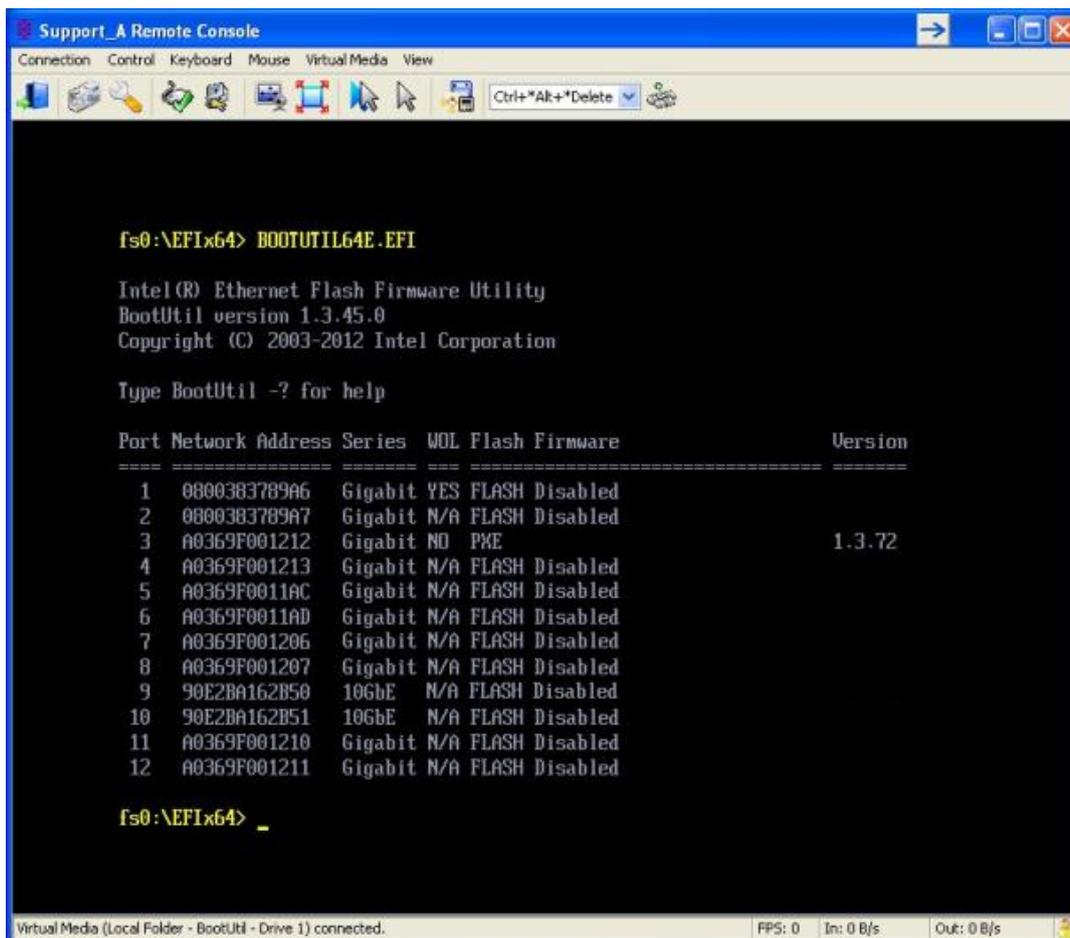
```
bootutil64e.efi
```

Example:

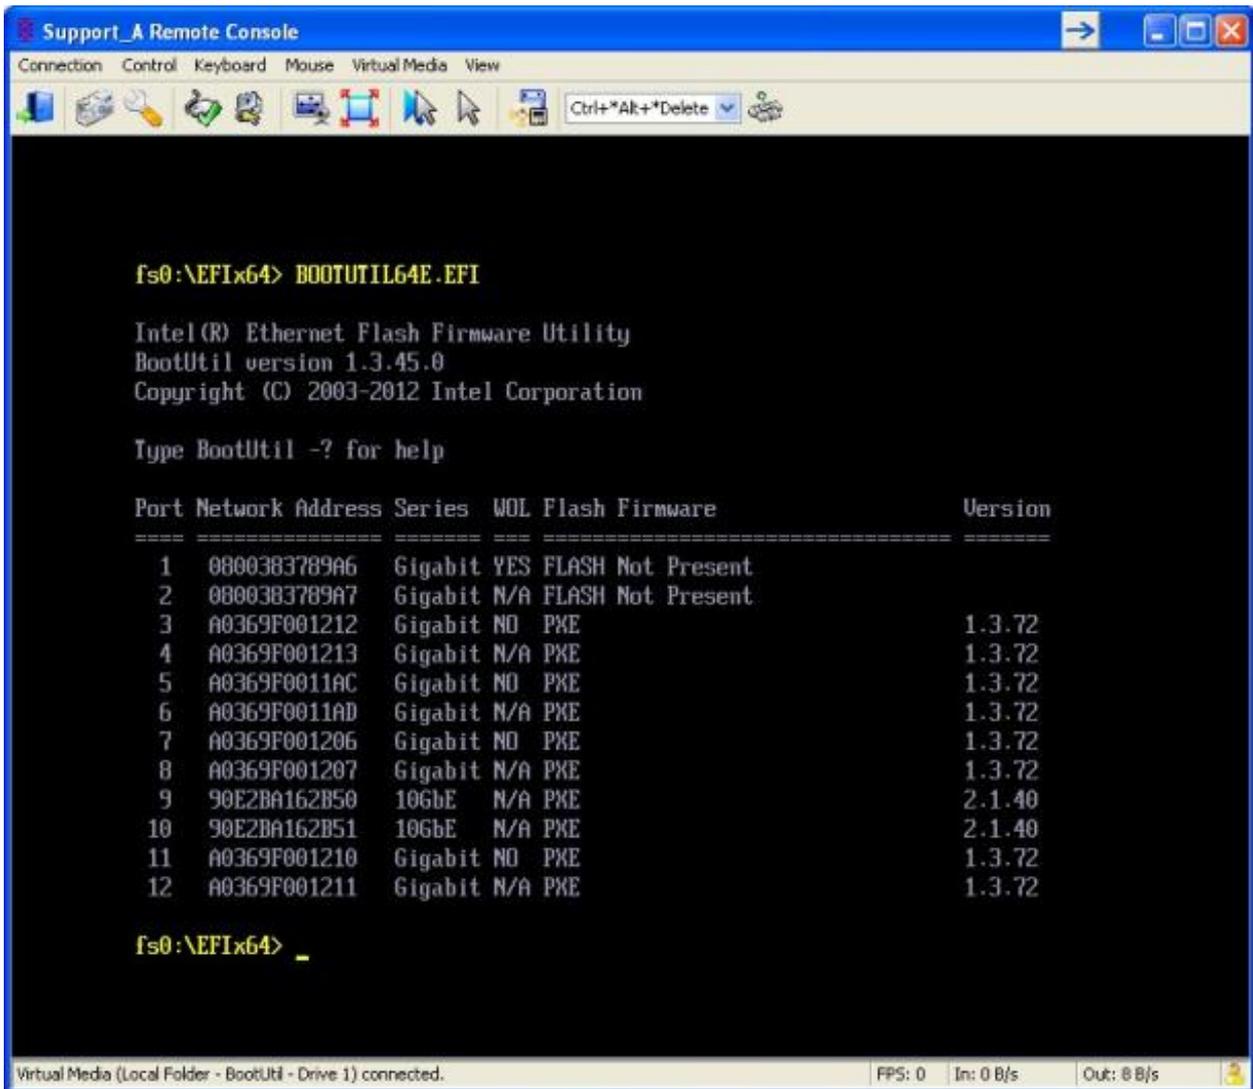
After the server reboot, the firmware versions are displayed:

In this view, ports 1 and port 2 are the ones of the embedded Ethernet controller (kawela), which is NOT upgradable with the 'bootutil' utility.
