# Release Note TS 019.03

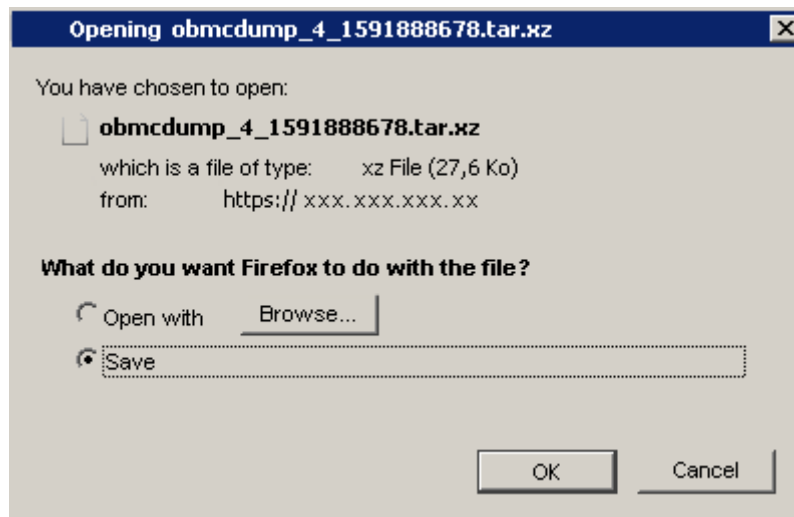
5. When the Success message appears, click Download log file

6. Save the archive of the BMC logs, as required.

When experiencing any issue with the system, it is strongly recommended to collect the BMC logs. The logs usually contain the information that will help solve the issue.
