Release Note TS 018.03

Hardware

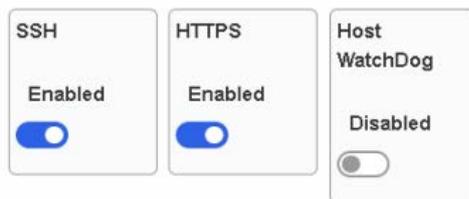
Ports Control

1. Connect to the Server Hardware Console (SHC).
2. From the **Control** tab, click **Security Settings**. The **Ports Control** page opens.

3. Click the SSH switch to enable the SSH.
