Release Note TS 044.01

Hardware

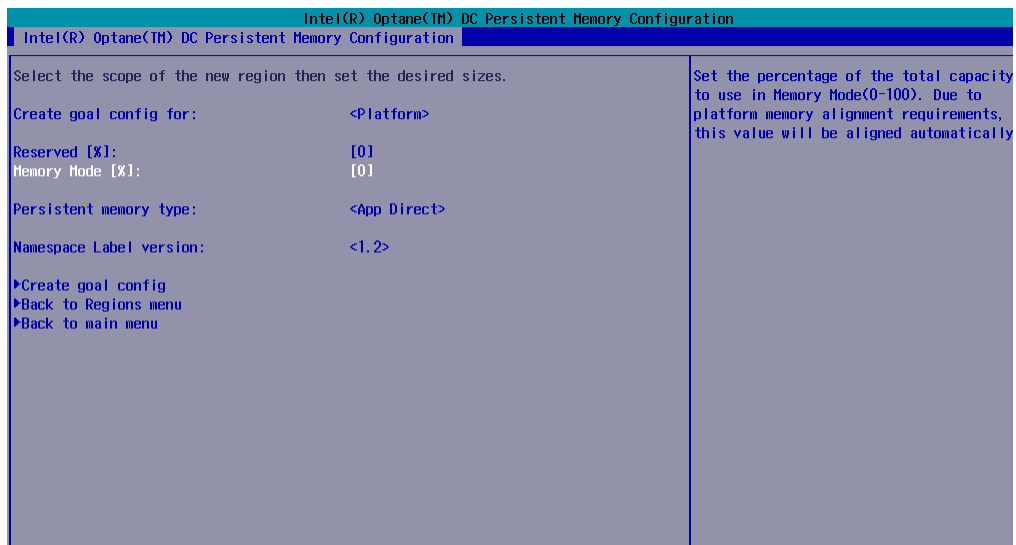
Check that Intel® Optane™ DC Persistent Memory (DCPMM) configuration is as follows:

Reserved [%]:	[0]
Memory Mode [%]:	[0]
Persistent memory type:	<App Direct>
