**BullSequana S**

# Release Note TS 074.02

86 A1 28FR 37 - October 2024

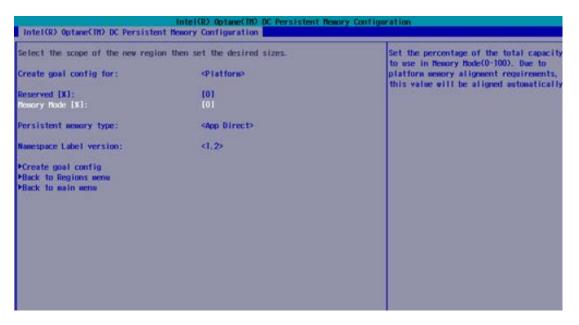
Check that Intel® Optane<sup>™</sup> DC Persistent Memory (DCPMM) configuration is as follows:

Reserved [%]: [0]

Memory Mode [%]: [0]
