# Release Note TS 034.02

### **Hardware**

**November 2020**

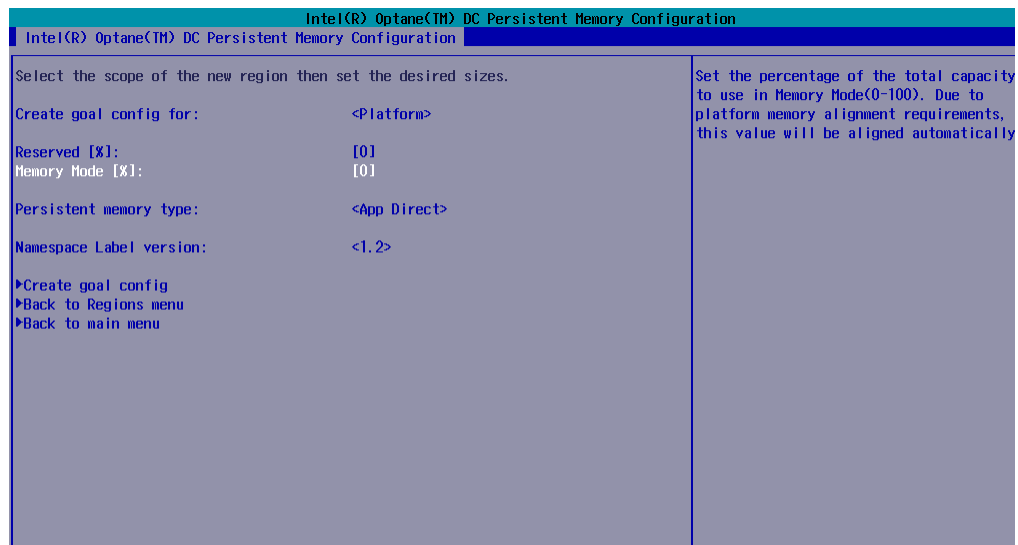
Check that Intel® Optane™ DC Persistent Memory (DCPMM) configuration is as follows:

Reserved [%]: [0]  
Memory Mode [%]: [0]  
Persistent memory type: <App Direct>

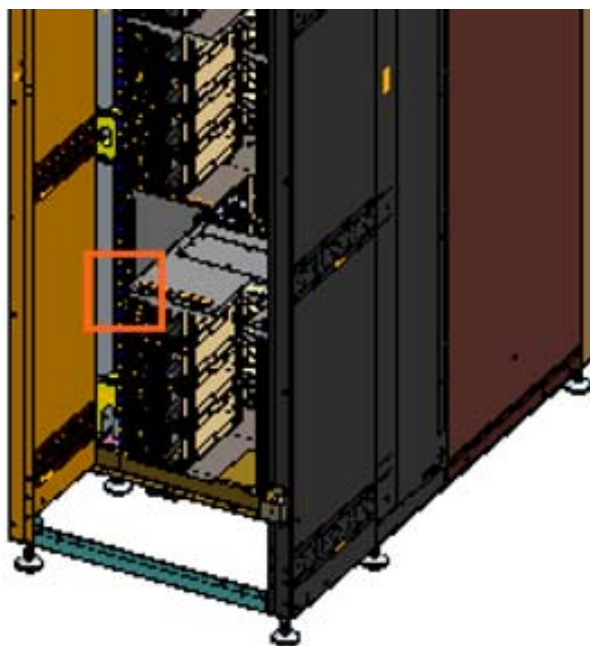
**Rear view**

2. Position the alignment accessory using the guiding pin.
3. Tighten the screws.

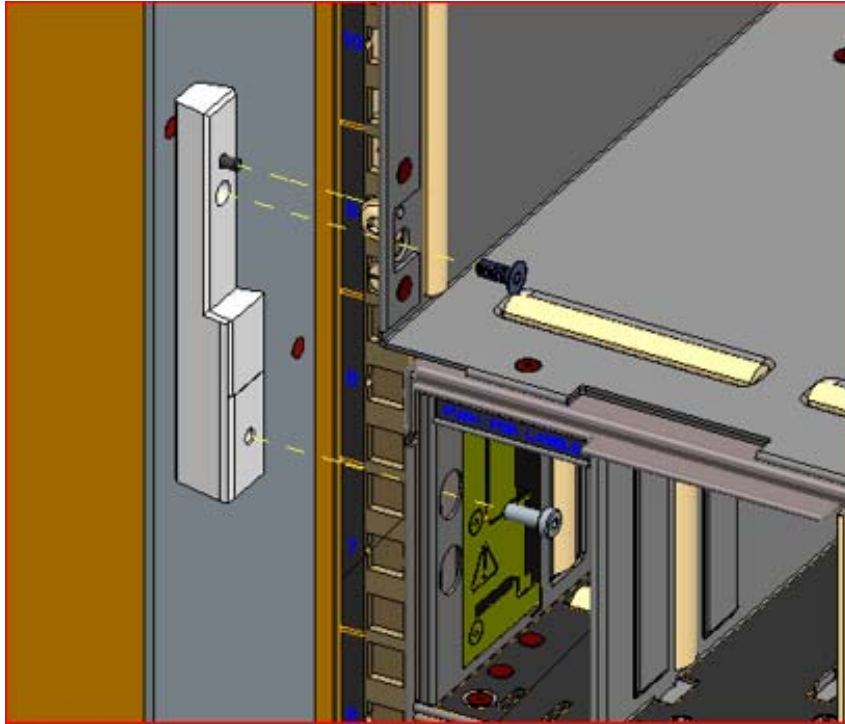
**Rear view**

**2. Align the top BullSequana S800 chassis with the UBox chassis**

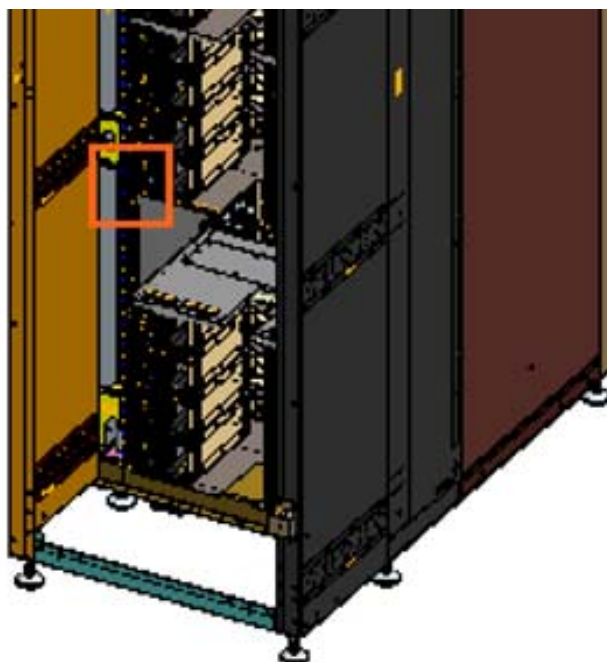
**Rear view**

1. Locate where the two chassis meet.

2. Position the alignment accessory using the guiding pin.
3. Tighten the screws.

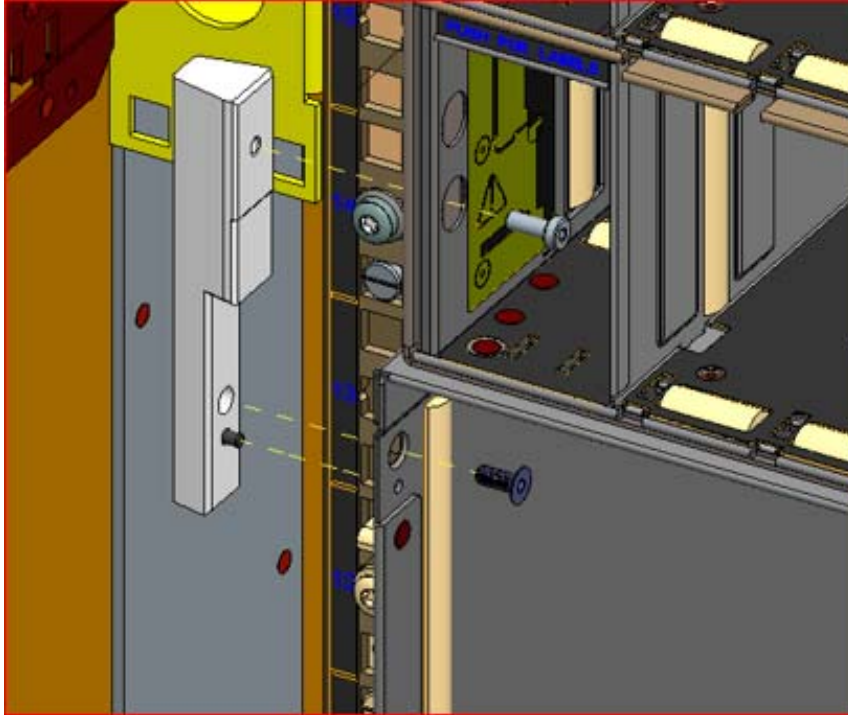
**Rear view**

3. **Install the 8-module connecting box as described in the Installation Guide**
