# Isolation Procedures

ESCALA Power7

REFERENCE  
86 A1 50FF 05

## Hardware

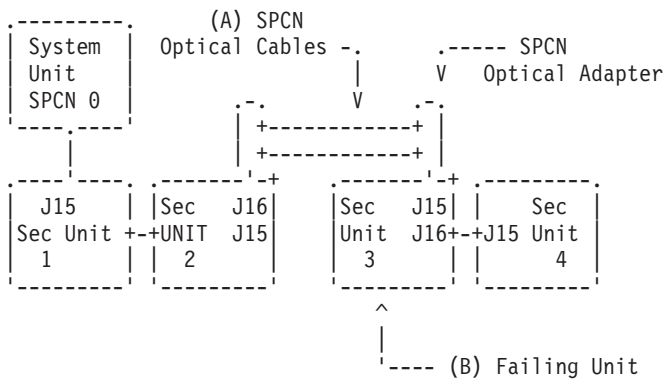
14. Do the SPCN optical cables (A) connect the failing unit (B) to the preceding unit in the chain or loop?
